Aircraft Accident Investigation Bureau of Myanmar

**FINAL REPORT OF SERIOUS INCIDENT OF NOSE LANDING GEAR
FAILURE EMERGENCY LANDING OF MYANMAR NATIONAL AIRLINES,
EMBRAER-190 AIRCRAFT (REG: XY-AGQ) AT MANDALAY
INTERNATIONAL AIRPORT, ON 12 MAY, 2019**

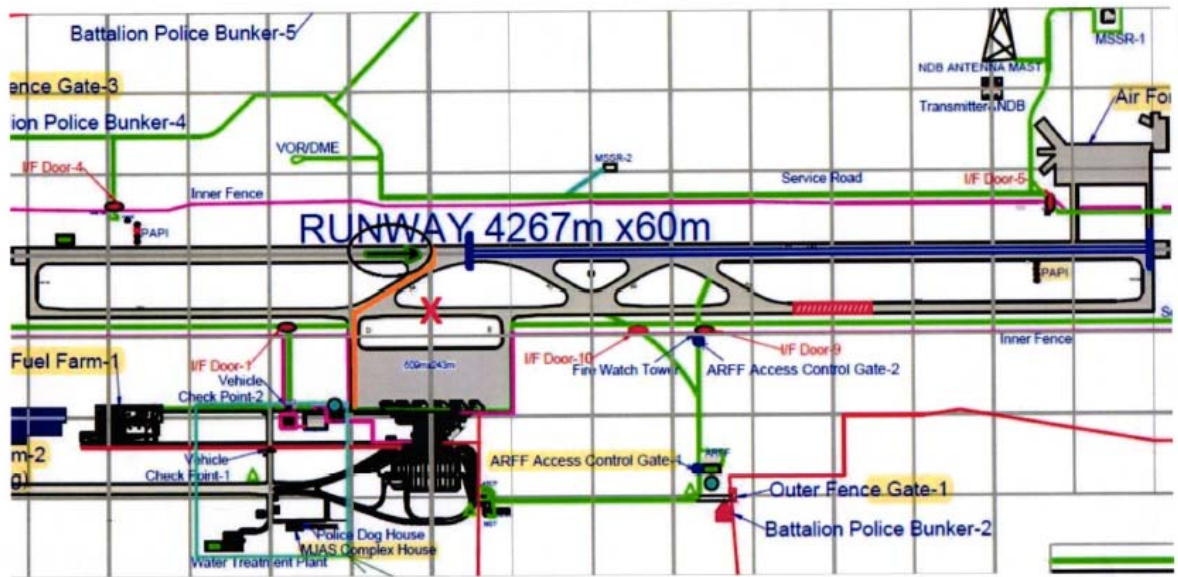
Figure(1) Layout of Serious Incident Site

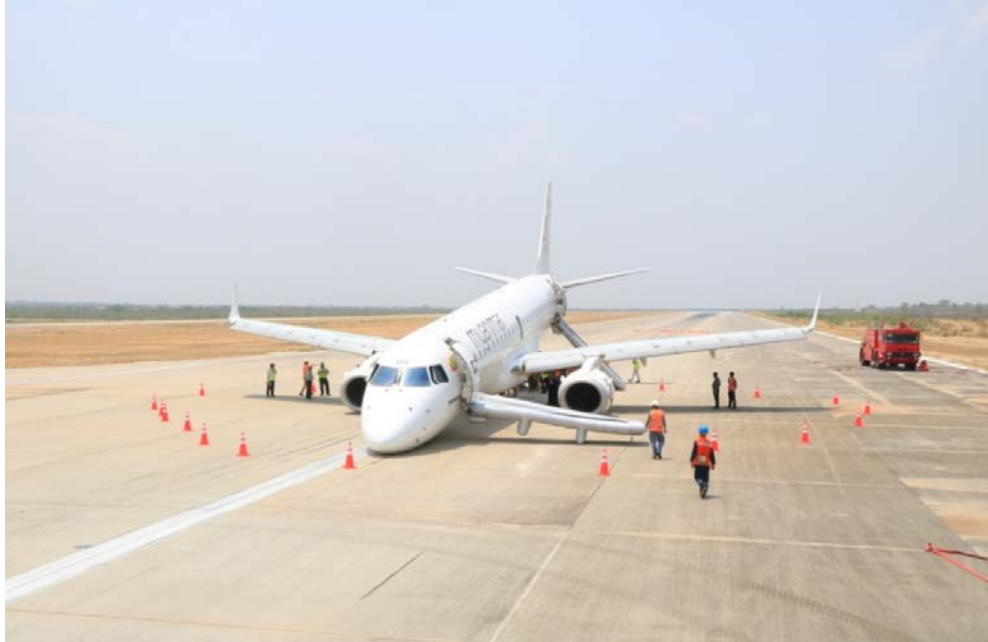
Figure (2) The final position of the aircraft on the runway of Mandalay International Airport

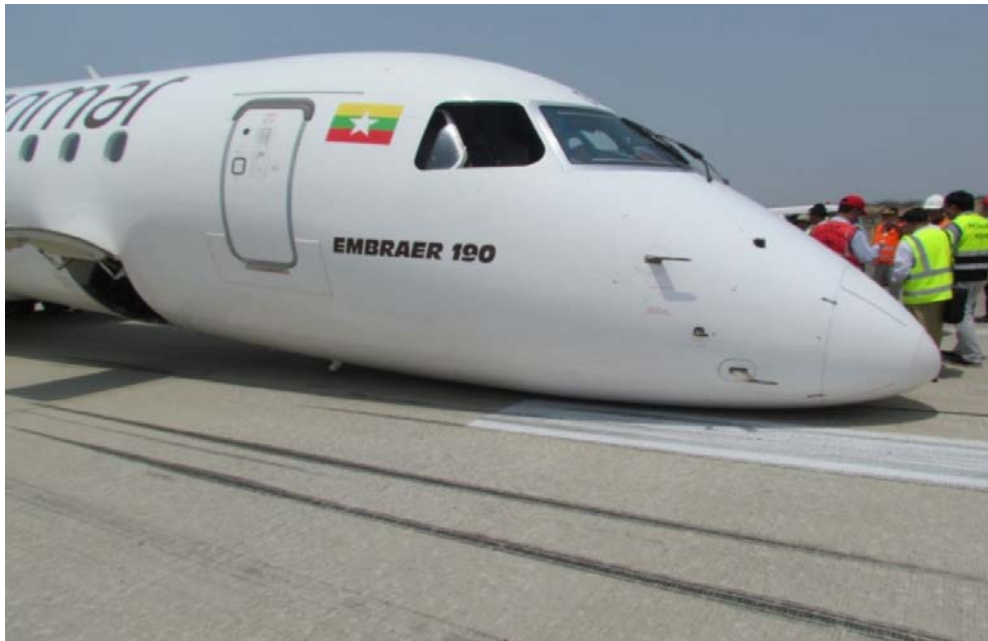
Figure (3) Closer view of the aircraft nose contact with the runway

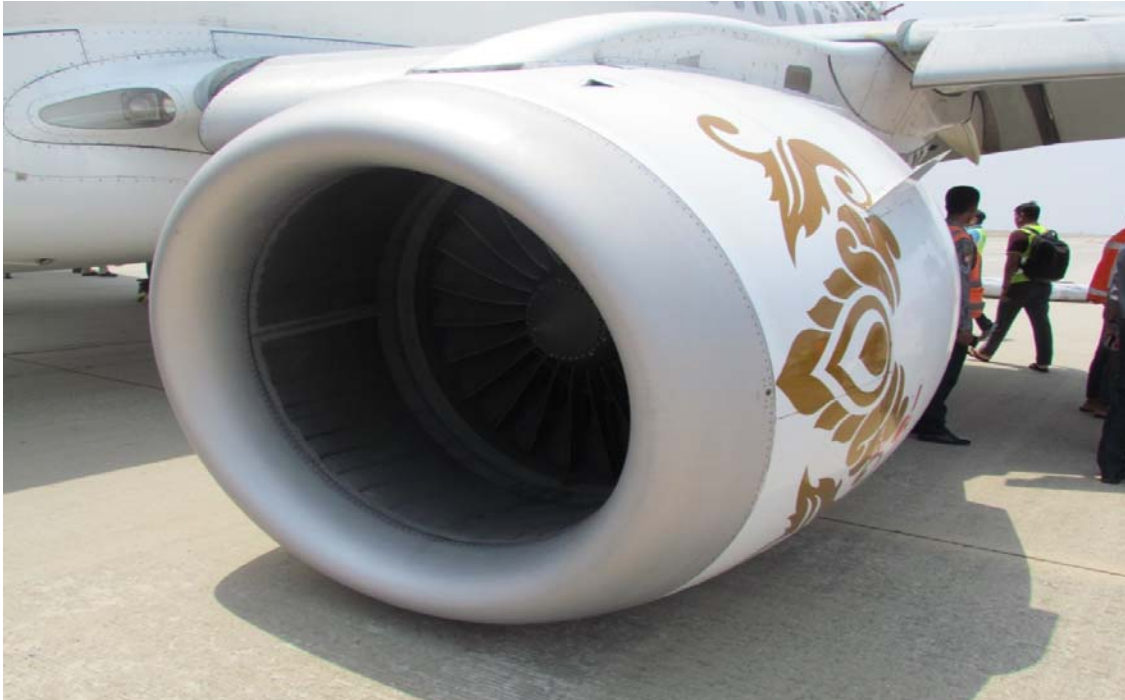
Figure (4) Left engine Cowling contact with the runway

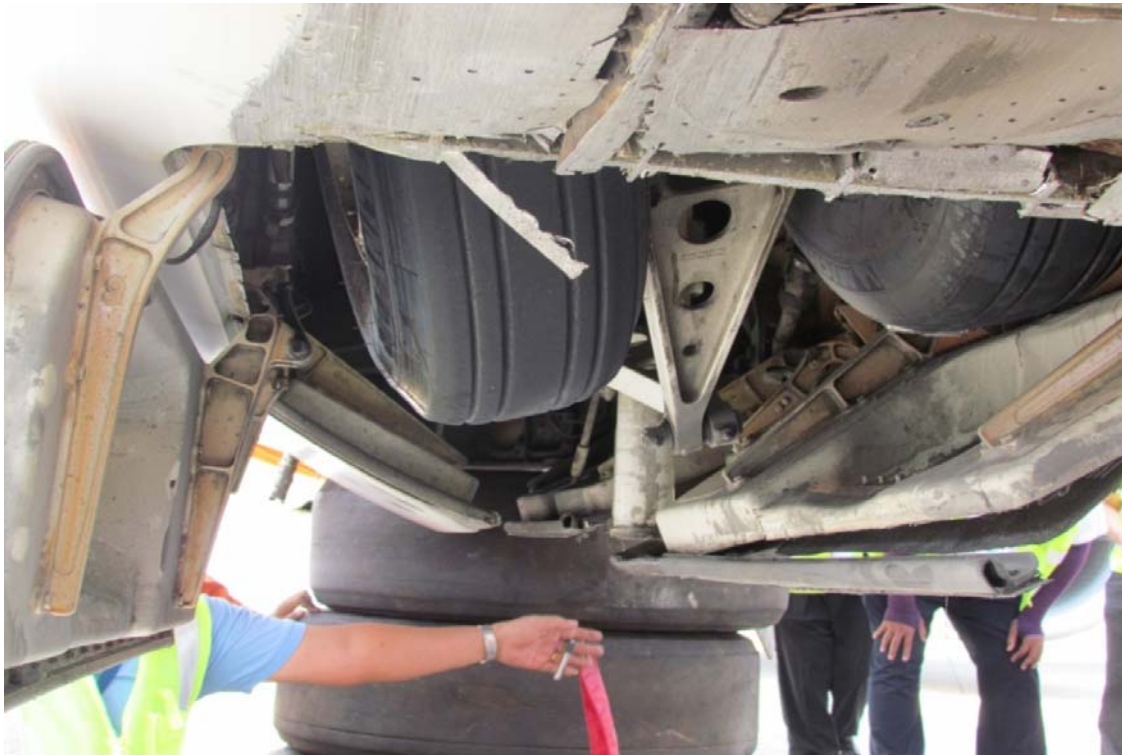
Figure (5) Closer view of the nose landing gear in the wheel well

When the investigation team arrived at the incident site, the disabled aircraft was on the runway of Mandalay international airport. The investigation team took the visual inspection of the aircraft itself and the impact marks on the runway. The nose landing gear door was found open ajar but the nose landing gear itself was misaligned and stuck in the wheel well. For the disabled aircraft removal, they discharged Nitrogen from the oleo of the nose landing gear and managed to lever it out.

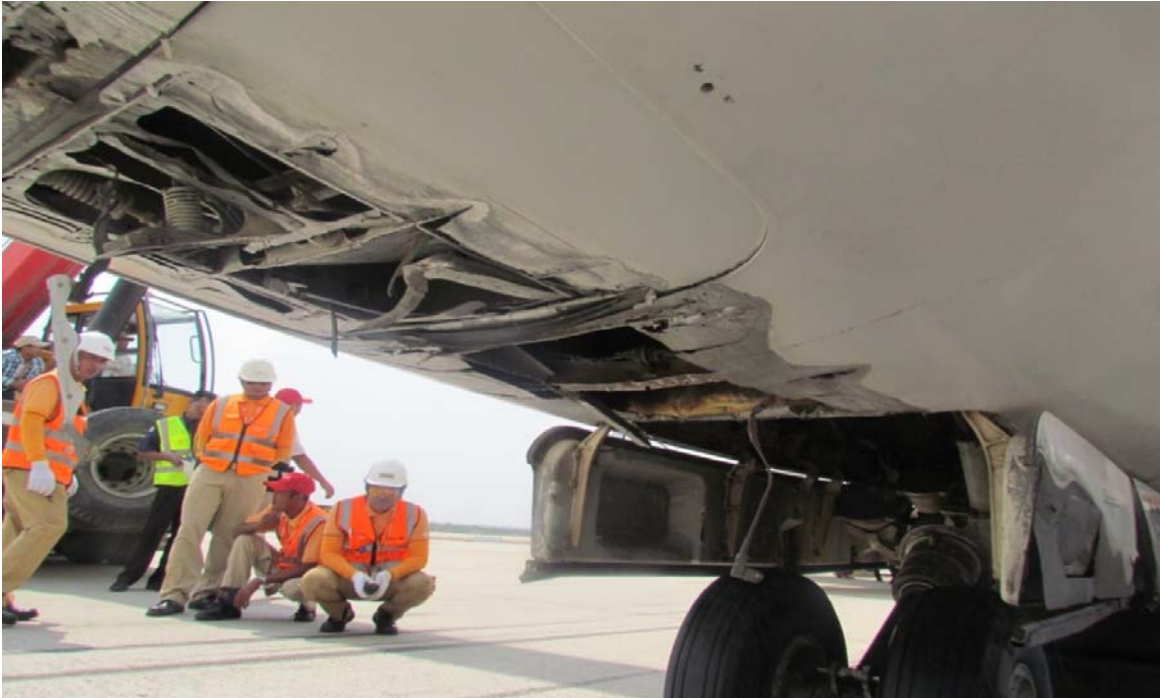
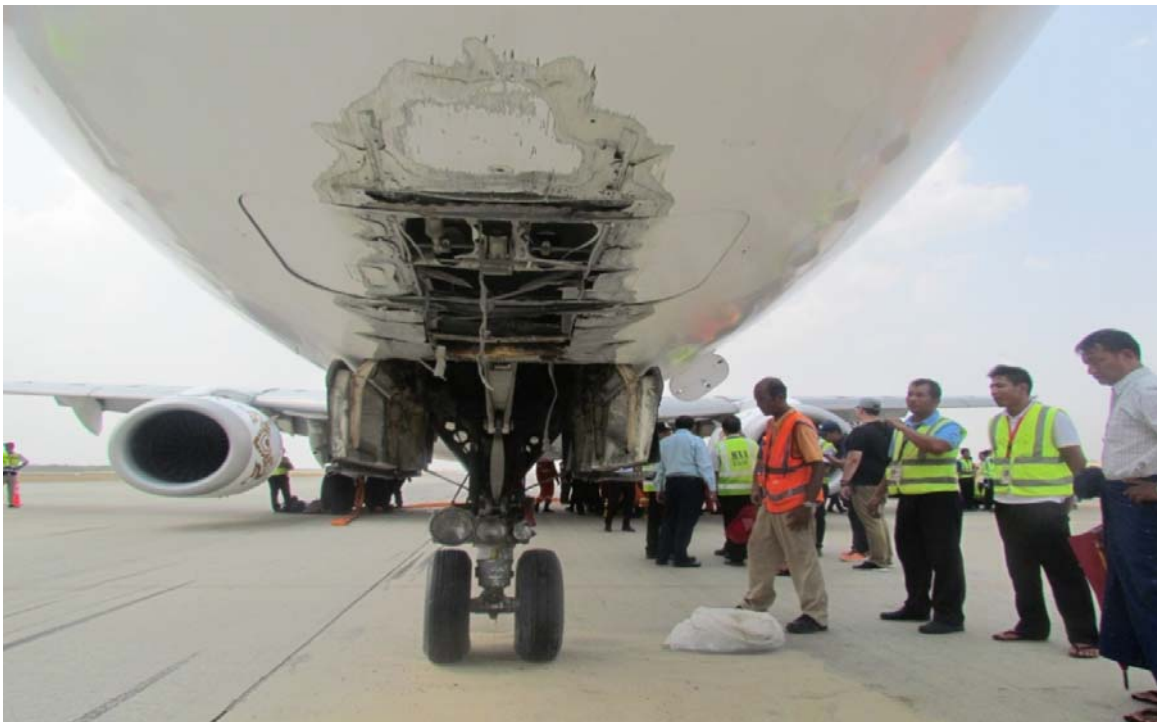
- Fuselage Lower Skin at Nose Landing Gear Section between FR3 and FR8 and STGR 26LH and 26RH
- Lower Skin and Lip Skin of Left Air Inlet Cowling
- Nose Landing Gear Door
- Forward Avionic Compartment Access Hatch
- Control Wire and Circuit Breakers at Cockpit Console

Figure (6) Damage to the aircraft Nose Landing gear section

Figure (7) Damage to the aircraft Nose Landing gear section

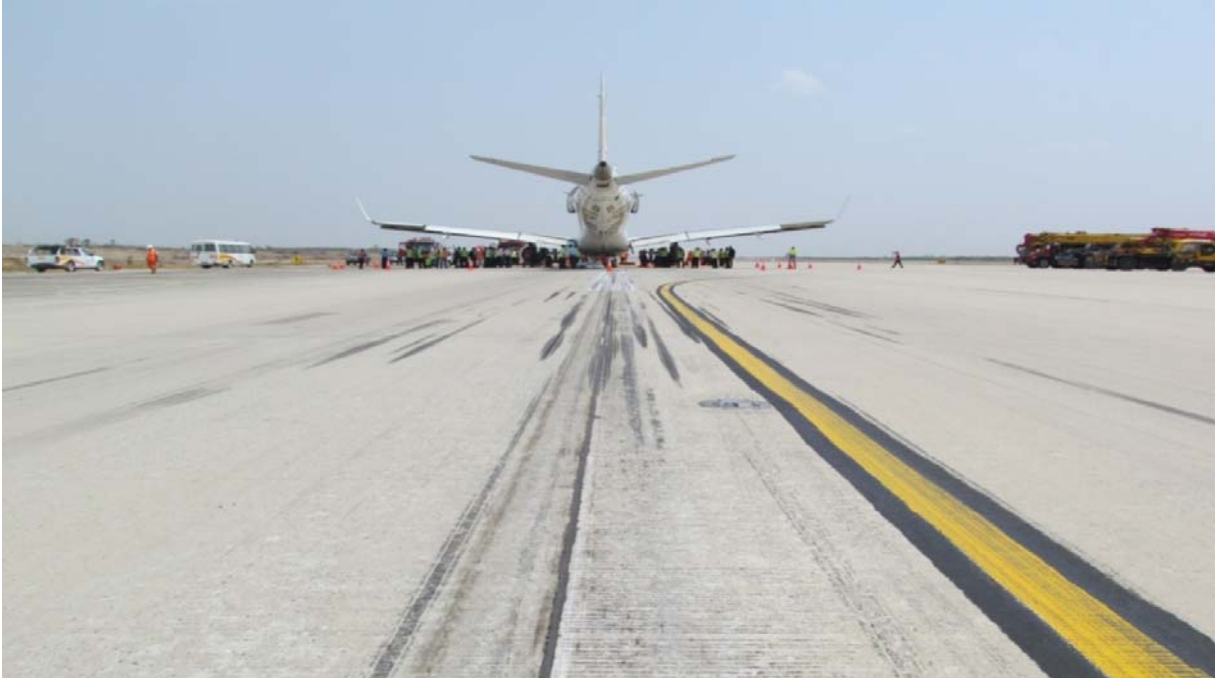
Figure (8) The Impact Marks on the runway

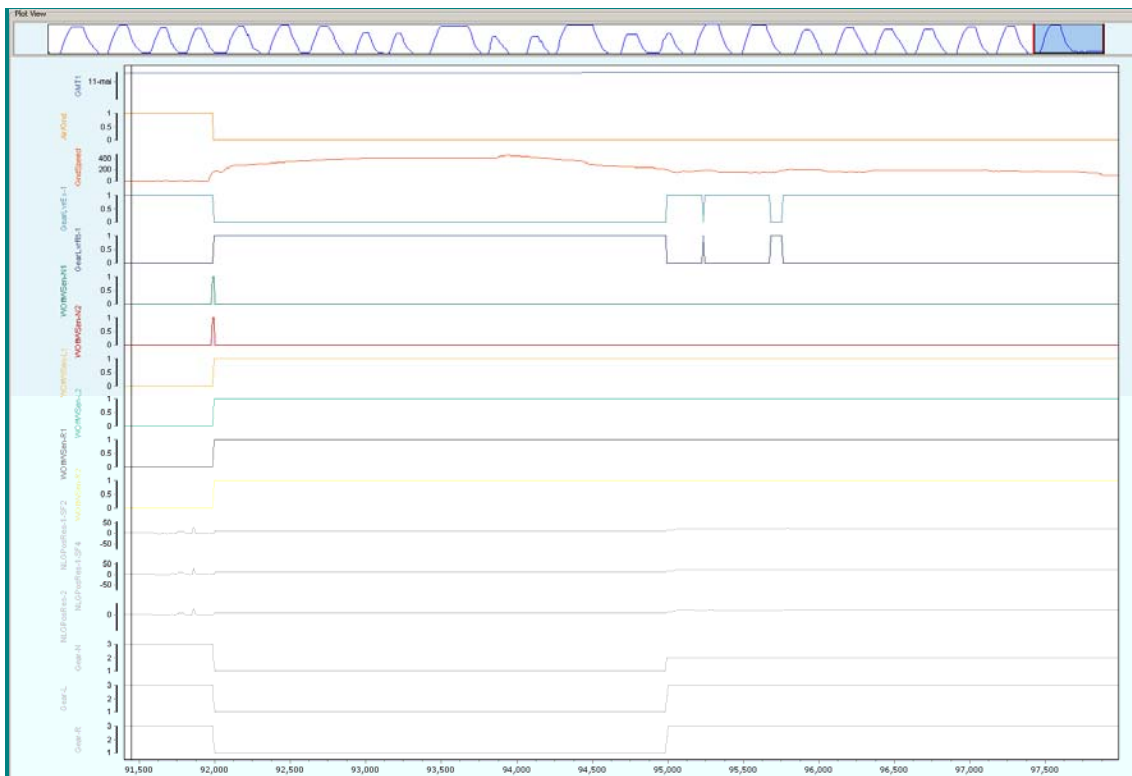
Figure (12) Event Flight Data – WoffW Sensors Signals

Analysing the Flight data, it can be seen that initially all 6 WOffW sensors had indicated a transition to “WOffW = TRUE” after the takeoff. See figure 12, below:

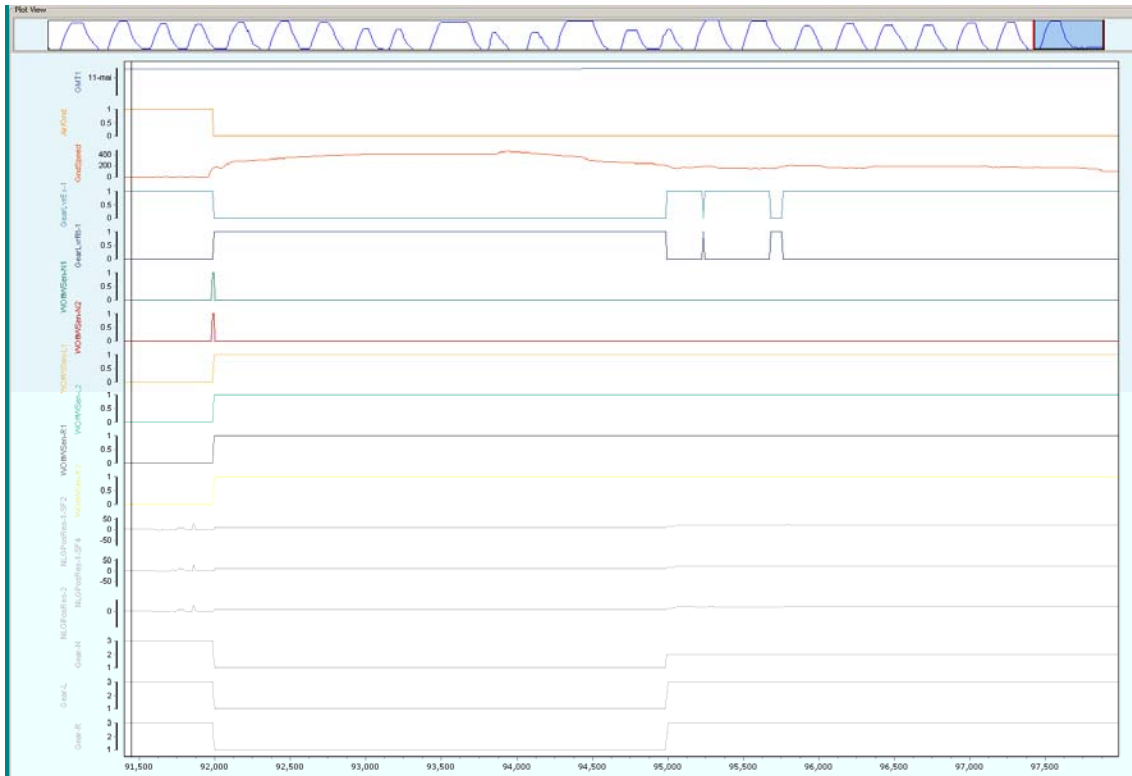
Figure (13) Event Flight Data - Gear Retract and Gear Extend Signals

With all 6 WOffW sensors indicating “WOffW = TRUE”, the LGCL could be commanded to “gear up” in order to command the landing gears to retract. It can be seen in the data that this command happens just after WOffW is established. See Figure 13, below:

It can be seen that, right after gears retraction command is given, all three gear position indications transition from “down and locked” to “in transit”.

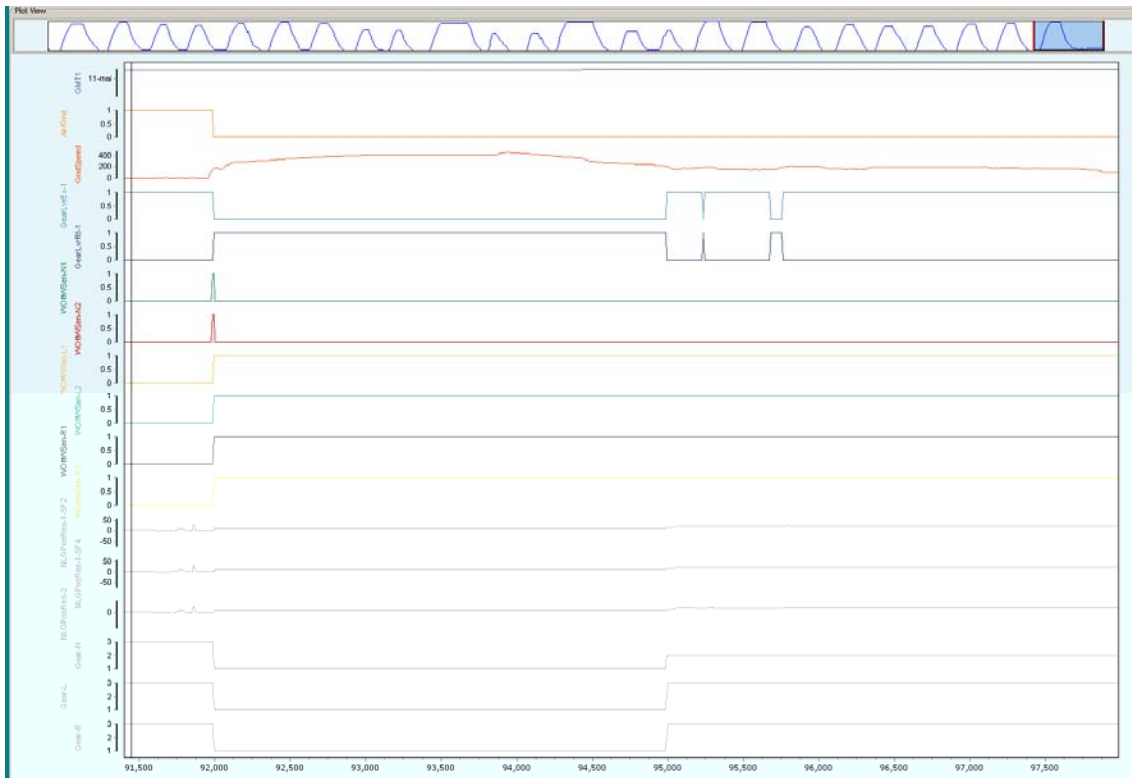
Figure (14) Event Flight Data - NLG WoffW Sensors and Gear Position Signals

At the same moment, it can be seen that, right after gears retraction command is given, both NLG WOffW sensors transition to “WOffW = FALSE”, which indicates that the NLG shock absorber compressed at least 13mm.

Referring back to the flight data; seconds after the NLG WoffW sensors transitioned to “WoffW = FALSE” the NLG steering position can be seen to shift from around 0° to around 20° . And just moments after that, all three gear
