Aircraft Accident Investigation Bureau of Myanmar

**FINAL REPORT OF SERIOUS INCIDENT OF THE NOSE LANDING GEAR
AXLE RUPTURE INVOLVING GOLDEN MYANMAR AIRLINES,
ATR 72-600 AIRCRAFT (REG: XY-AJM) AT YANGON INTERNATIONAL
AIRPORT, ON 2nd AUGUST, 2019**

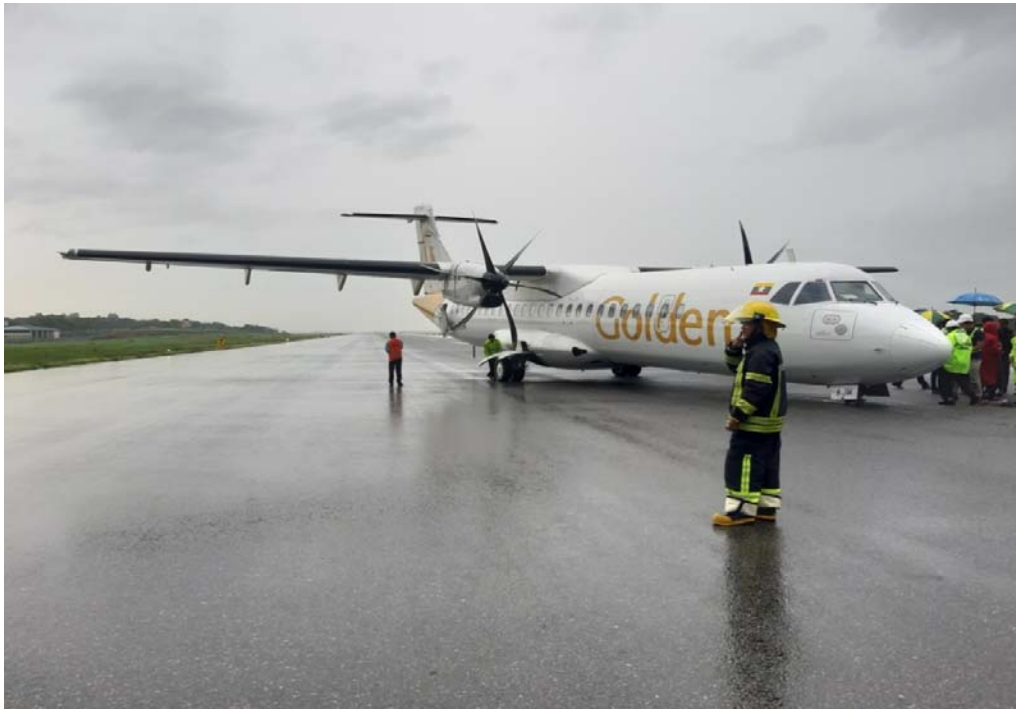
Figure (2) Final position of the aircraft on the runway

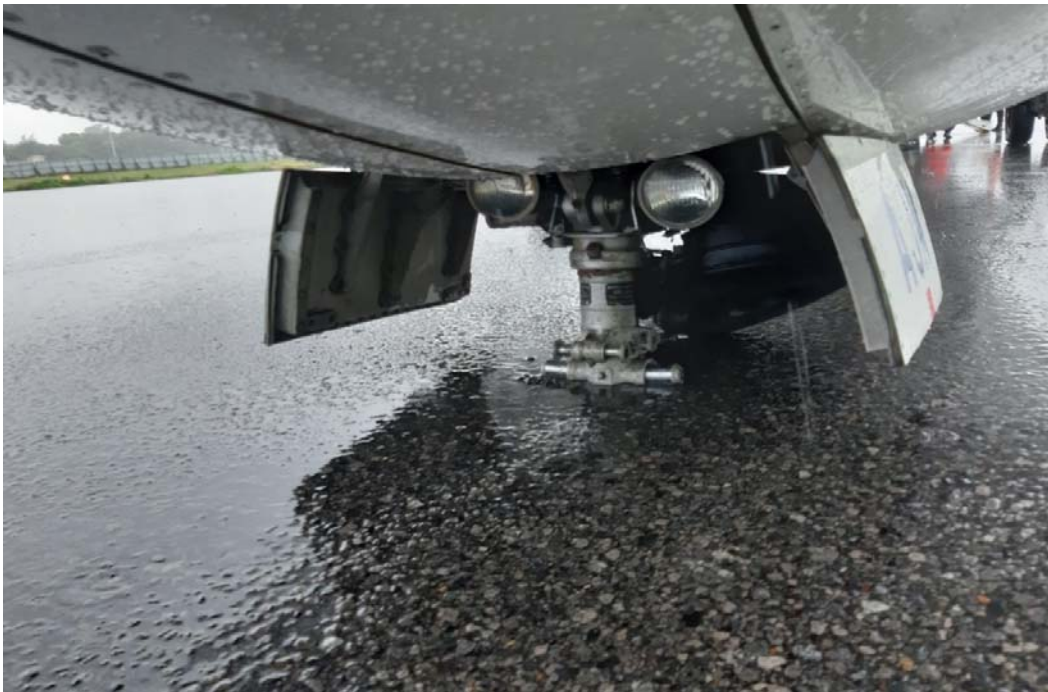
- (a) Nose landing wheels hub broken off
- (b) LH lower skin perforated and dented
- (c) RH lower skin 2 small dents
- (d) Forward panel edge with superficial scratch
- (e) Nose landing gear (NLG) doors damaged
- (f) Both NLG tires burst
- (g) Torque link broken
- (h) NLG doors stop fittings damaged

Figure (3) Nose landing gear damage

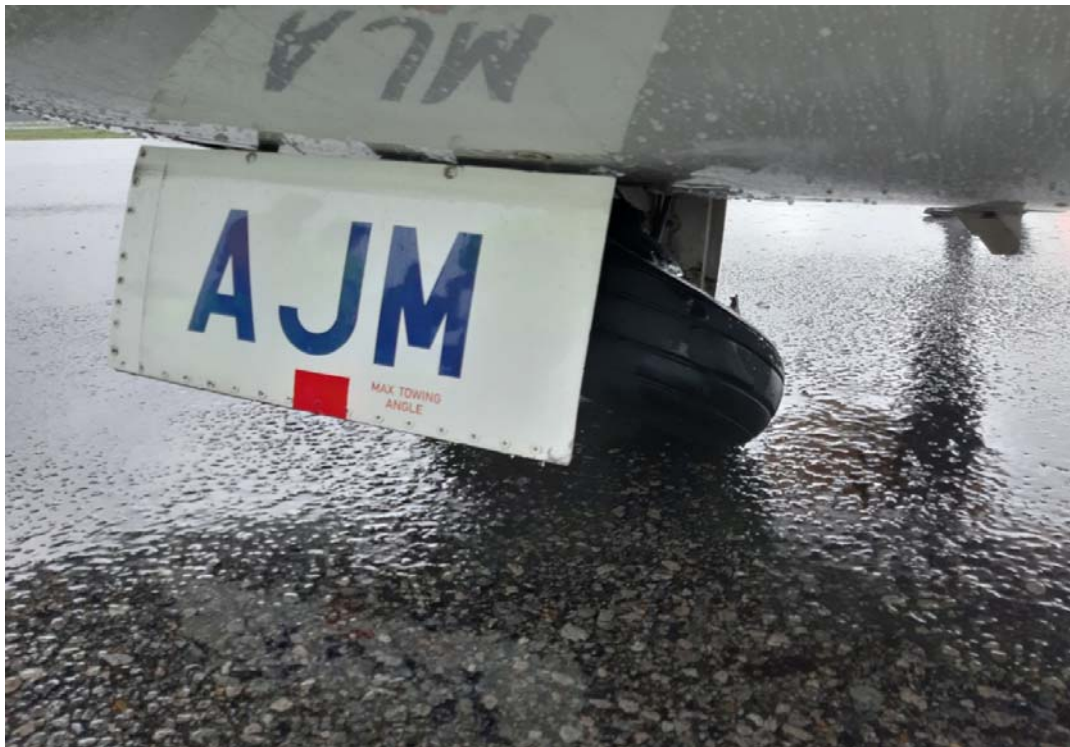
Figure (4) Both nose wheels thrown off from the axle with the no.(1) nose wheel tire hanging attached to the torque link

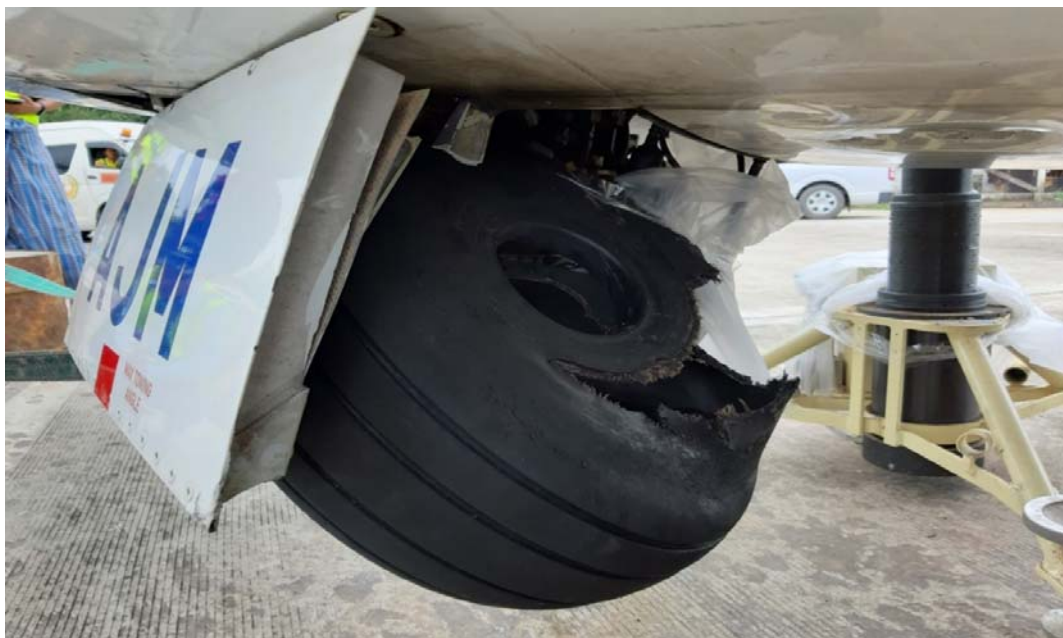
Figure (5) Both nose wheels thrown off from the axle with the no.(1) nose wheel tire hanging attached to the torque link

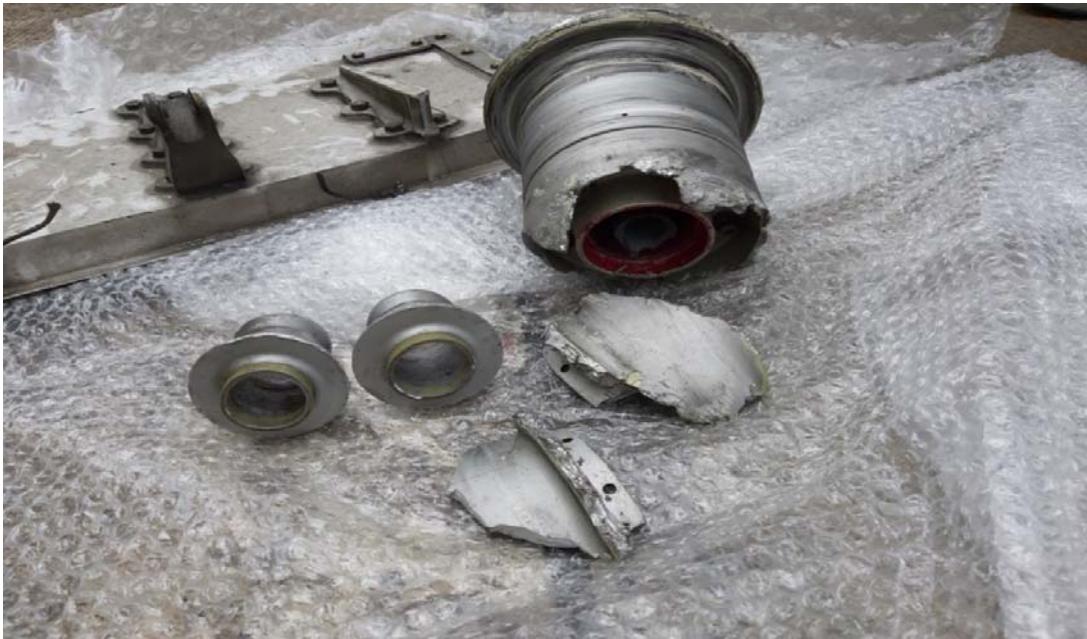
Figure (6) Broken pieces from the aircraft

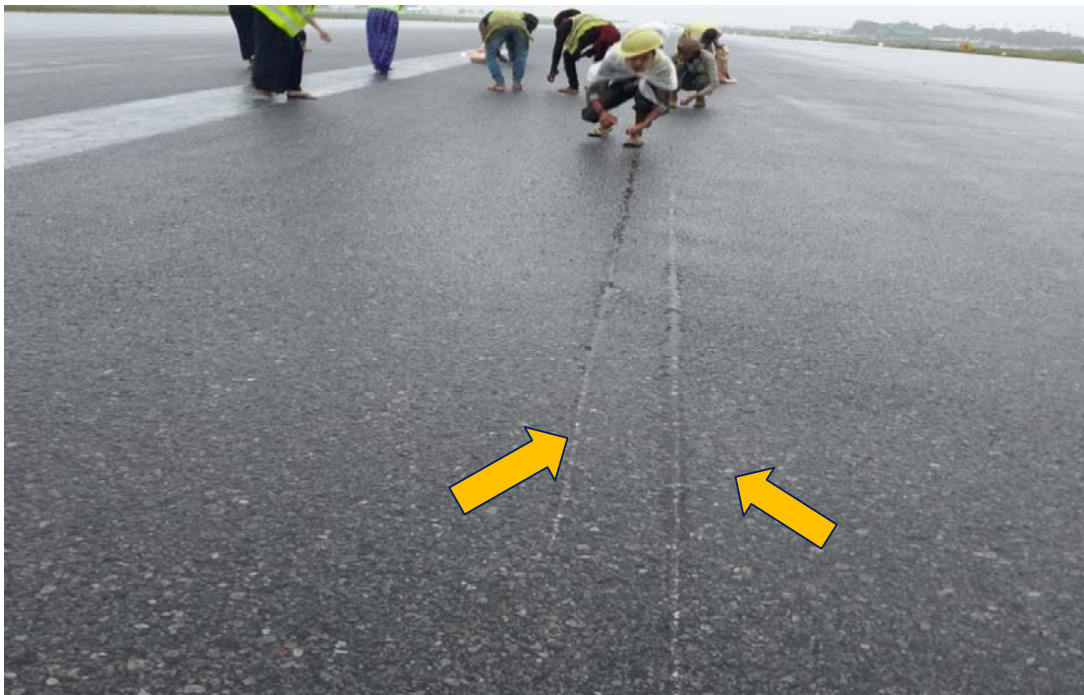
Figure (7) Impact marks on the runway

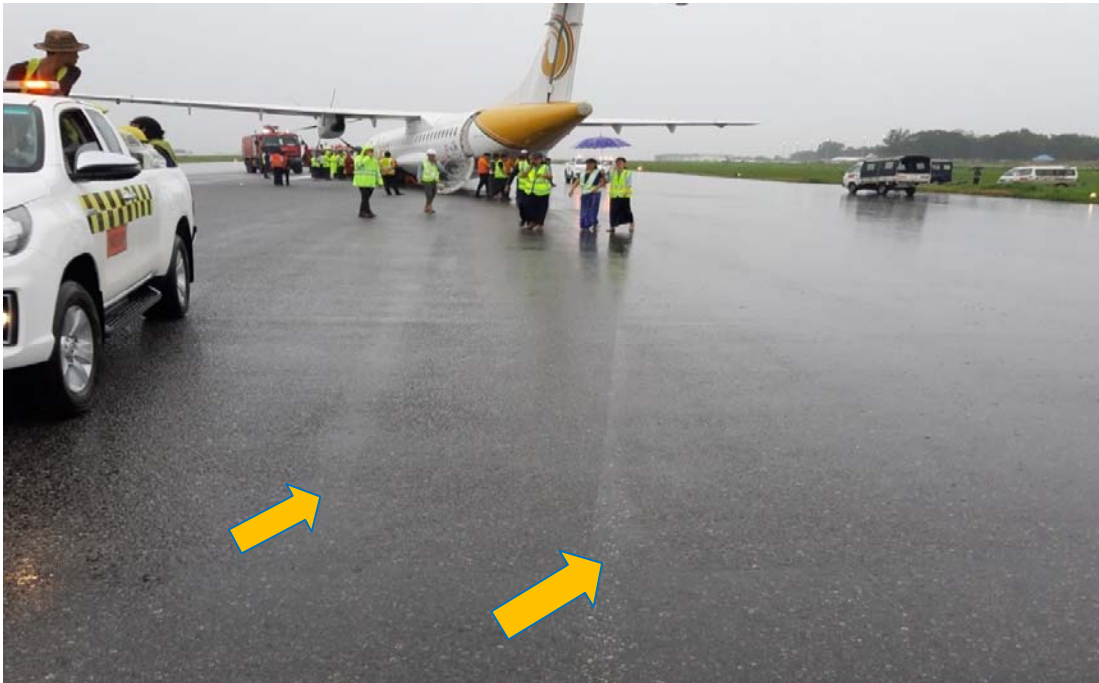
Figure (8) Impact marks on the runway
