Aircraft Accident Investigation Bureau of Myanmar

**FINAL REPORT OF SERIOUS INCIDENT OF MYANMAR
NATIONAL AIRLINES CESSNA 208B GRAND CARAVAN
(Reg: XY-AMB) AT MAWLAMYING DOMESTIC AIRPORT ON 27th
NOVEMBER, 2018**

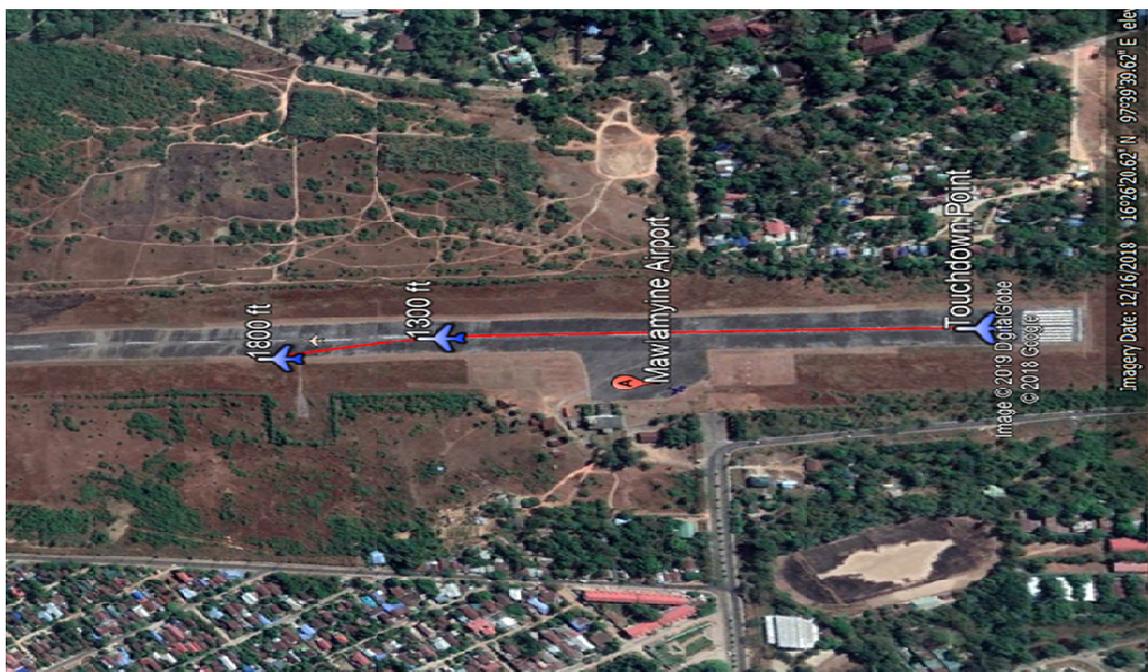
Figure :1 Layout of Serious Incident Site

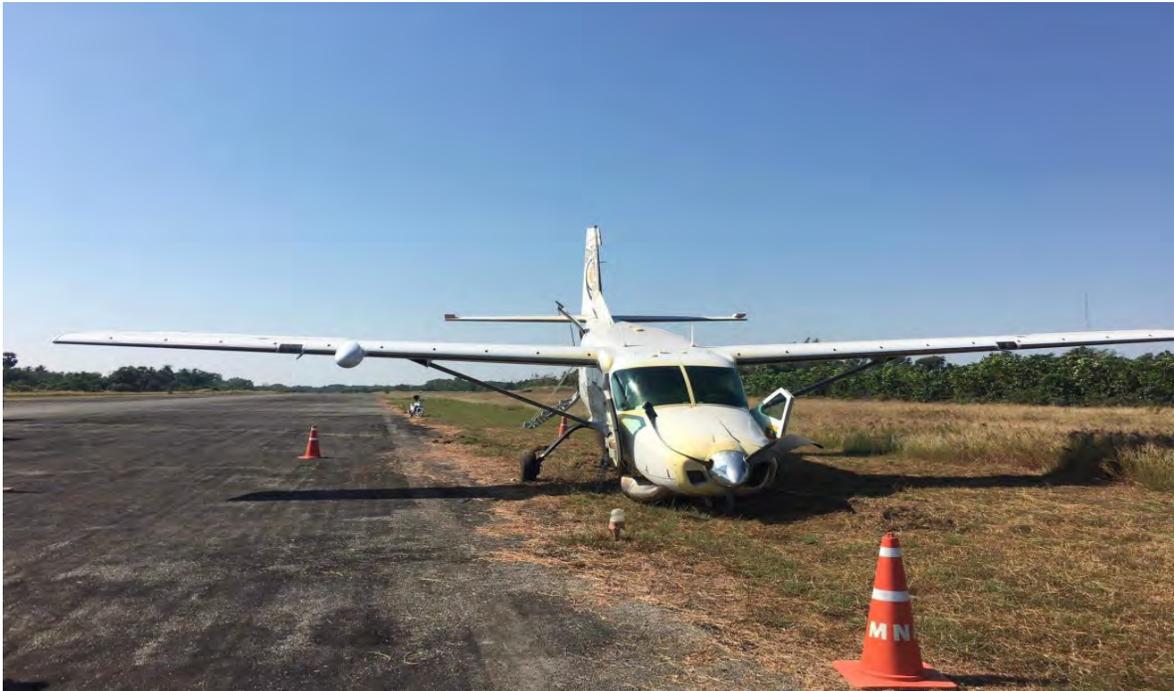
- (a) Nose Landing Gear was broken and Nose wheel was busted.
- (b) Propeller blades were twisted and deformed.
- (c) Emergency Locator Transmitter (ELT) transmitted distress signal.
- (d) The plane was nosedived into the grass turf at the edge of the Runway- 04.

Figure-2 The Aircraft came to rest on the grass tuft at the edge of the Runway

- e) With the nose gear detached, the pilot flying was unable to maintain directional control, that likely resulted in the aircraft veering off the runway.

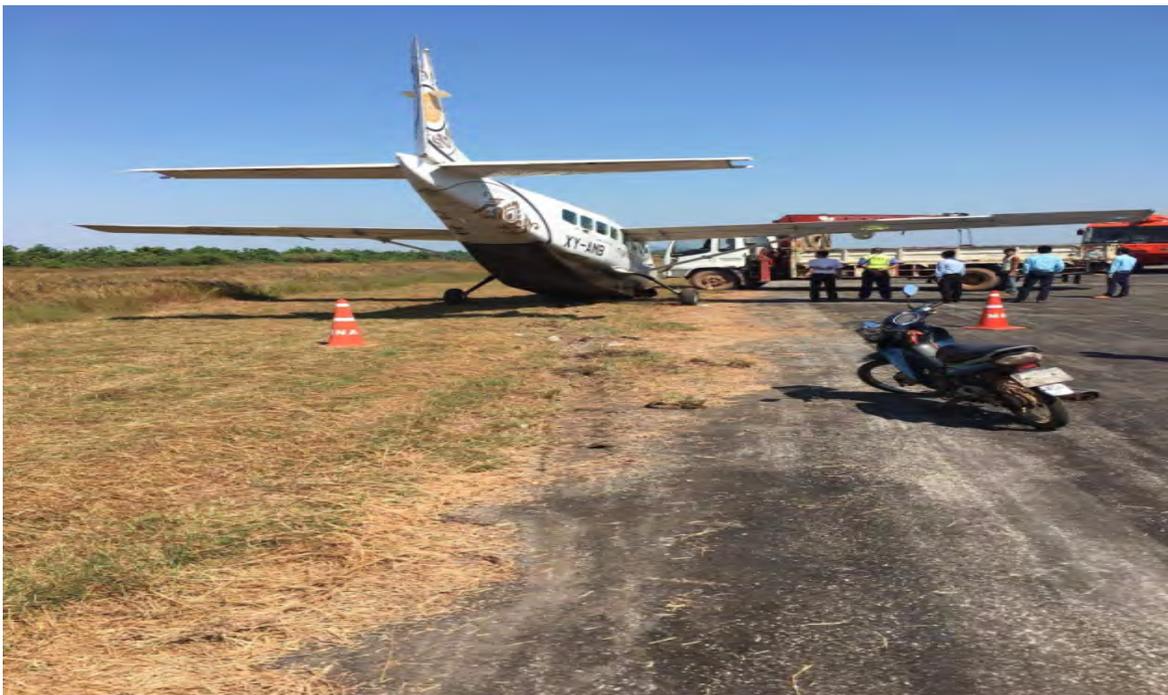
Figure-3 Aircraft Nosedived position after the accident

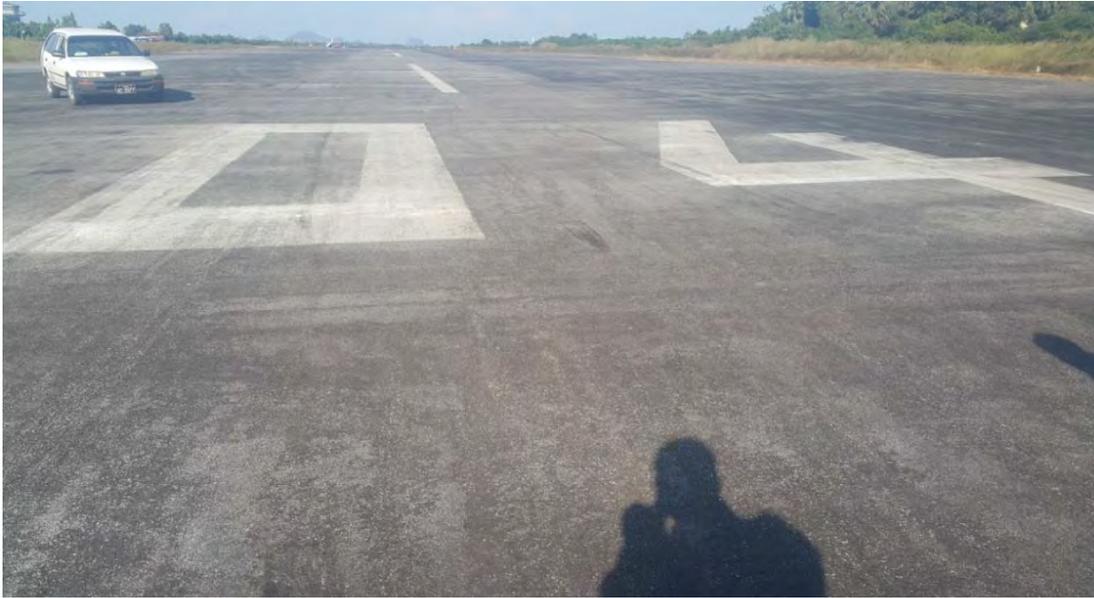
Figure-4 The Ground Mark of the Nose wheel Touched down point
(Viewed from Runway-04 to crash site)

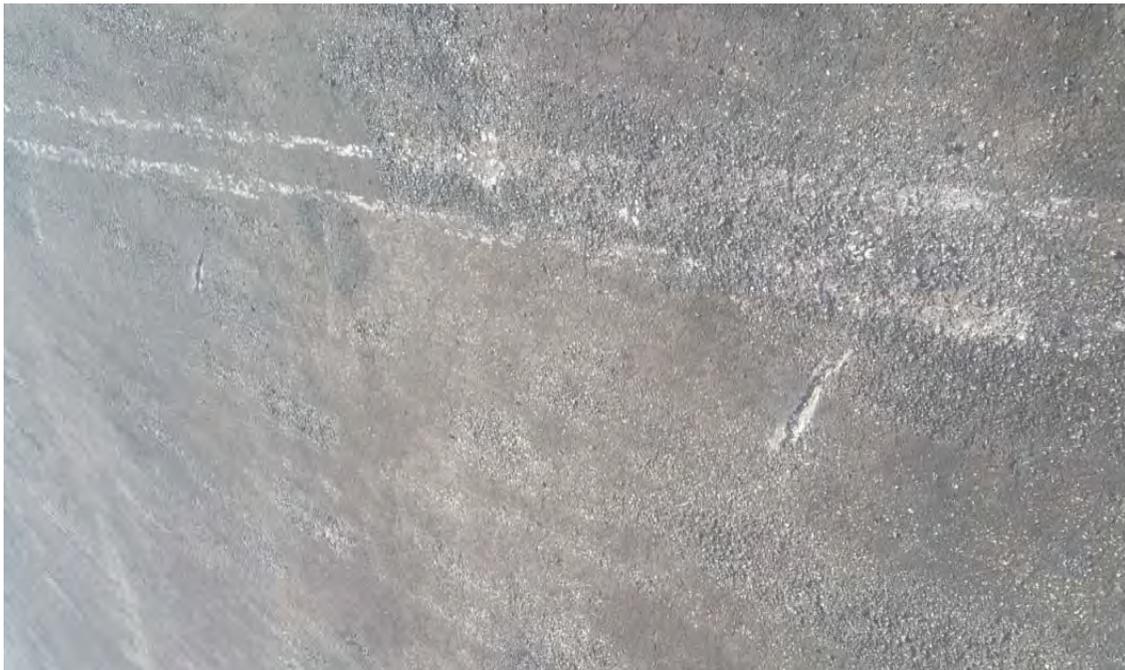
Figure-5 The Ground Mark of the Propeller Striking the Runway and Nose Landing
Gear Oleo (Viewed from Runway-04)

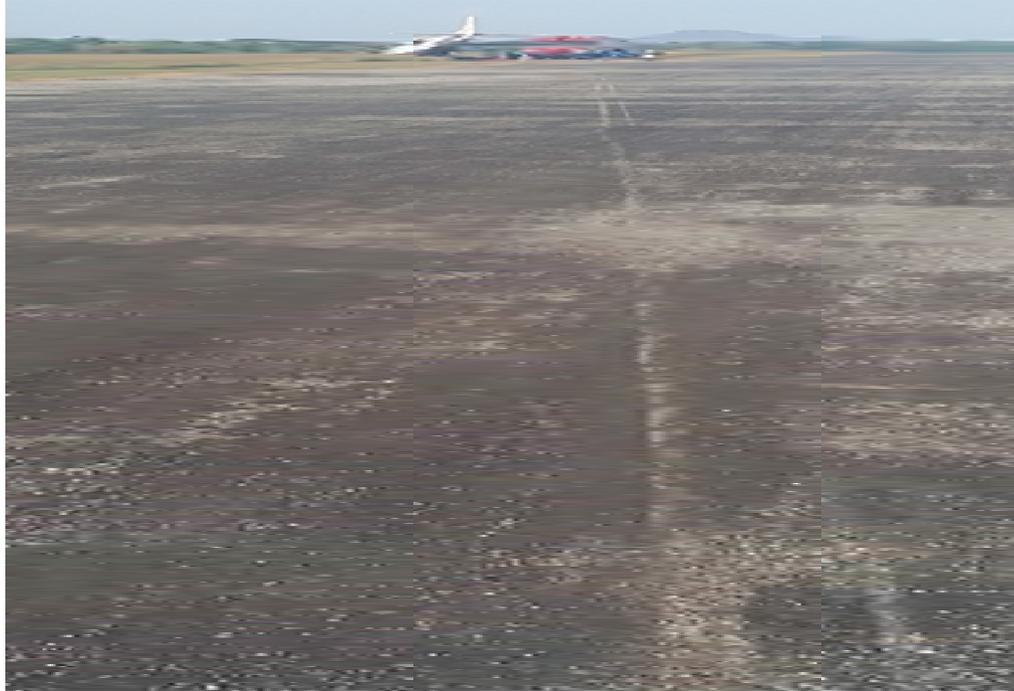
Figure-6 The Ground Mark of the Propeller Striking the Runway and Nose Landing Gear Oleo (Viewed from Runway-04)

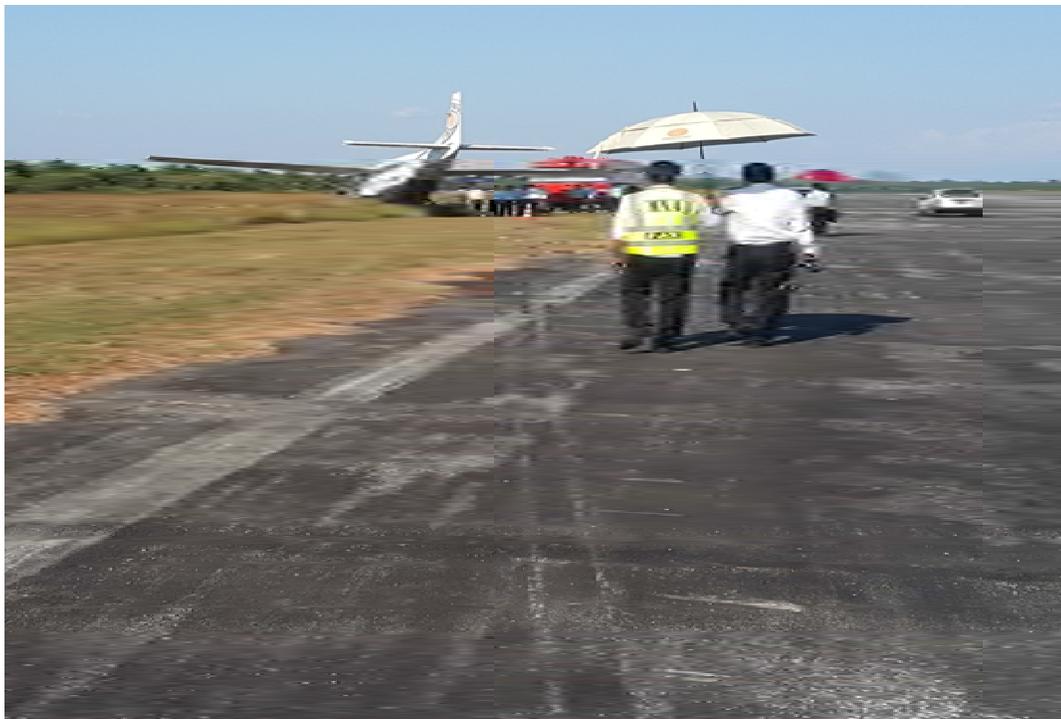
Figure-7 The Ground Mark of Nose Landing Gear Oleo (Viewed from Runway-04)

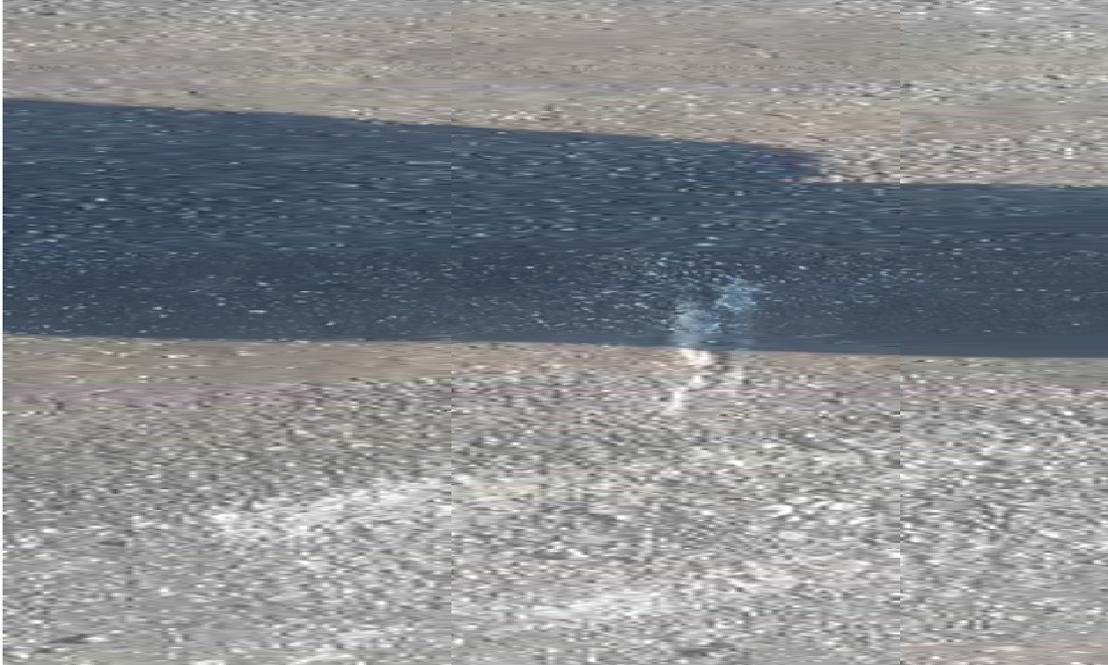
Figure-8 The Ground Mark of Propeller Striking the Runway

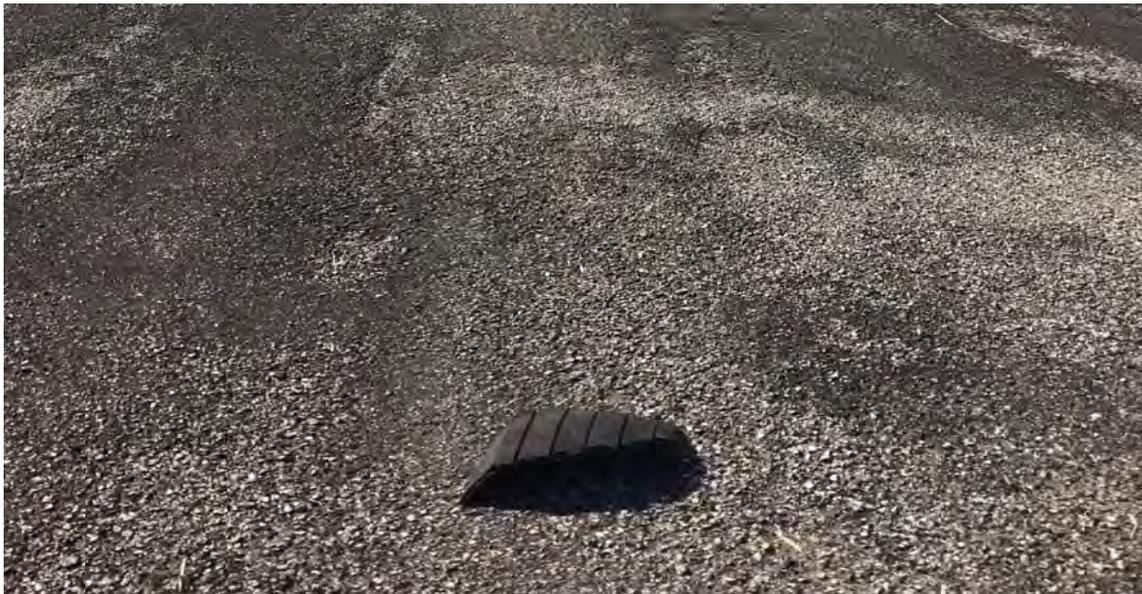
Figure-9 The Broken Part of Nose Wheel on the Runway

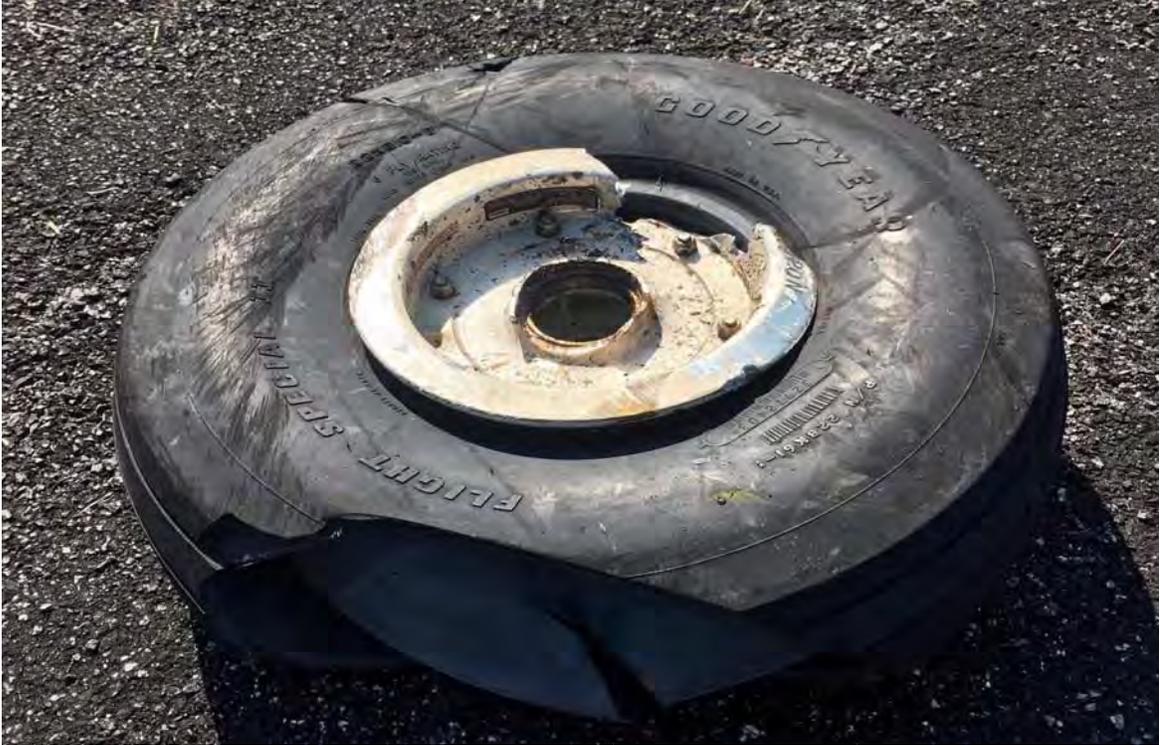
Figure-10 The Broken Part of Nose Wheel Hub

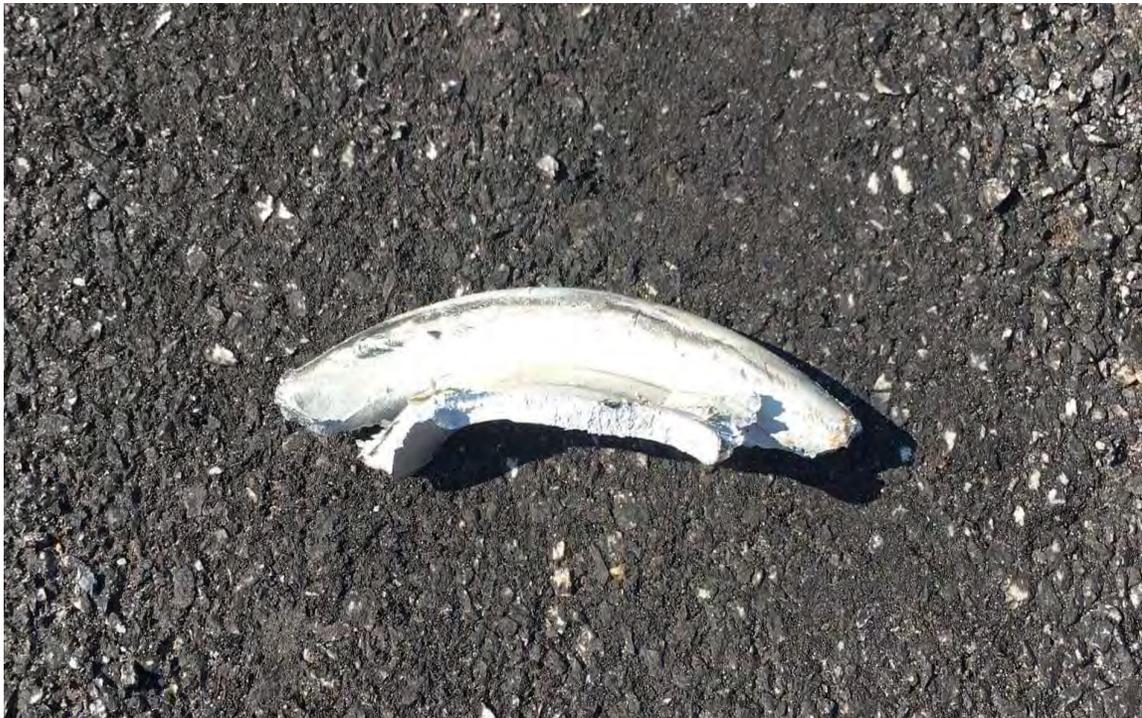
Figure-11 The Broken Part of Nose Landing Gear

- c) Despite the unstabilized approach, both flight crew appeared committed to land the aircraft and did not consider executing a go-around.
- d) The aircraft experienced a hard landing on the first instance of touching down on the runway, with the vertical acceleration reaching a value of +2.938G. This resulted in the nose gear breaking off.

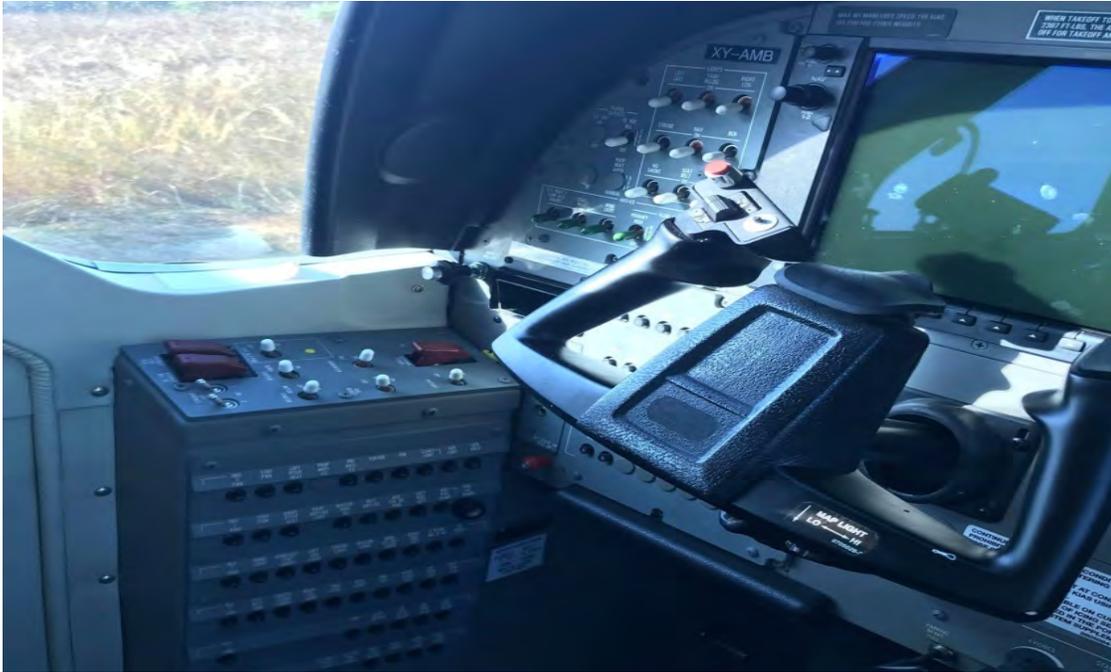
Figure-12 The Cockpit View after the Incident

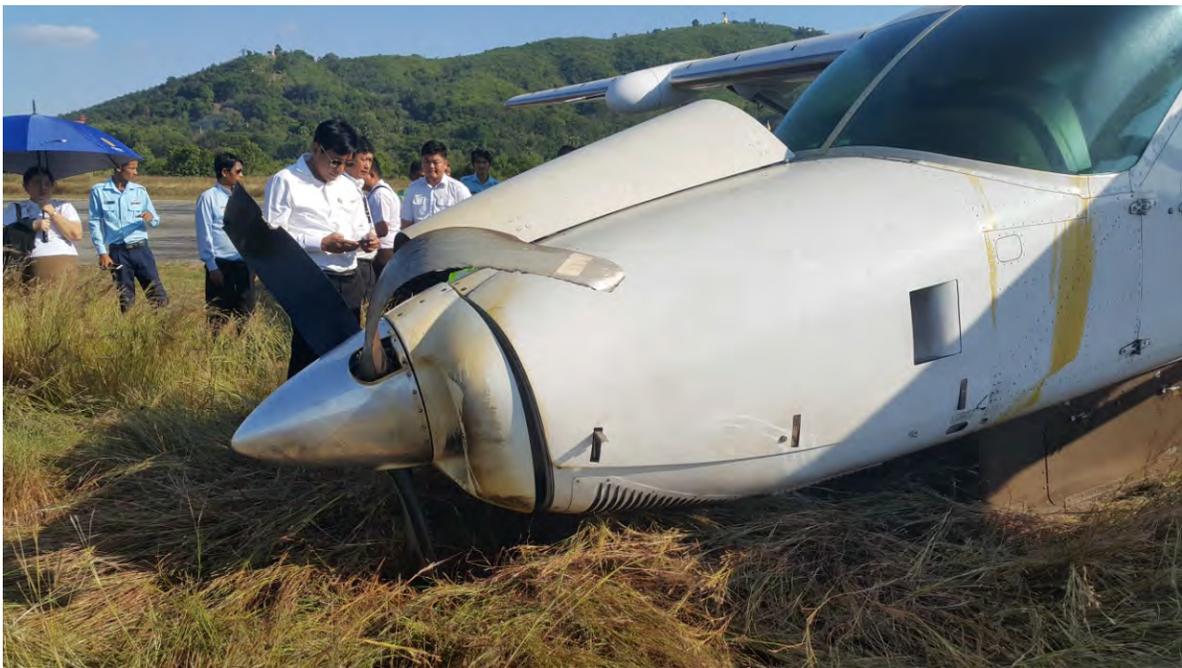
Figure-13 The Closer View of the Propeller damaged

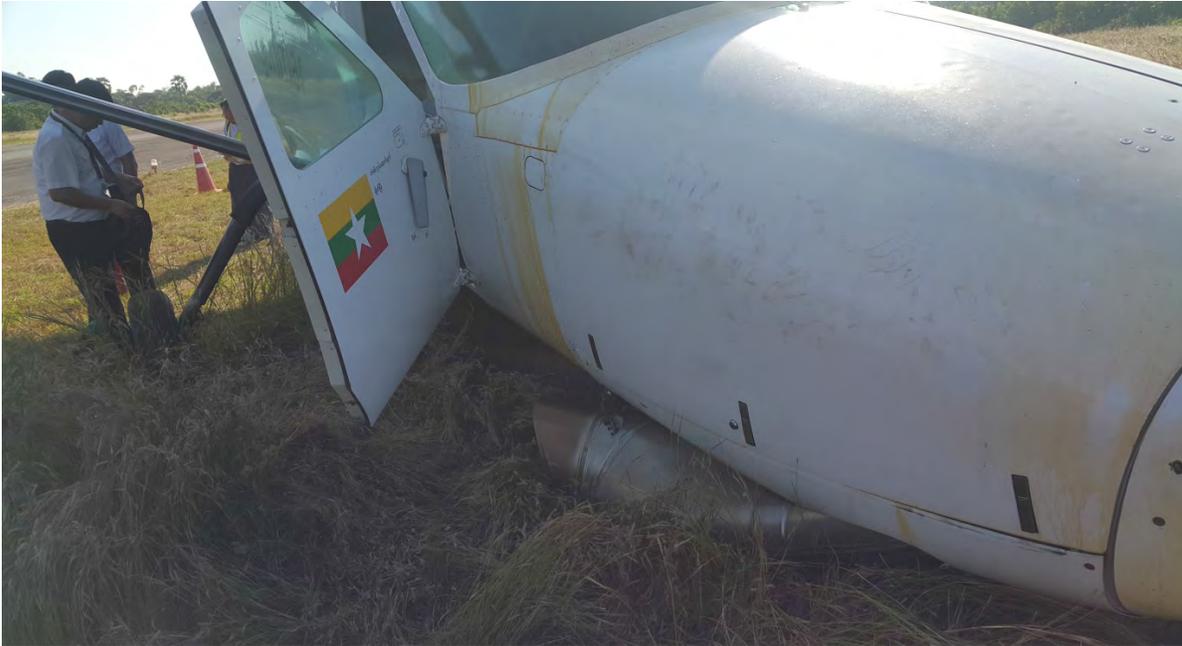
Figure-14 The Closer View of the Nose Landing Gear Damaged
