## **Aircraft Accident Investigation Bureau of Myanmar**

**FINAL REPORT OF SERIOUS INCIDENT OF NOSE LANDING GEAR  
FAILURE EMERGENCY LANDING OF MYANMAR NATIONAL AIRLINES,  
EMBRAER-190 AIRCRAFT (REG: XY-AGQ) AT MANDALAY  
INTERNATIONAL AIRPORT, ON 12 MAY, 2019**

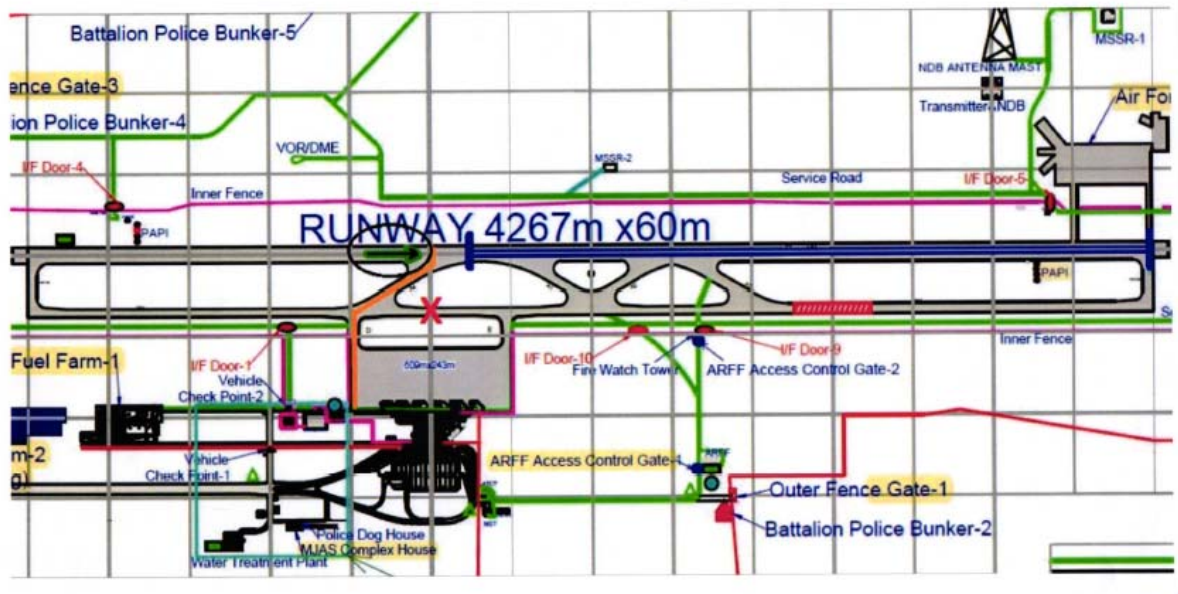
Figure(1) Layout of Serious Incident Site

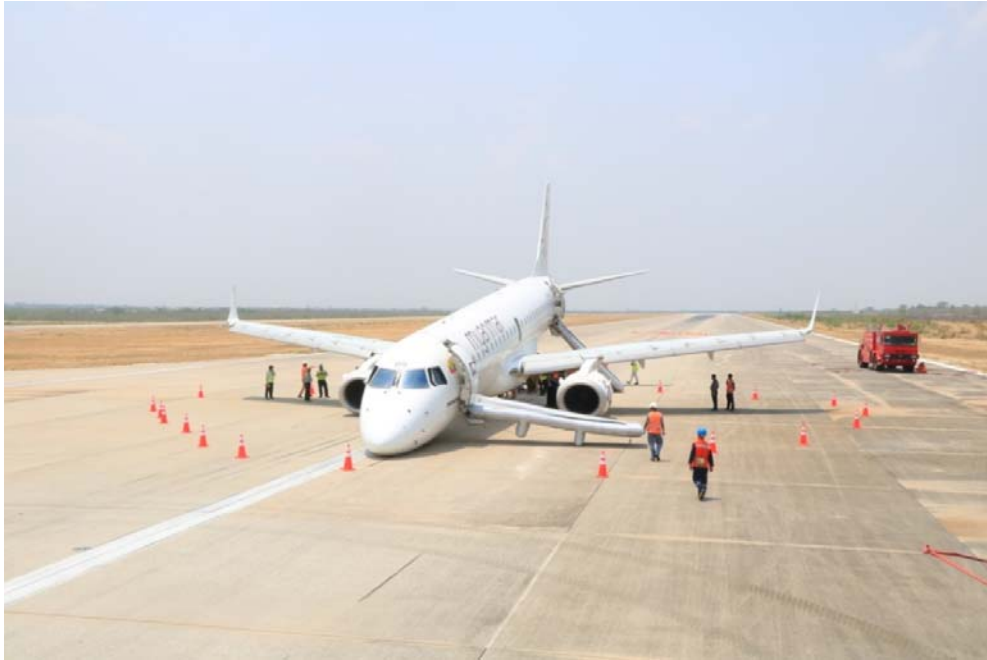
Figure (2) The final position of the aircraft on the runway of Mandalay International Airport

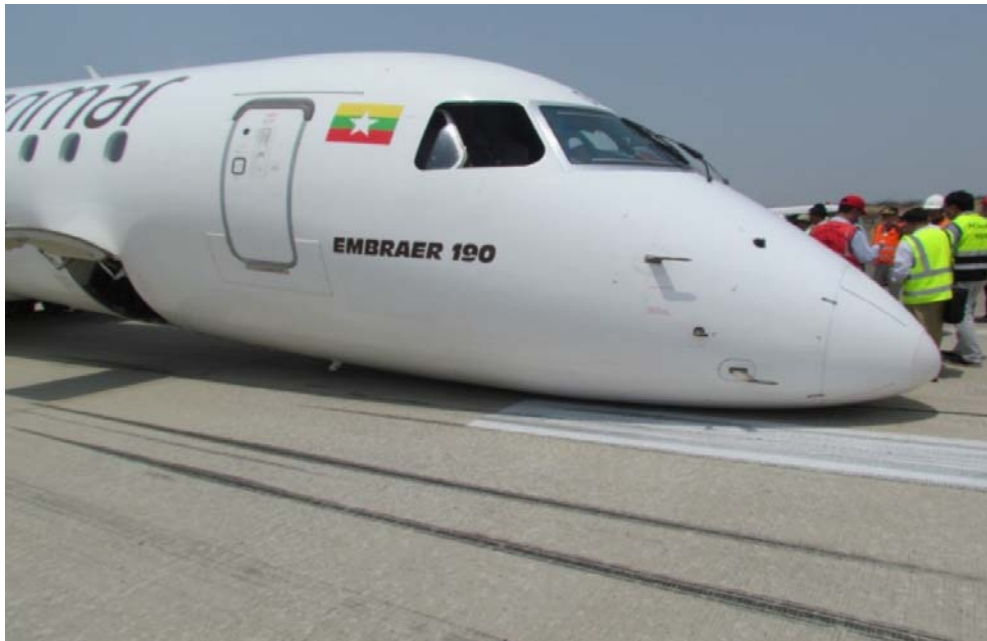
Figure (3) Closer view of the aircraft nose contact with the runway

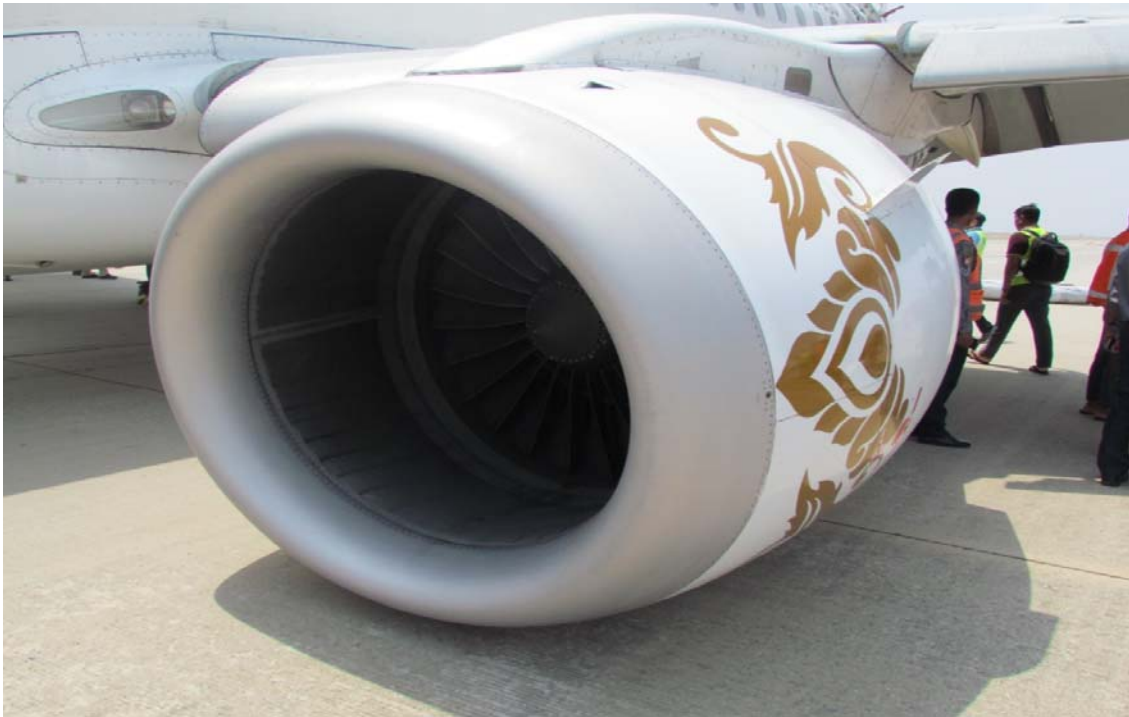
Figure (4) Left engine Cowling contact with the runway

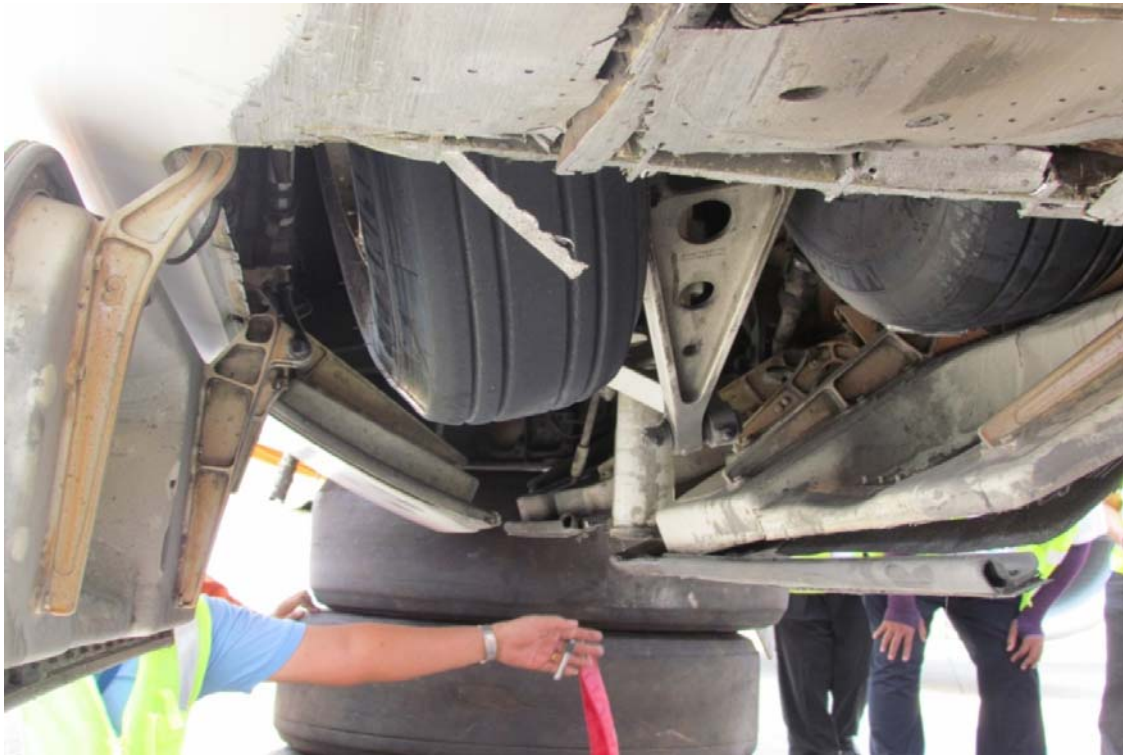
Figure (5) Closer view of the nose landing gear in the wheel well

When the investigation team arrived at the incident site, the disabled aircraft was on the runway of Mandalay international airport. The investigation team took the visual inspection of the aircraft itself and the impact marks on the runway. The nose landing gear door was found open ajar but the nose landing gear itself was misaligned and stuck in the wheel well. For the disabled aircraft removal, they discharged Nitrogen from the oleo of the nose landing gear and managed to lever it out.

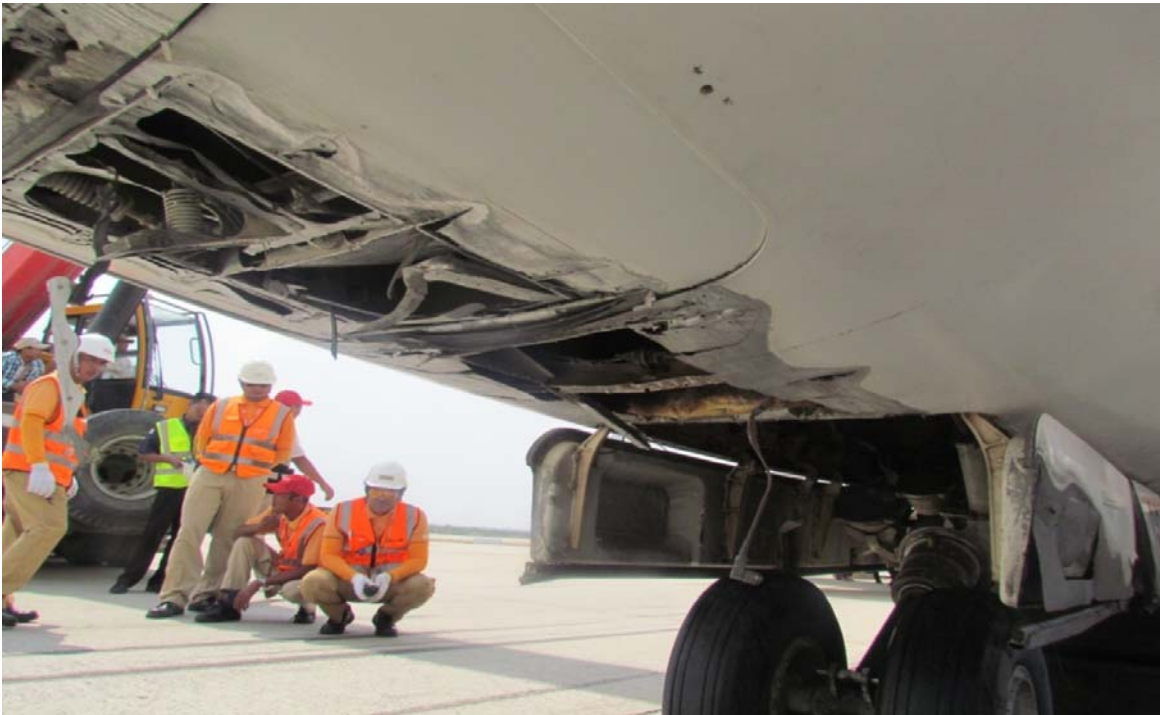
- Fuselage Lower Skin at Nose Landing Gear Section between FR3 and FR8 and STGR 26LH and 26RH
- Lower Skin and Lip Skin of Left Air Inlet Cowling
- Nose Landing Gear Door
- Forward Avionic Compartment Access Hatch
- Control Wire and Circuit Breakers at Cockpit Console

Figure (6) Damage to the aircraft Nose Landing gear section

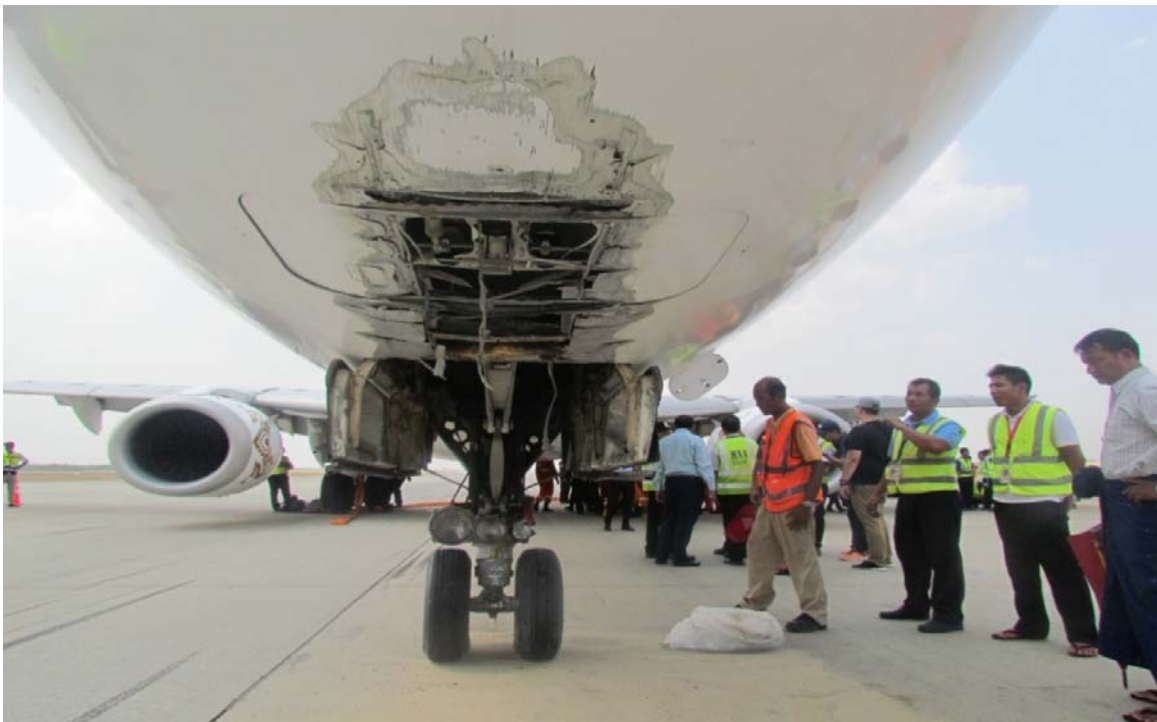
Figure (7) Damage to the aircraft Nose Landing gear section

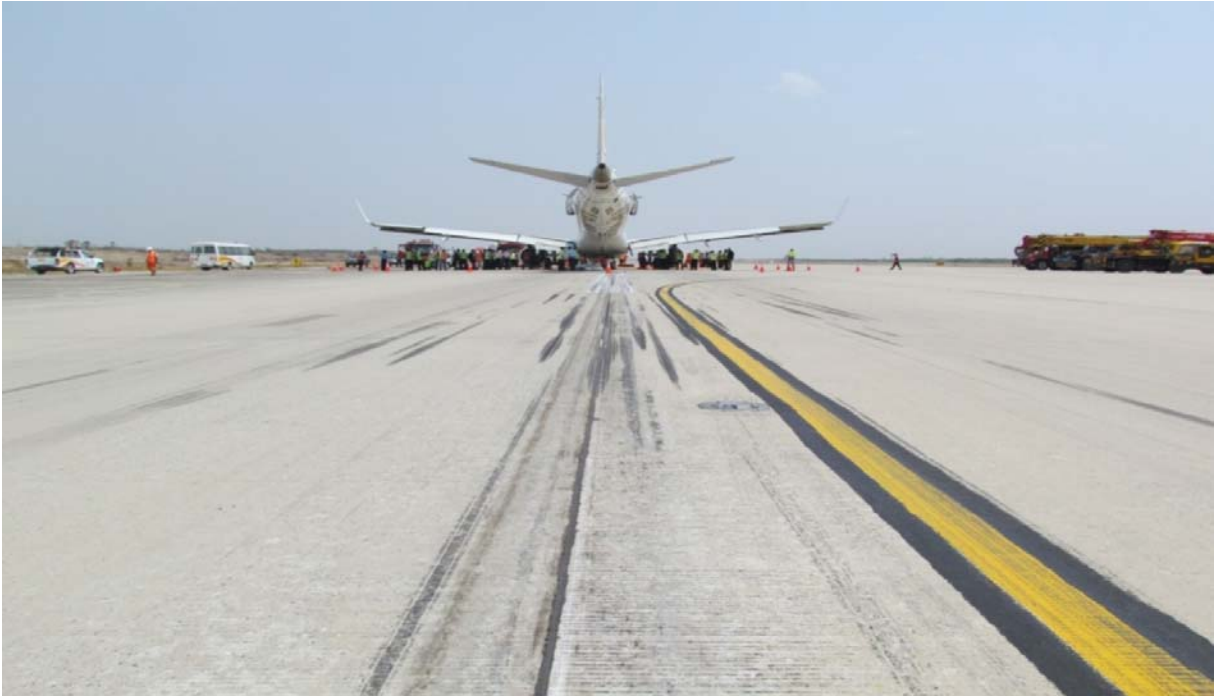
Figure (8) The Impact Marks on the runway

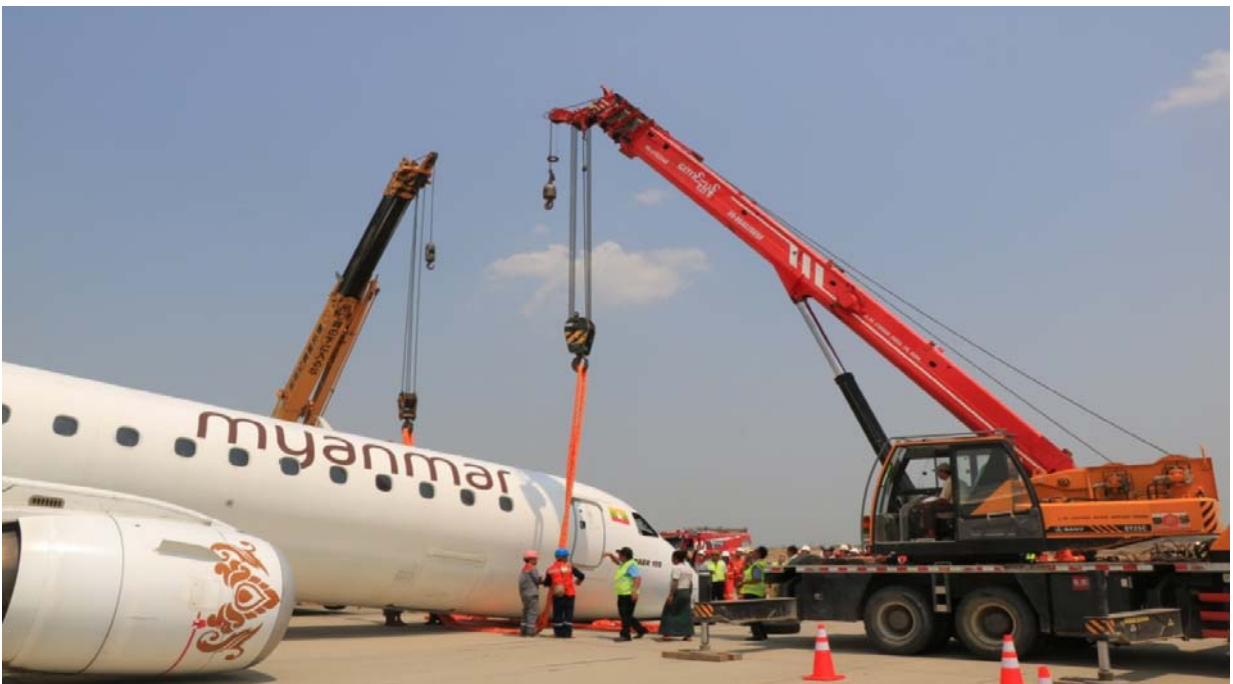
Figure (9) Disabled aircraft removal action

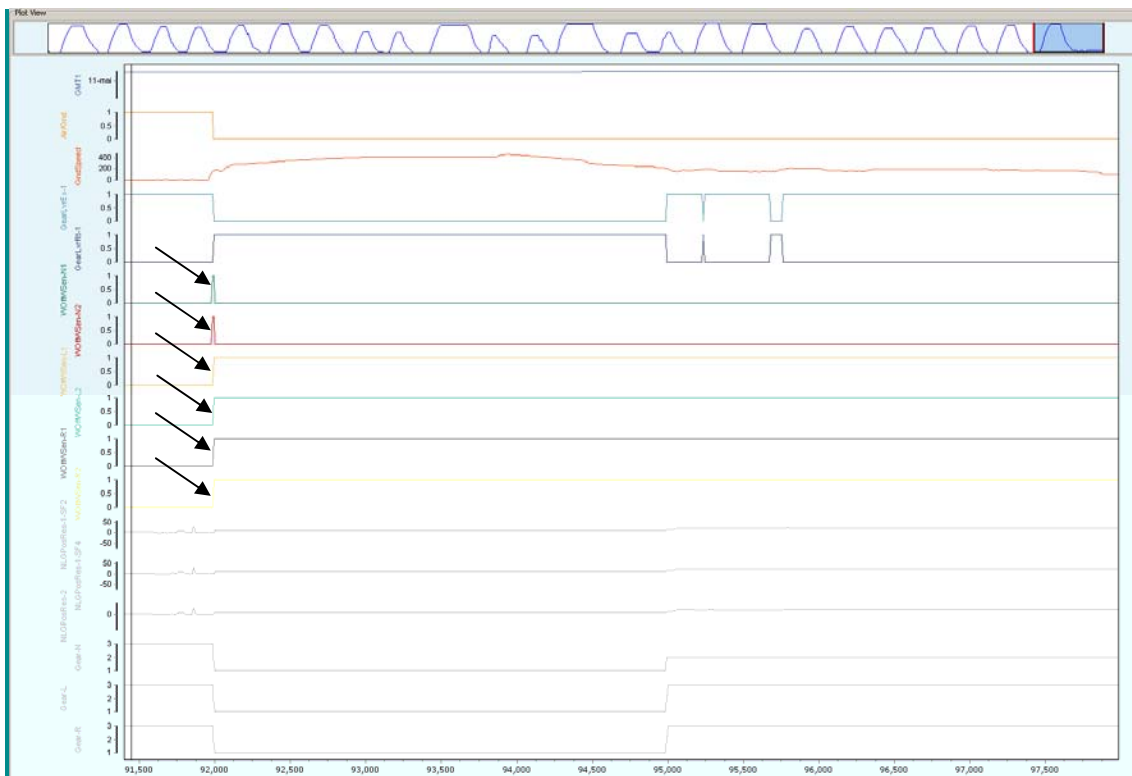
Figure (12) Event Flight Data – WoffW Sensors Signals

Analysing the Flight data, it can be seen that initially all 6 WoffW sensors had indicated a transition to “WoffW = TRUE” after the takeoff. See figure 12, below:

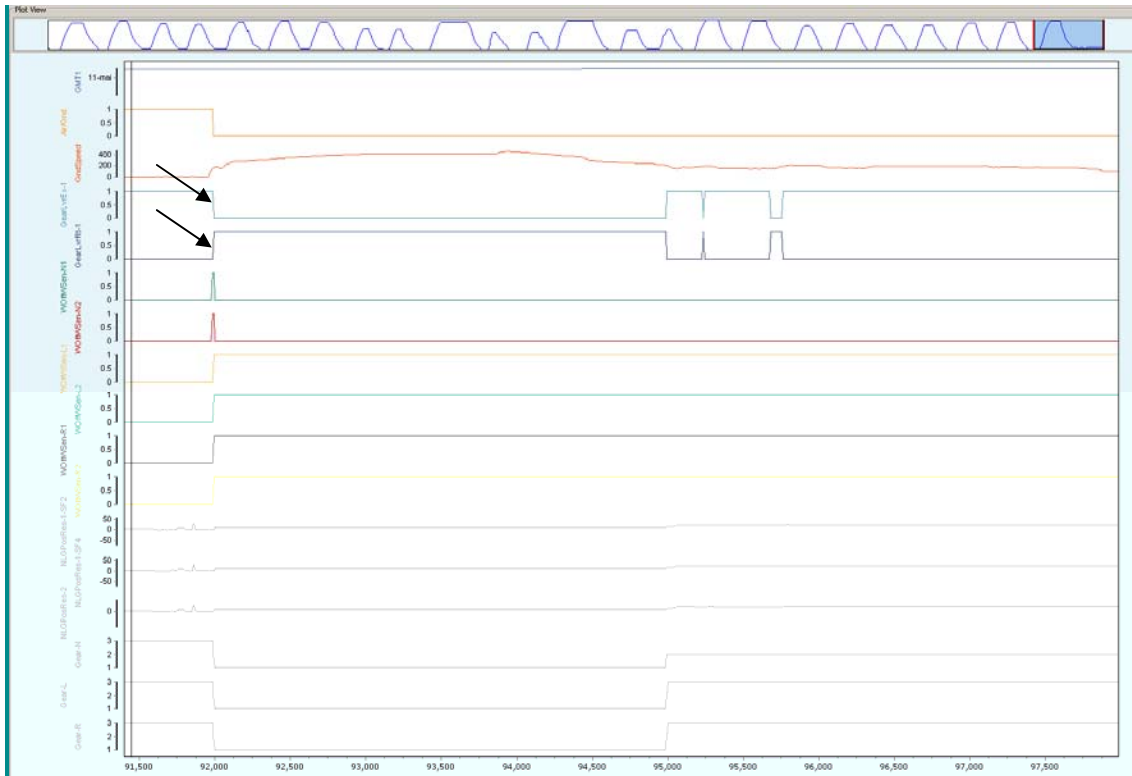
Figure (13) Event Flight Data - Gear Retract and Gear Extend Signals

With all 6 WOffW sensors indicating “WOffW = TRUE”, the LGCL could be commanded to “gear up” in order to command the landing gears to retract. It can be seen in the data that this command happens just after WOffW is established. See Figure 13, below:

It can be seen that, right after gears retraction command is given, all three gear position indications transition from “down and locked” to “in transit”.

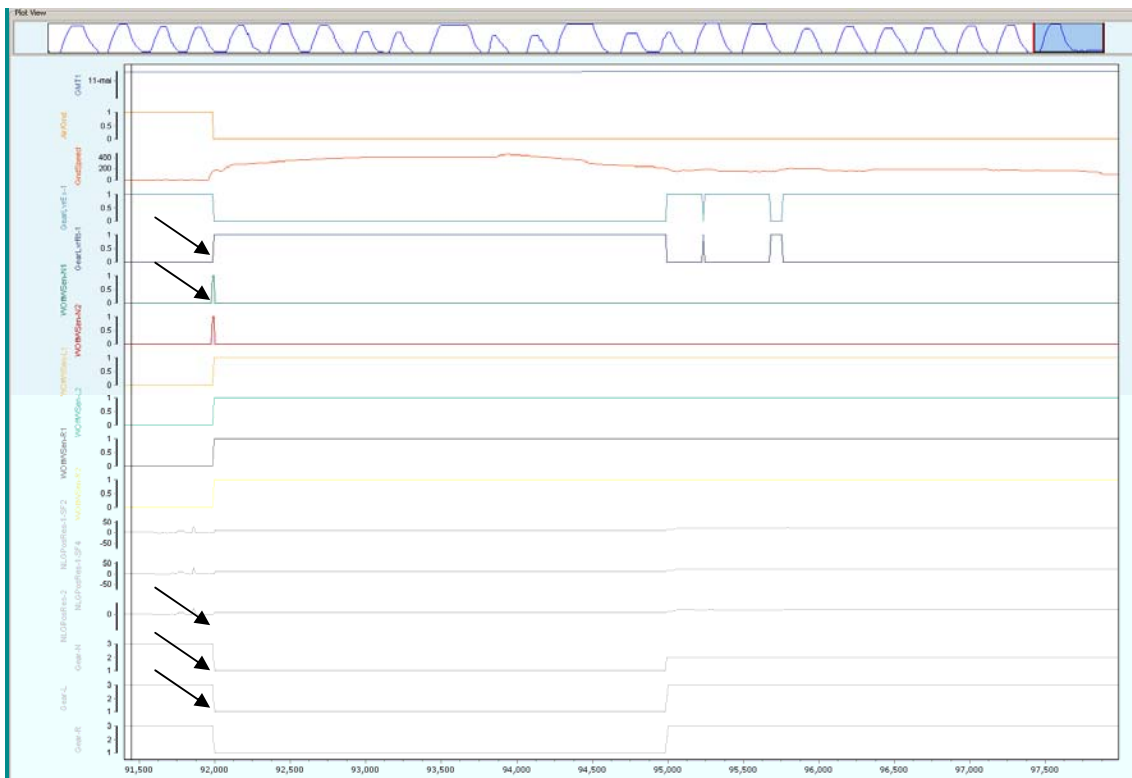
Figure (14) Event Flight Data - NLG WoffW Sensors and Gear Position Signals

At the same moment, it can be seen that, right after gears retraction command is given, both NLG WOffW sensors transition to “WOffW = FALSE”, which indicates that the NLG shock absorber compressed at least 13mm.

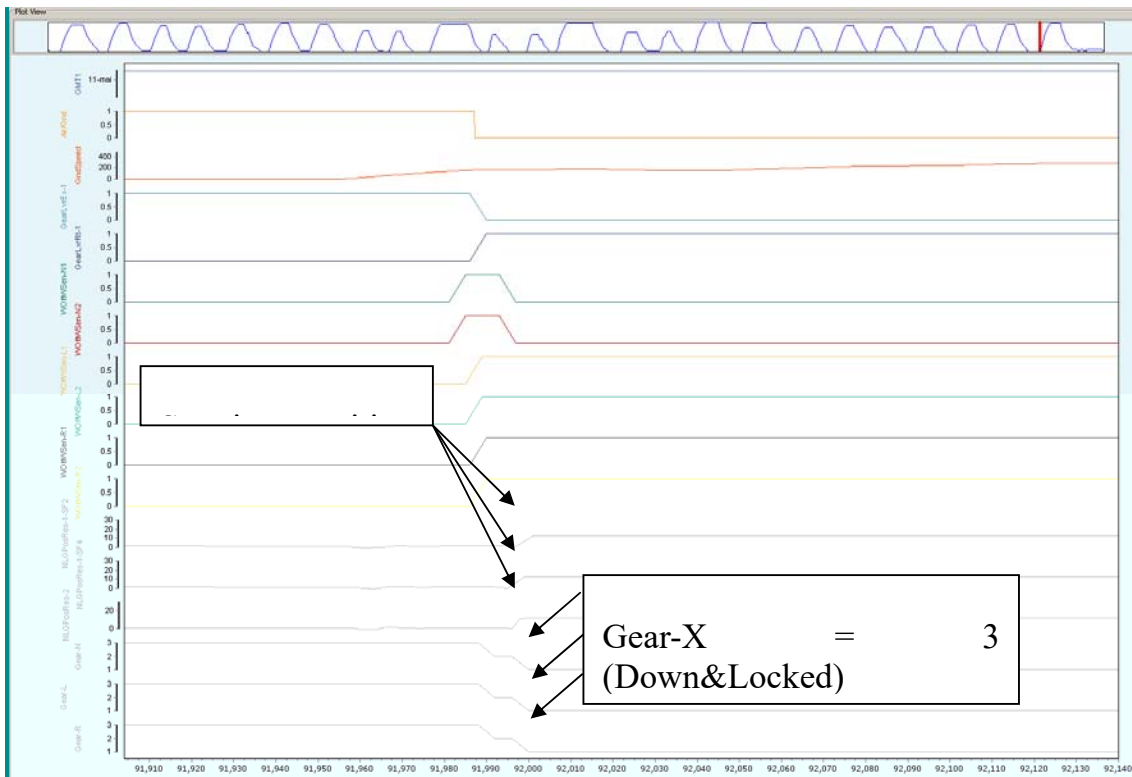
Figure (15) Event Flight Data - NLG Steering Position\* and Gear Position Signals

Referring back to the flight data; seconds after the NLG WoffW sensors transitioned to “WoffW = FALSE” the NLG steering position can be seen to shift from around  $0^\circ$  to around  $20^\circ$ . And just moments after that, all three gear

position indications transition from “in transit” to “up and locked”. See Figure 15, below (zoomed out view of the same data plot).

When analyzing these data points is that after the landing gears were commanded to retract the NLG shock absorber compressed sufficiently to disengage the self-centering cam feature of the NLG so that it was possible to turn while entering the NLG wheel bay. Inside the wheel bay the NLG locked in the up position while turned by around 20°. The NLG remained in this turned position for the remainder of the flight. When the landing gears were commanded to extend, the NLG unlocked from its up & locked position, but got physically stuck in the wheel bay because it was turned more than 8°.
