**FINAL REPORT ON TAIL STRIKE INVOLVING AN
AIRBUS A330-343 AIRCRAFT (REG: 9V-SSI) AT
YANGON INTERNATIONAL AIRPORT,
ON 25 NOVEMBER 2019**

**Aircraft Accident Investigation Bureau
Ministry of Transport and Communications
Myanmar**

9 November 2021

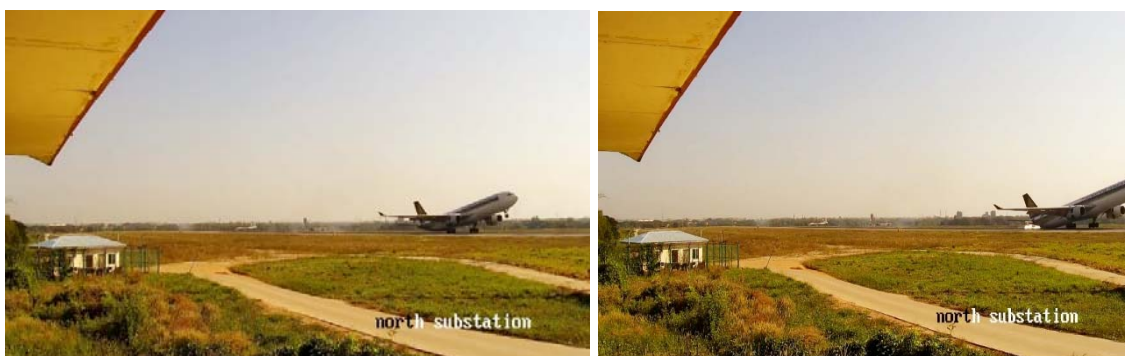
A surveillance camera located at a lookout hut in the vicinity of the runway recorded the event landing. Figures (2) and (3) shows the sequence of the tail strike.

Figure (3) Photos showing the tail strike on the runway

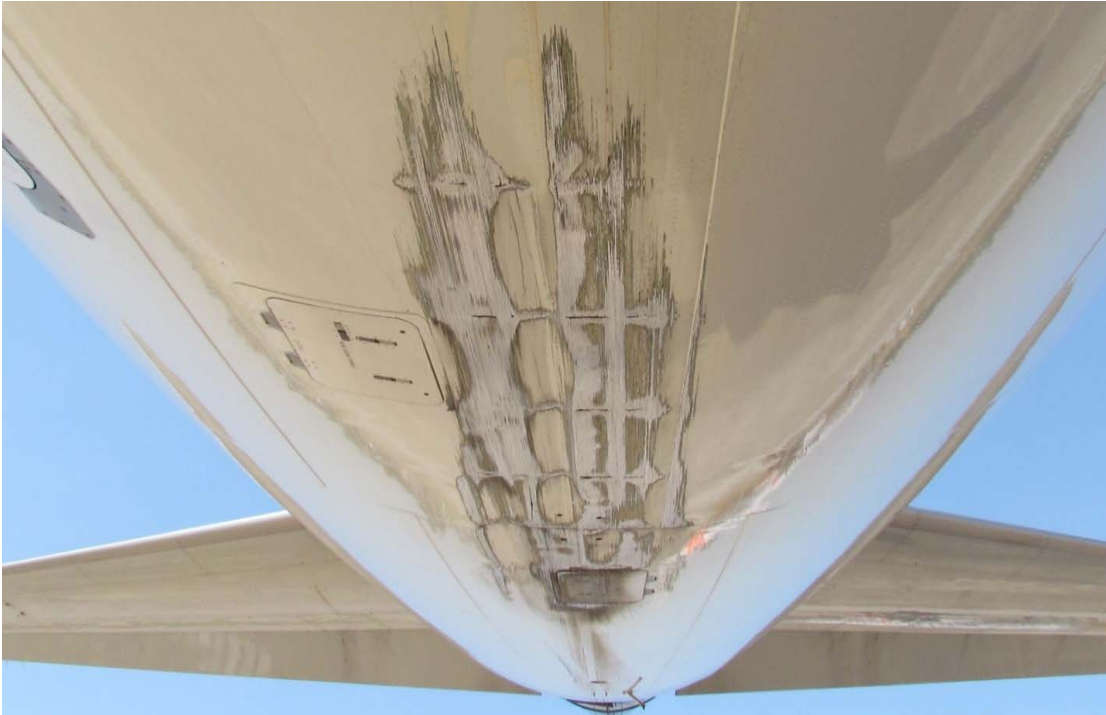
- (a) Fuselage Lower Skin between frames 68 and 73 in the tail section were dented, scratched and torn
- (b) Fuselage frames between frames 60 and 73 in the tail section were bent and scratched

Figure (4) Scrape marks on aircraft tail section

During the landing, the pitch up inputs by the PF caused the aircraft to reach a maximum pitch angle of 10.7 degrees, resulting in the tail strike.

- (1) The operator to ensure that its instructor pilots have greater urgency to take over control of the aircraft, especially during landing.
- (2) The operator to ensure that pilots performing pilot monitoring duties to use standard phraseology such as “PITCH PITCH” when the pitch angle of the aircraft exceeds 7.5 degrees during landing, as required by its procedures.

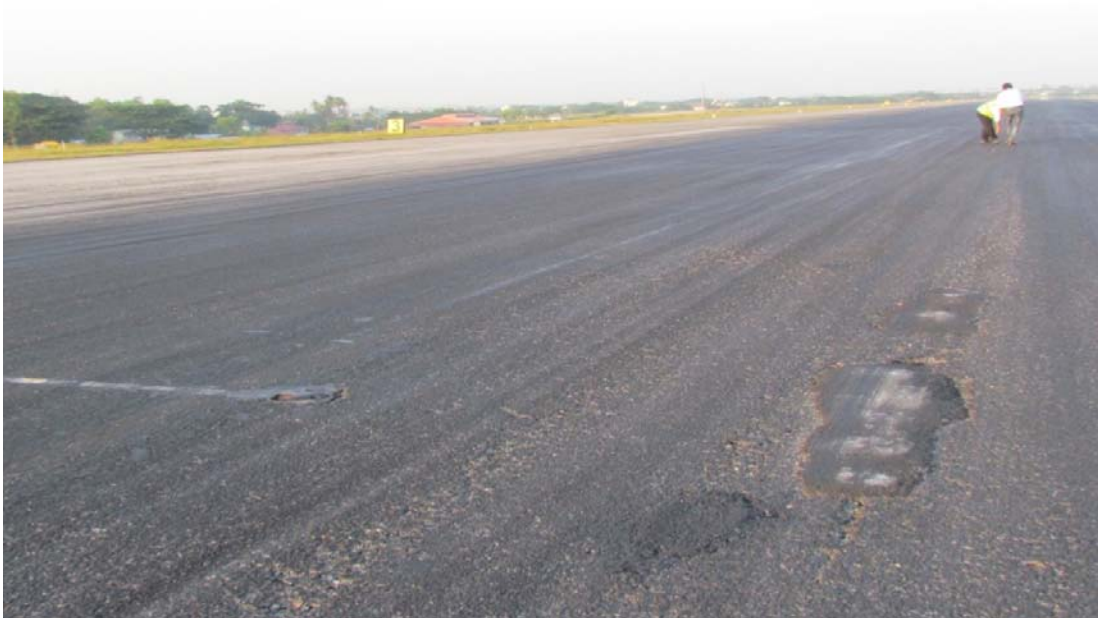
Scrape marks were found on the surface of the runway.

Figure (5) Scrape marks on the runway
