**FOKKER F-28 MK 0100, XY-AGC  
ACCIDENT NEAR HEHO AIRPORT (VYHH)  
ON 25 DECEMBER 2012**

**Executive Summary**

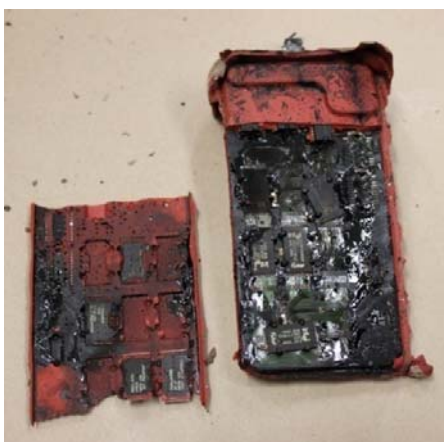
Figure 6: FDR memory module (accident module on left, normal module on right)

The SSUFDR's construction was outer steel housing, insulation liner, thermal block and memory board with 9 chips. The SSUFDR was severely burnt during the post-impact fire and significantly damage by fire. SSUFDR circuit board was removed at ATSB Lab. It is required special techniques to recover the recorded information. ATSB contacted to manufacture Honeywell and with the instruction of Honeywell carefully removed each chip from circuit board and downloading. A track plot of the flight is contained in figure and recorded information from the flight is included in ([Appendix-D](#)).

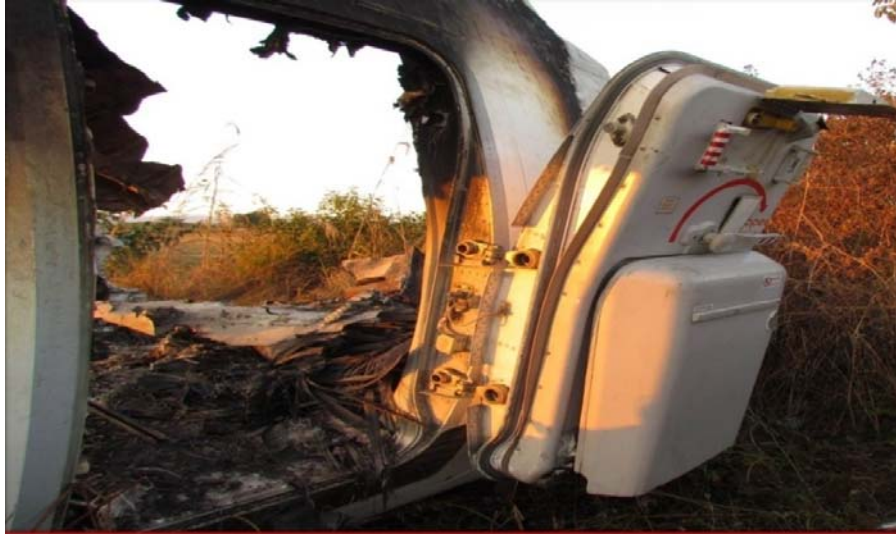
Figure 10: Forward cabin door (right side).

The forward cabin door left door slide activated and deployed but the cabin crew deactivated the service door slide on the right side, due to the close proximity of the ground and so it was not deployed (Figure 10).
