FINAL REPORT ON ACCIDENT TO  
HELI- UNION COMPANY LTD.  
HELICOPTER SIKORSKY S76 C++  
NEAR YETAGUN IN ANDAMAN SEA  
ON 11.07.2011

| 2. Aircraft type | : Helicopter SIKORSKY S76 C++ |
| 4. Registration | : F-HJCS |
| 6. Date & Time | : 11 July 2011 at 10 h 19 (local time) |

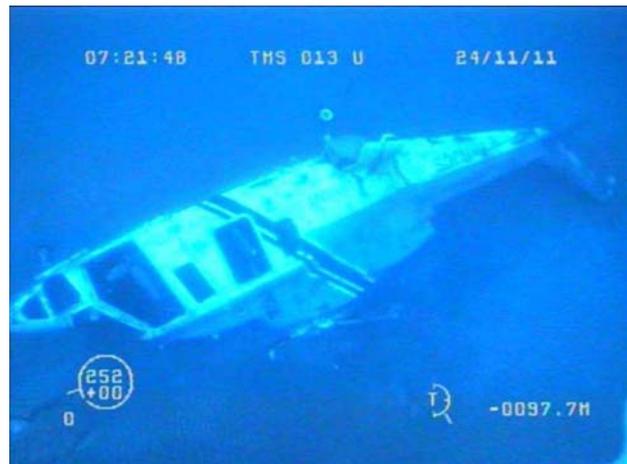
The helicopter was slightly damaged by the impact with the sea and it toppled just after ditching and the prolonged salt water immersion. The main rotor blades and tail rotor blades were broken. The right crew door, the window of the right sliding door, the right front window and the window of the left side door were missing, probably due to actions of the crew and passengers during evacuation.

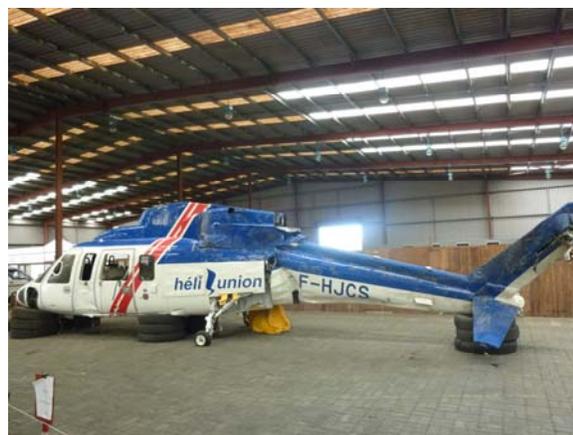
The airframe was in good general condition. The tail boom was damaged and partially separated from the cabin probably due to the contact with the sea surface and then with the seabed and increased by the recovery operations. The main gear box was severely damaged due to its housing corrosion. The main rotor head came off during the recovery operation.

All four main rotor blades were broken off from the rotor head and the remaining sections still attached were approximately 50 cm in length. The blades were not recovered.

The tail rotor blades were broken off from the tail rotor assembly and not recovered. The cabin and cockpit including instrument panel and controls were in good condition.

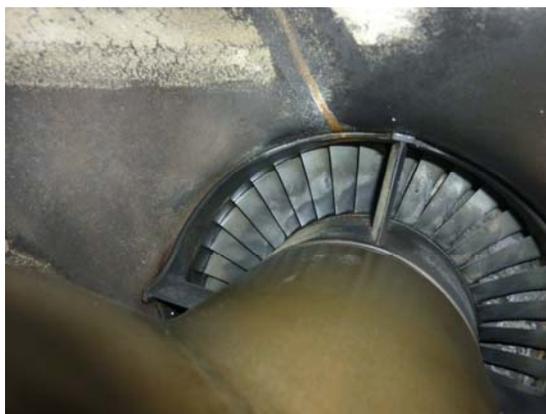
Engine #

1 (s/n 42266) did not exhibit any pre-accident damage with no particular findings to report.

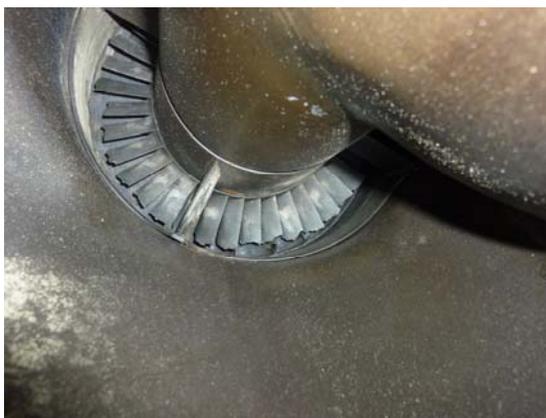
The on-site boroscopic examination of engine #2 (s/n 42265) revealed damages to the blade tips of both high pressure turbine (gas generator) and power turbine (free turbine). The pipes at the accessories gearbox breather gear output and at the bleed valve output were found disengaged. The moment of their disengagement could not be established. The disengagement of those pipes does not affect the engine's ability to deliver the required power. There were no other significant findings on engine #2.

The high-pressure blade: the HP turbine wheel had one blade broken below its platform near the top of the fir tree root. All the other blades were normally positioned on the disk and exhibited impact damage and material loss above their platforms.

The nozzle guide vane's (NGV) vanes trailing edges exhibited impact marks. The power turbine blades, normally positioned on the disk, exhibited impact damage and material loss above their platforms. This resulted from HP turbine blades' debris being sent down the air path and colliding with the power turbine blades.

The engine #2 HP turbine wheel assembly was analysed. The examination identified the fatigue rupture of blade #6 below the platform. Damages to the other blades above the platform were consecutive to the rupture of this blade.

It consists of adding a damper in the inter-blade area under the platform and reinforcing inspections on new and repaired HP turbine wheels.

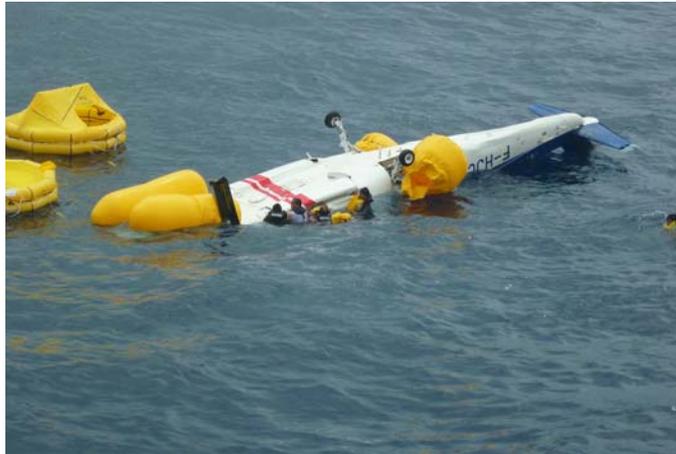
The helicopter was equipped with an emergency flotation system consisting of four inflatable units. A flotation bag was installed on each main landing gear compartment door and two were installed in compartments next to the nose landing gear. The emergency flotation system was successfully inflated by the PF just before ditching. The picture below shows that the devices were inflated.

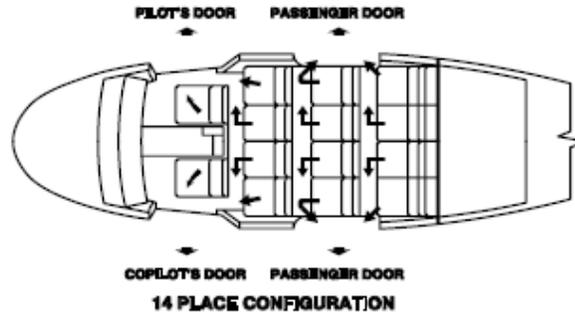
All emergency exits must be usable at all times, except if an official concession is obtained. All emergency exits of F-HJCS were usable. The captain evacuated through the right pilot's door while the passengers and the co-pilot evacuated through the window of the right sliding passenger door.
