**FINAL REPORT**  
**MA-60, XY-AIP, RUNWAY EXCURSION**  
**ACCIDENT KAWTHAUNG AIRPORT (VYKT)**  
**ON 10 JUNE 2013**

**Executive Summary**

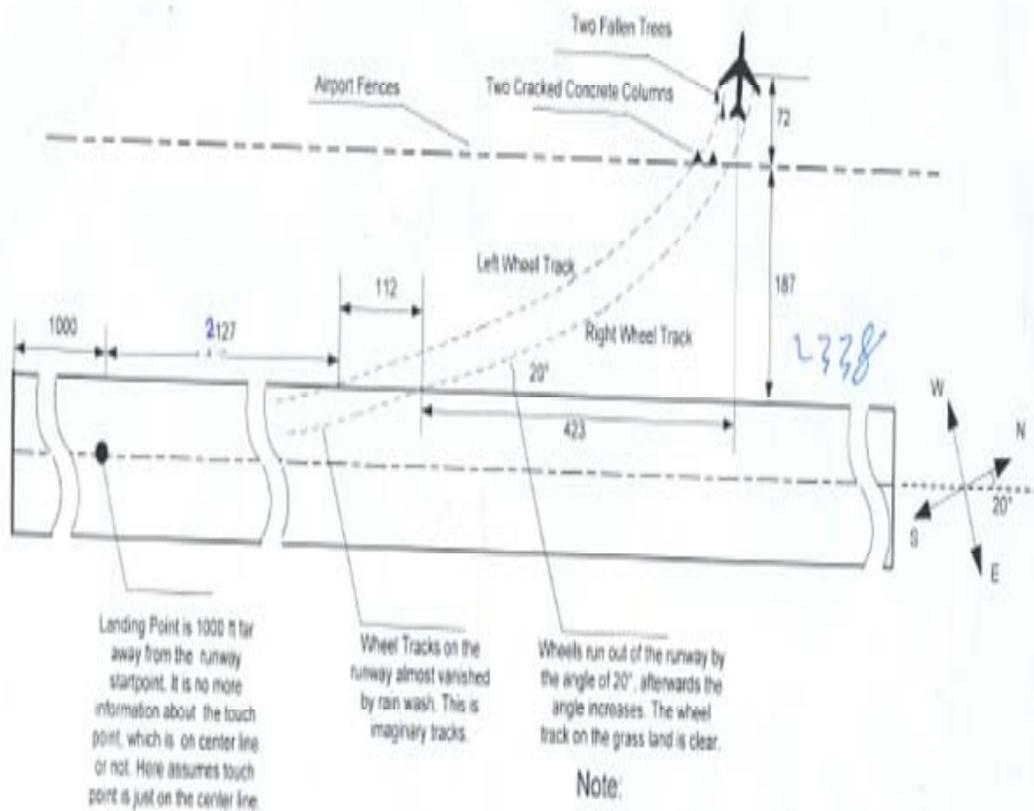
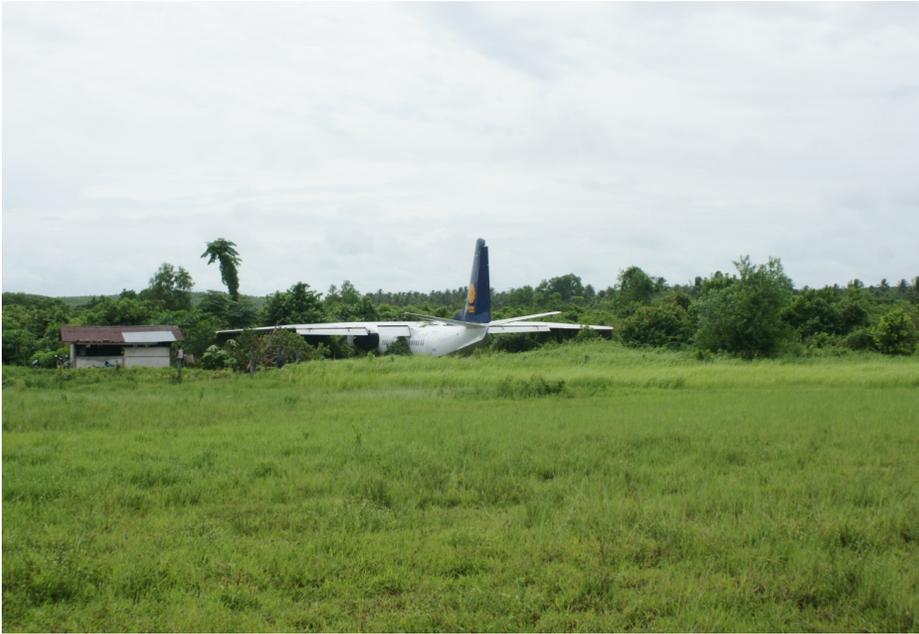
Figure (2). Accident site

Aircraft cannot able to steer and veer off left side of runway at about 3200ft. Firstly aircraft striked to fence pillars with propellers and nose wheel, then aircraft turned 90° to left and stopped after striking to tree with left wing.

The accident site was located in a small bushes area (200) ft from runway left side. Aircraft veer off runway left side and struck to fence pillars with nose and left landing gears, left engine. Aircraft came to rest after striking to tree with left wing.

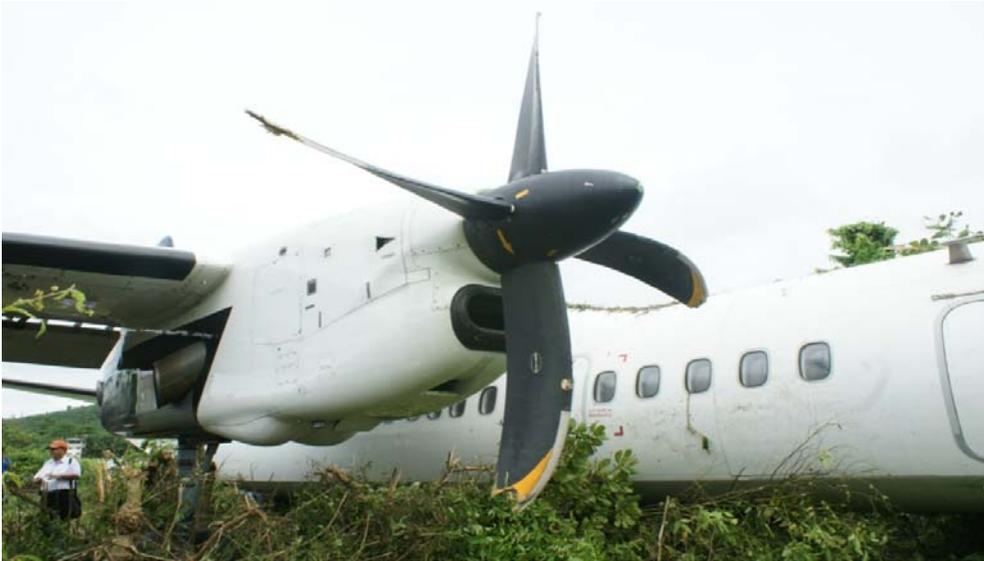
Figure (3). Damage to Aircraft

The left and right engines propellers blades were damaged, left engine casing cracked, left wing leading edge was dent, and lower fuselage frame was dent. Aircraft need to be major repair.

- Both of the propellers were damaged.
- The landing gears was fully extended (down and locked).
- Flap position was extended about (27) degree.
- Nose wheel was steering position.
- Left wing leading edge was dent due to strike with tree. Lower fuselage was dent.
- Left engine casing was crack due to strike with fence pillar.
- The aircraft was needed to major repair.

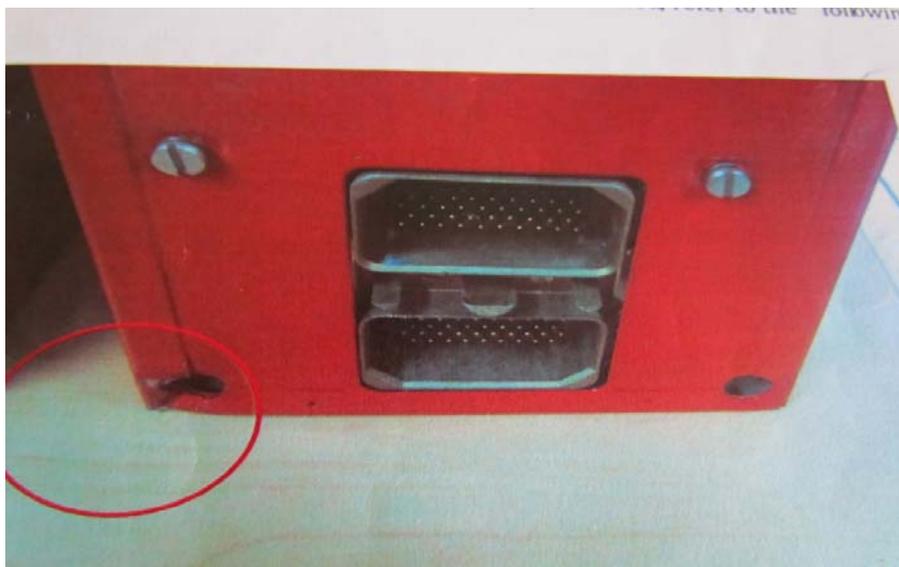
Fig (7). FDR Casing

Myanmar Civil Aviation Requirement (MCAR), part-7 mentioned requirement FDR and CVR. The aircraft was equipped with a China made FDR Part No- FB- 30C. It was found seriously deformed at the rear fix point of the casing. (Attach photo)

The rear fix point of FB- 30 FDR (S/N- 0710006) is seriously deformed. Before the downloading, it was conducted self - test and worked normally. FDR was download with FZJ-1, FDR integrated data processing equipment in China Academy of Civil Aviation Science and Technology lab, CAAC.

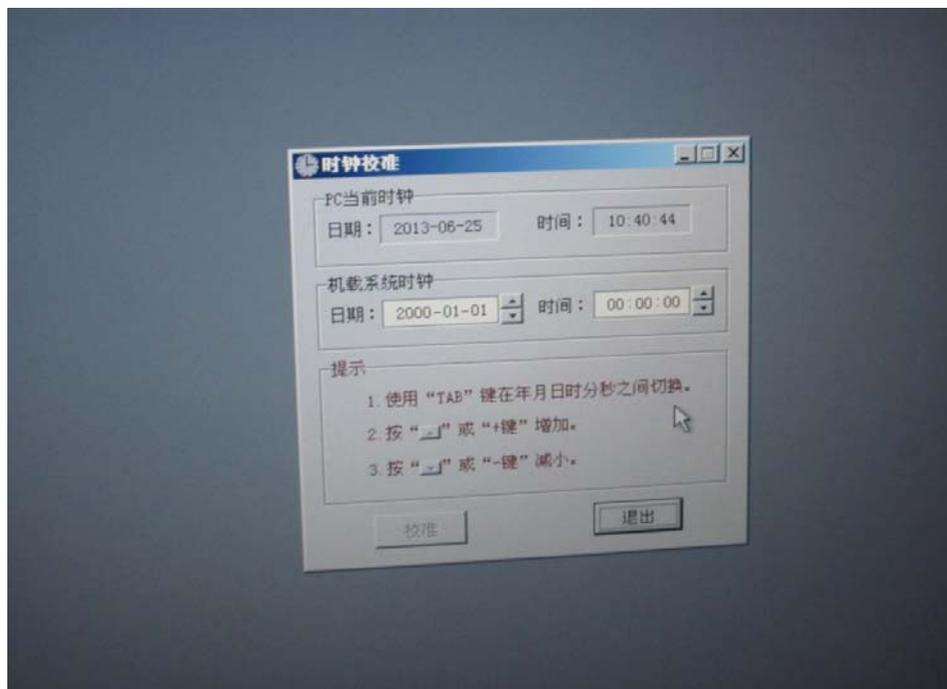
Figure ( 8). FDR (S/N- 0710006) self-test record.

The data was downloaded with FZJ-1 (FDR) integrated data processing equipment. Before the downloading, the FB-30C (FDR) conducted self-test, the FDR worked normally. The size of the downloaded file was 32MB. For FB-30C FDR (S/N 0710006), the latest recording was "22 Sept 2011", no recording of the accident flight. The FR-30C Quick Access Recorder PC card was read by FDK-1 PC cards downloading device. The downloading was uneventful, but found it was stopped recording since March 24, 2013 (the data recording was stopped since FDR (S/N-0710006) installation). This FR-30C PC card was also downloaded in Myanmar, and the same result as done in CAST laboratory and there were also no data of accident flight. **(Appendix- B)**

On FB - 30C, FDR (S/N- 0710006), the latest recording was 22- Sept 2011, No recording of the accident flight. This FDR (S/N - 0710010) was removed from (XY-AIP) aircraft in same date and sent back to China for repairing. Then FDR (S/N- 0710006) was reinstalled on (XY-AIP) on 24- March 2013 (No further data recorded since installation).

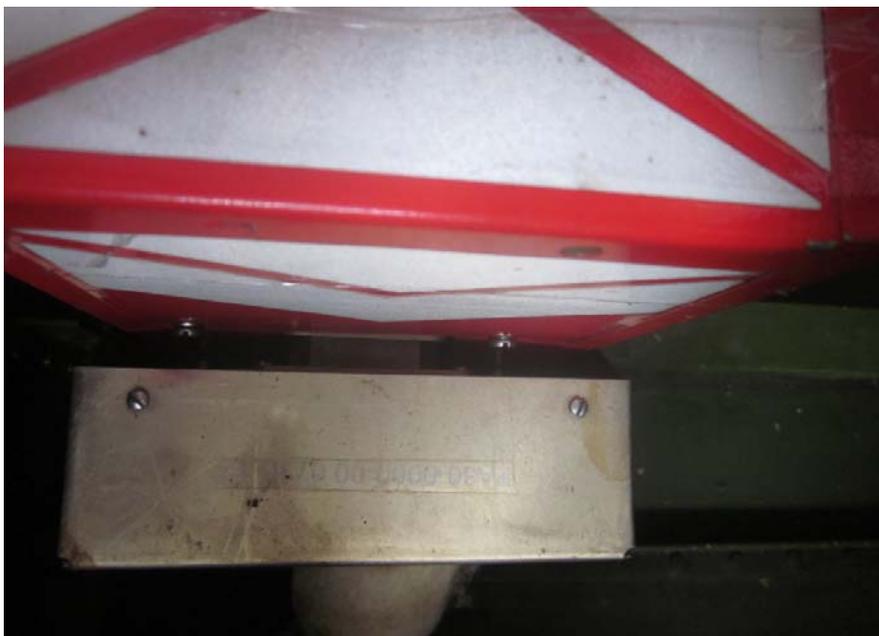
Figure (11). Gap between FDR and Plug of installation bracket

FDR (S/N- 0710006) was installed and checked on XY-AIO (MSN- 0806) and XY-AIP (MSN- 0807). After installation of FDR, power on the system, FDR warning came on continuously in the warning panel. Which reminds that the flight record system is under failure. After surveying, no proper installation of FDR was found (gap between the rear panel of FDR and plug of installation bracket longer than normal, not proper fitting).

- No proper installation of FDR was found (Gap between the rear panel of FDR and plug of installation bracket longer than normal, not proper fitting).
- During maintenance FDR was not proper self-test.
