**FINAL REPORT ON
MA-60, XY-AIQ, RUNWAY EXCURSION
ACCIDENT MONGHSAT AIRPORT (VYMS)
ON 16 MAY 2013**

Executive Summary

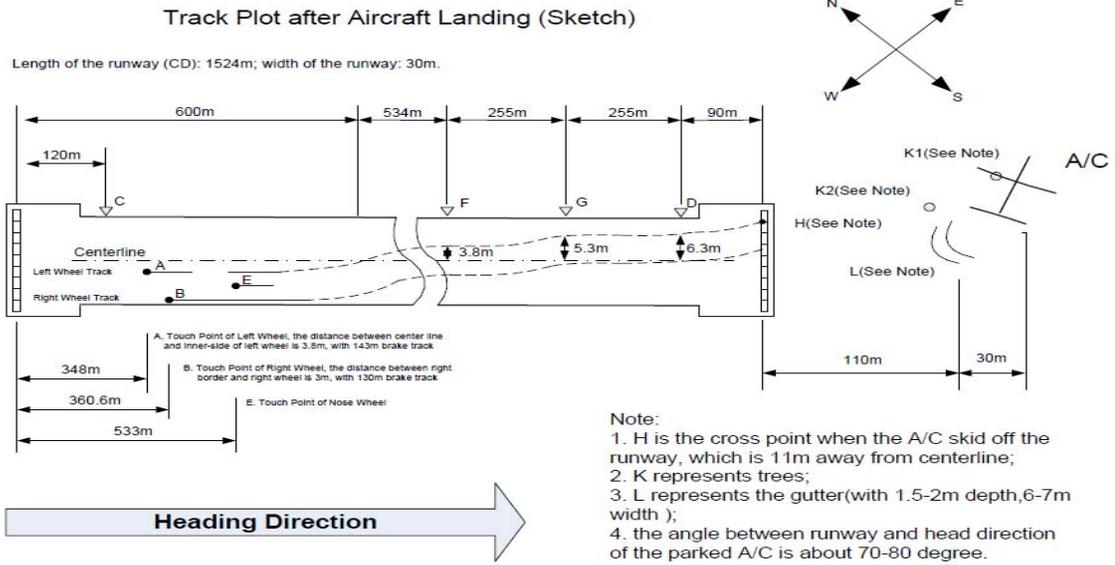
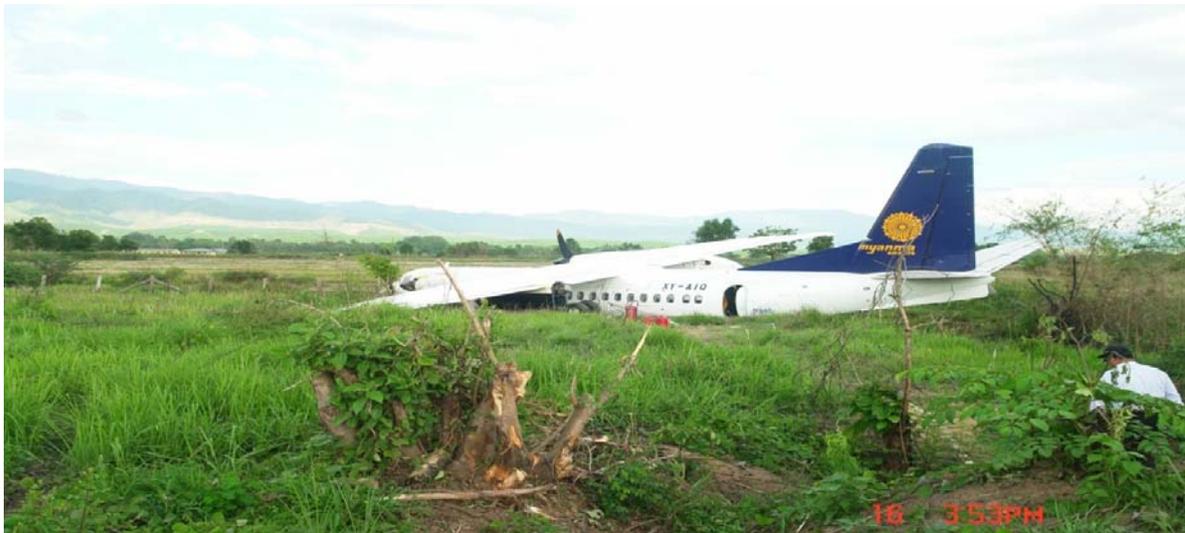
Figure (3). Accident site,

At about 11:47:59 local time, aircraft first touchdown to runway 12 with IAS 114 knots, vertical speed -288, flap 30 degree. During landing roll, aircraft over run to runway 30. At about (11:48:33) local time, aircraft struck to tree stump with IAS 40 knots and passing across to water drainage (gutter) located 110 meters from runway 30. After striking, aircraft turned to left 80 degree and came to rest. Cabin crews performed emergency evacuation, one passenger suffered serious injury, other one suffered minor injury and 53 of the occupants were survived.

The accident site was located in a over run area about 140 meters from the threshold of runway 30 at an elevation of 1895 ft. The initial strike with trees stump with left propellers, left landing gear and nose gear; then aircraft passing a water drainage (gutter). After aircraft struck the trees stump, left main landing gear and nose gear folding struts broken and then aircraft turning left and came to rest. Left wing tip was broken, lower fuselage was dent.

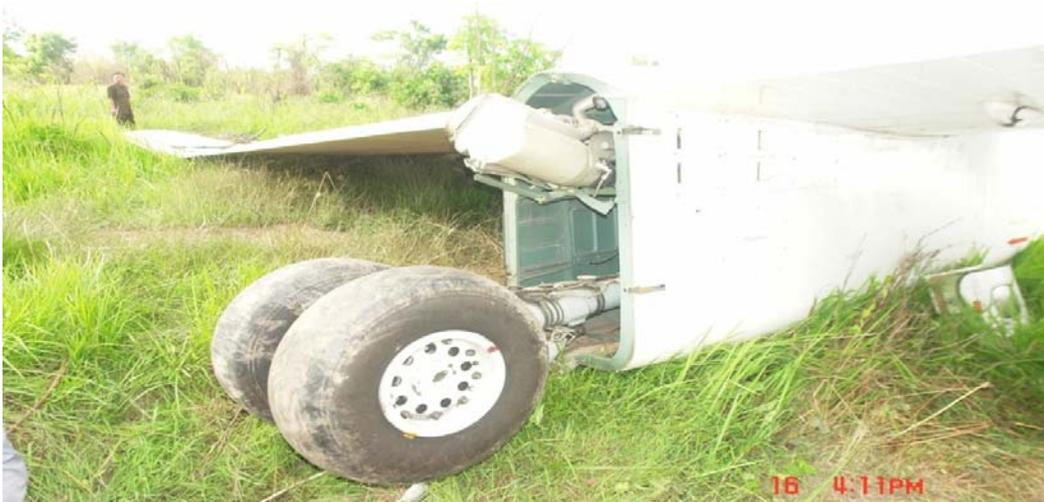
Figure (4). Damage to Aircraft

The left main leading gear and nose landing gear strut broken, left engine propeller blades broken, left wing tip broken and lower fuselage frame dents. Aircraft was substantial damage.

- Left wing tip was broken.
- Left landing gear collapsed backward and nose gear forward. .
- Flap position was fully up and selector S/W retract position.

- Left emergency door and passenger door were opened. The cargo door and right emergency exit were not deployed due to right engine propellers rotating.
- Lower fuselage skin was dent and antennas were broken.
- Left propeller blades were broken.

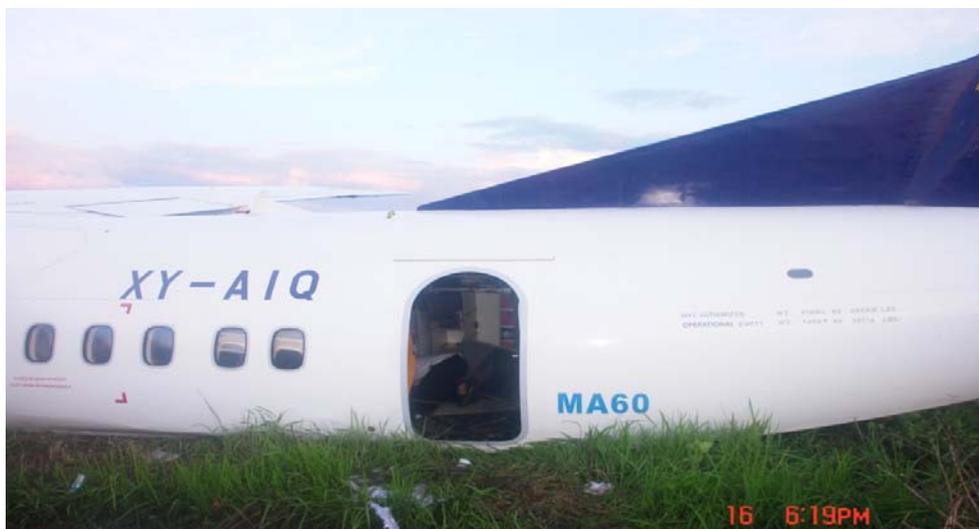
Figure (10). Survival aspect

The cabin crew initiated an emergency evacuation as soon as the aircraft came to rest. The MA-60 aircraft has 5 exits and 1 front cargo door. Passenger entry door left and right passenger cabin emergency exits, cockpit emergency exit hatch, rear cargo compartment door and front cargo compartment door and passenger entry door. The entry door and left passenger cabin emergency exit opened. The right side passenger emergency exit and front cargo exits remained closed due to the damage of right propeller rotating. One passenger serious injury, one passenger minor injury and other were survived.

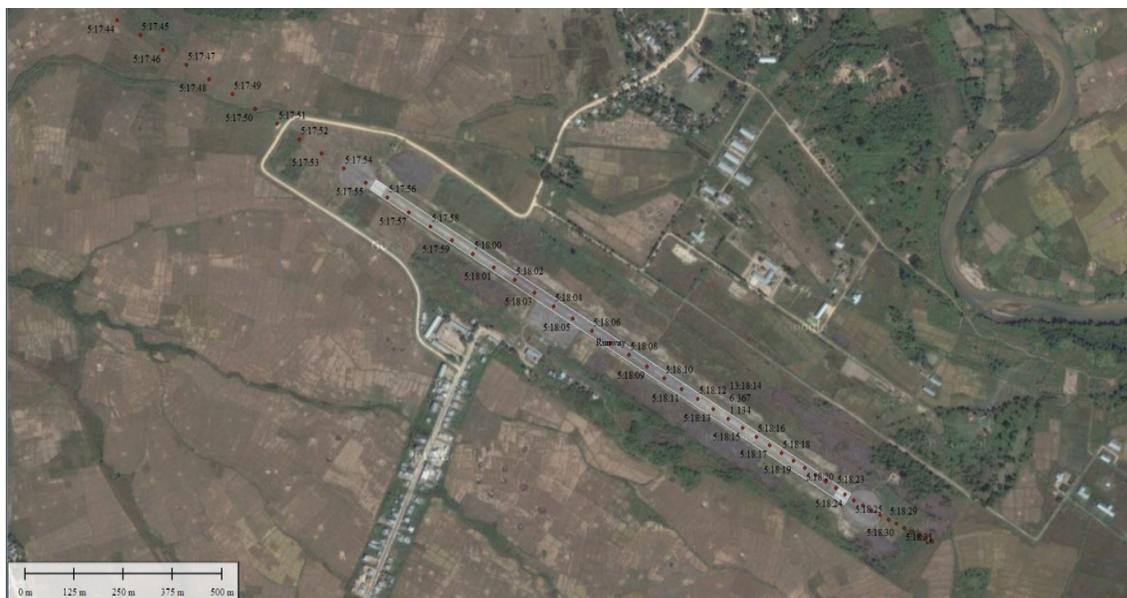
Figure (12). XY-AIQ Track

- 11:48:09, IAS 93.6 knot, Radio altitude 5.39-ft, vertical speed 32ft/ min, left/ /Right PLA 36.8/ 36.5° respectively vertical acceleration 0.7g, the flap began to be retracted.
- 11:48:16, IAS 72.8 knot, Radio altitude 0.02-ft, engines torque 2/3, vertical speed +128ft/min, left/ Right PLA 36.8/36.6° vertical acceleration 0.96, pitch-1, Elevator (-2.5), Flaps were retracted to 1° (**Appendix- D**), and flight path animation file. Left/ Right engine torque starting to increase.
- 11:48:50, IAS 40 knot, Radio altitude 3-4-ft, engine torque 14/15, vertical acceleration 2-g, vertical speed 32, Flap 0.15°, PLA 36.8/ 36.6° (Aircraft struck trees stamp and come to rest at 11:49 local time.
