Aircraft Accident Investigation Bureau of Myanmar

**FINAL REPORT OF ACCIDENT OF A COLLISION WITH TERRAIN
INVOLVING BIMAN BANGLADESH AIRLINES AIRCRAFT
BOMBARDIER DHC-8-402, REGISTERED S2-AGQ AT YANGON
INTERNATIONAL AIRPORT, MYANMAR ON 8 MAY, 2019**

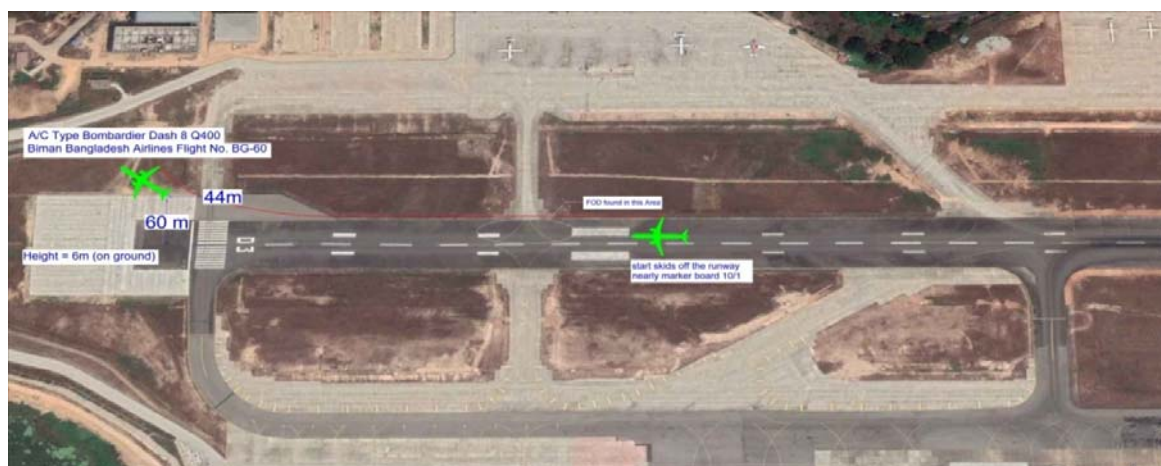
Figure (1) Layout of Accident Site

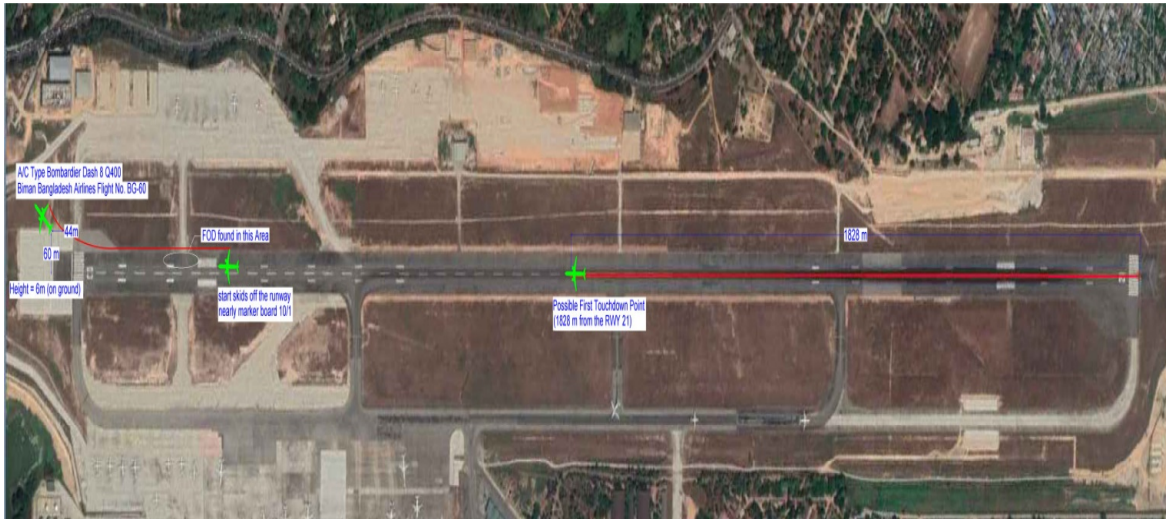
Figure (2) Layout of Accident Site

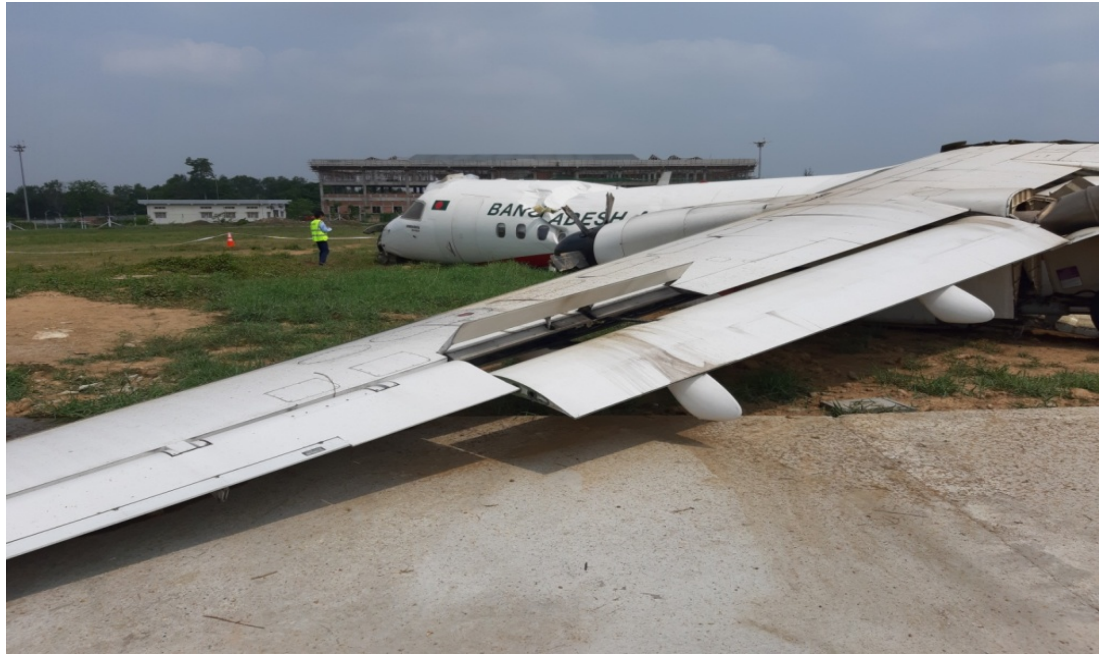
Figure (3) Final position of the aircraft on the overrun of Runway 03

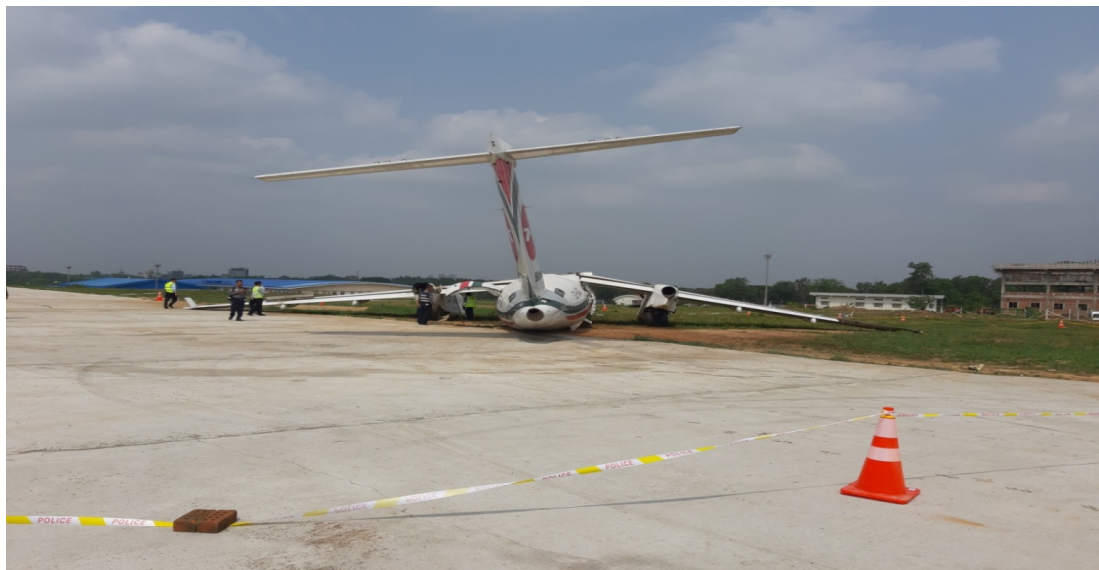
Figure (4) Final position of the aircraft on the overrun of Runway 03

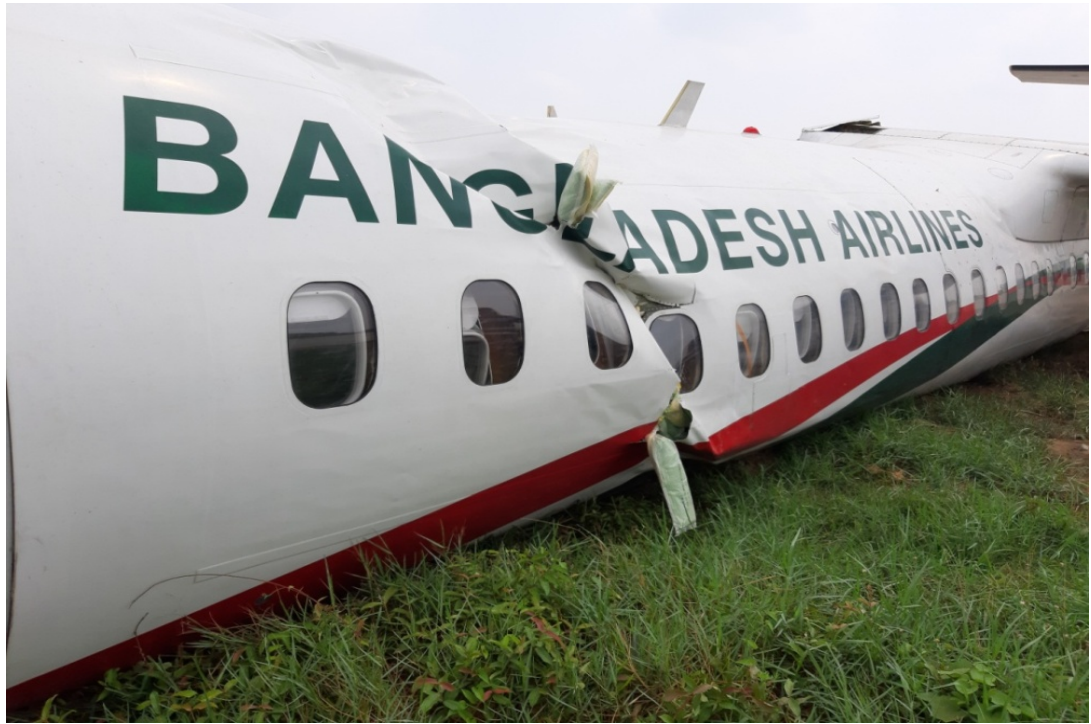
Figure (5) Damaged Fuselage of the Aircraft

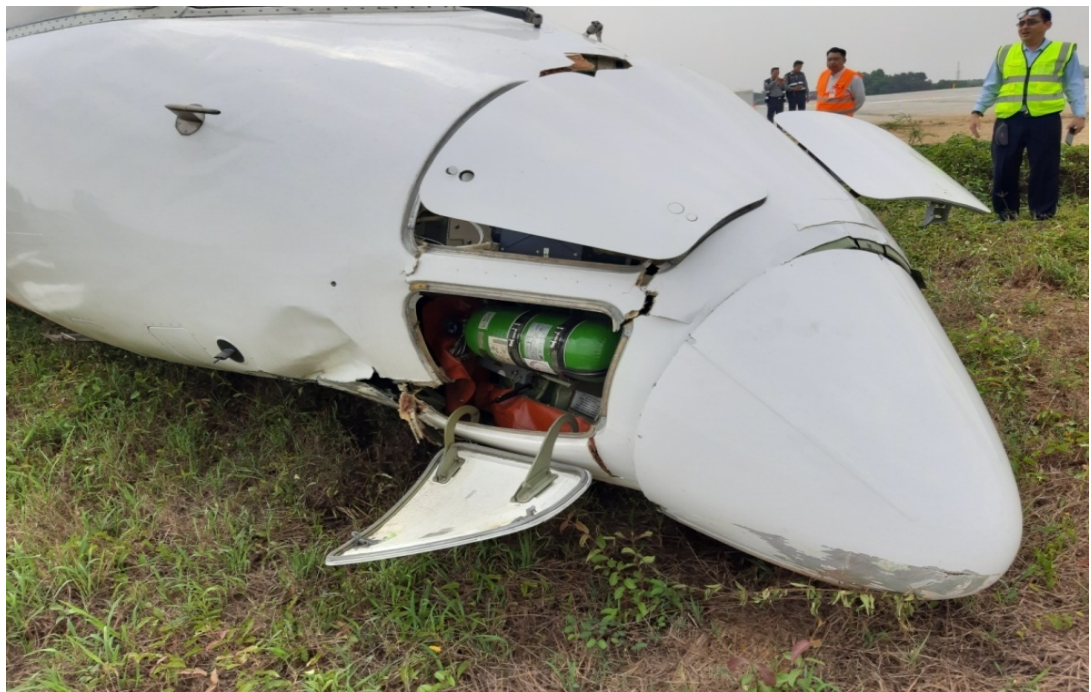
Figure (6) Damaged Radome of the Aircraft

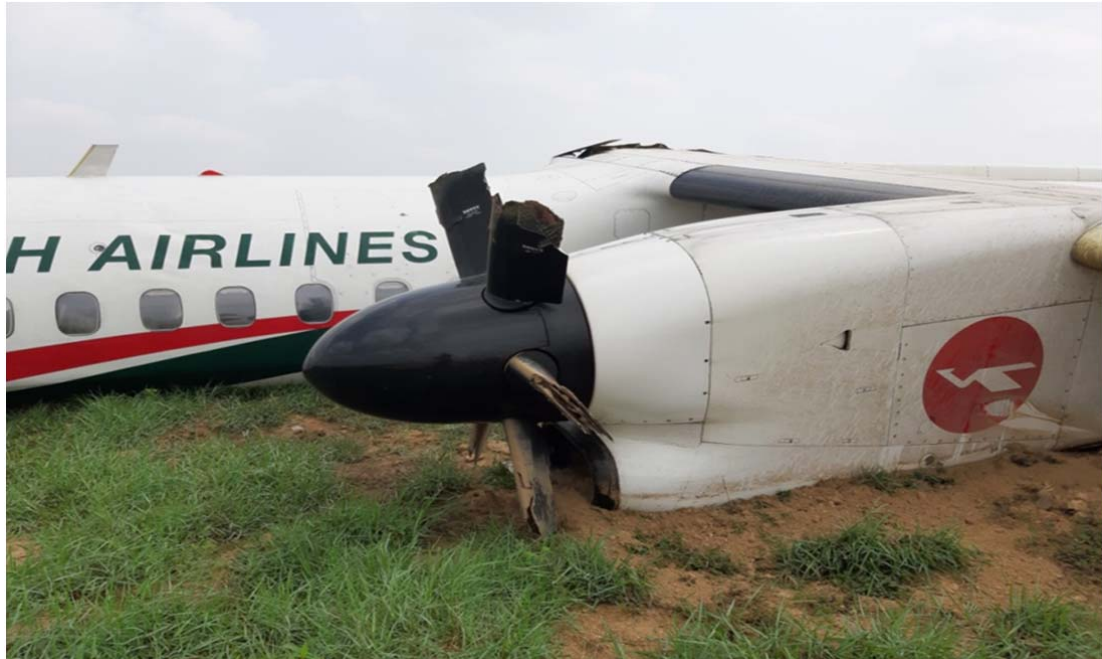
Figure (7) Damaged Propellers of the Aircraft

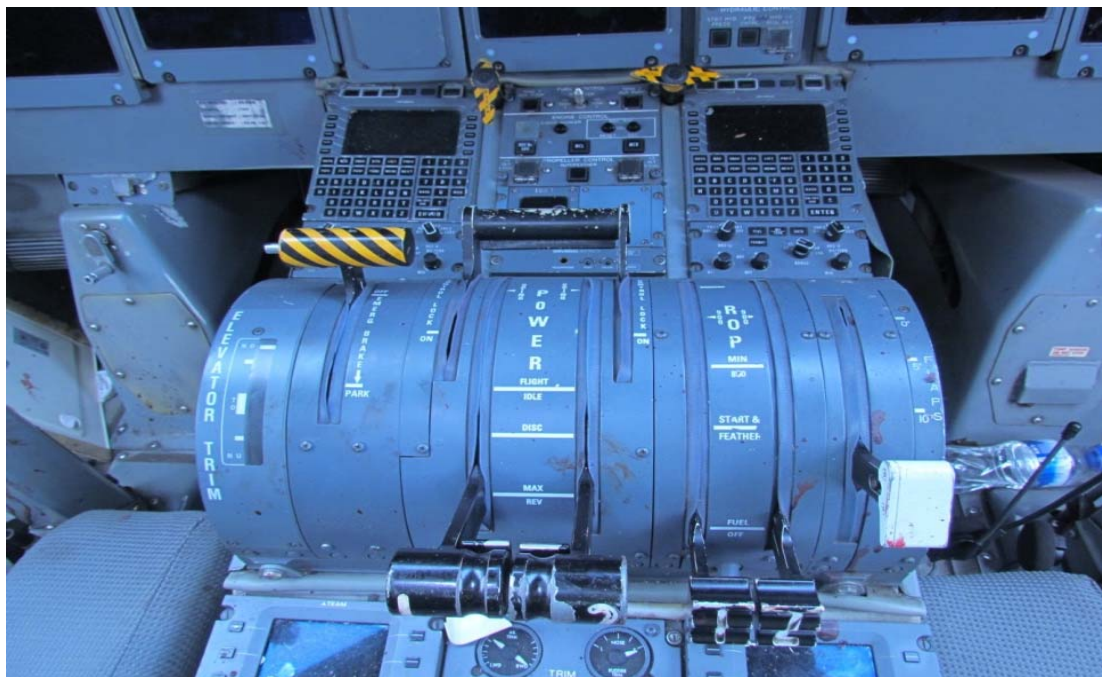
Figure (8) The Cockpit view of the Aircraft

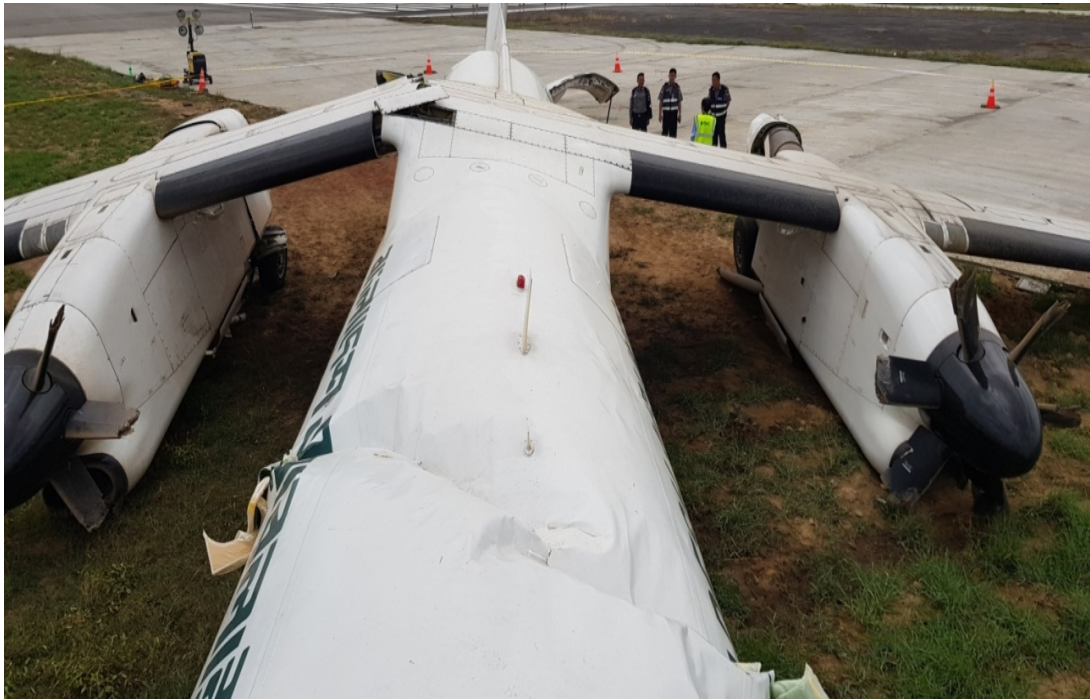
Figure (9) Right hand wing of Aircraft broken at the attachment point with the fuselage

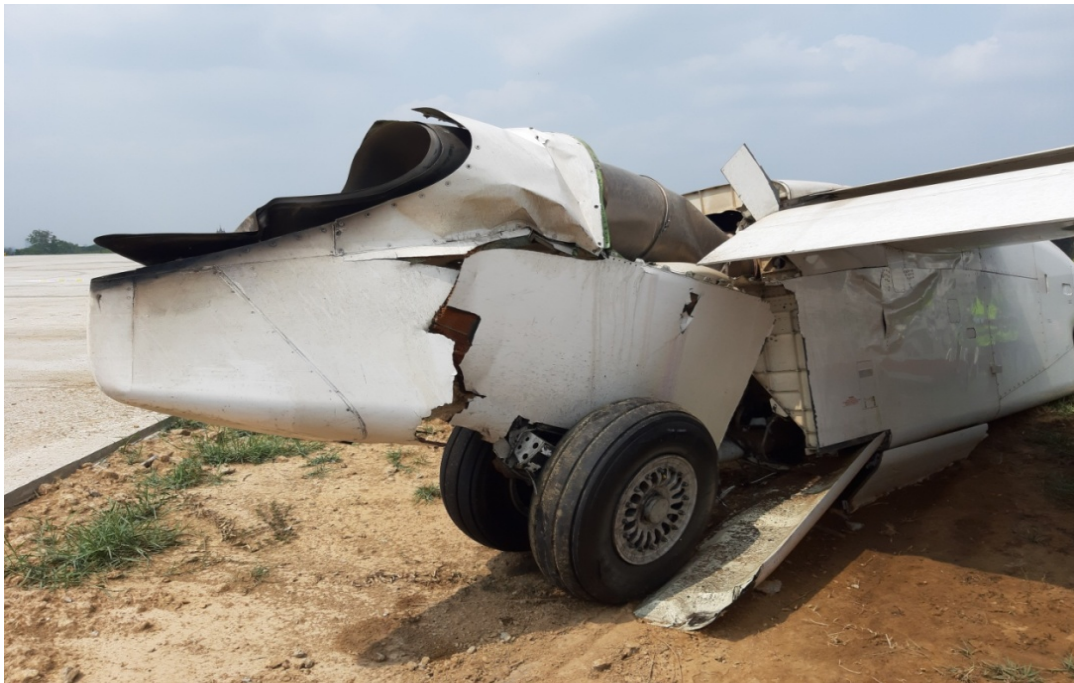
Figure (10) Damaged main landing gears of the Aircraft

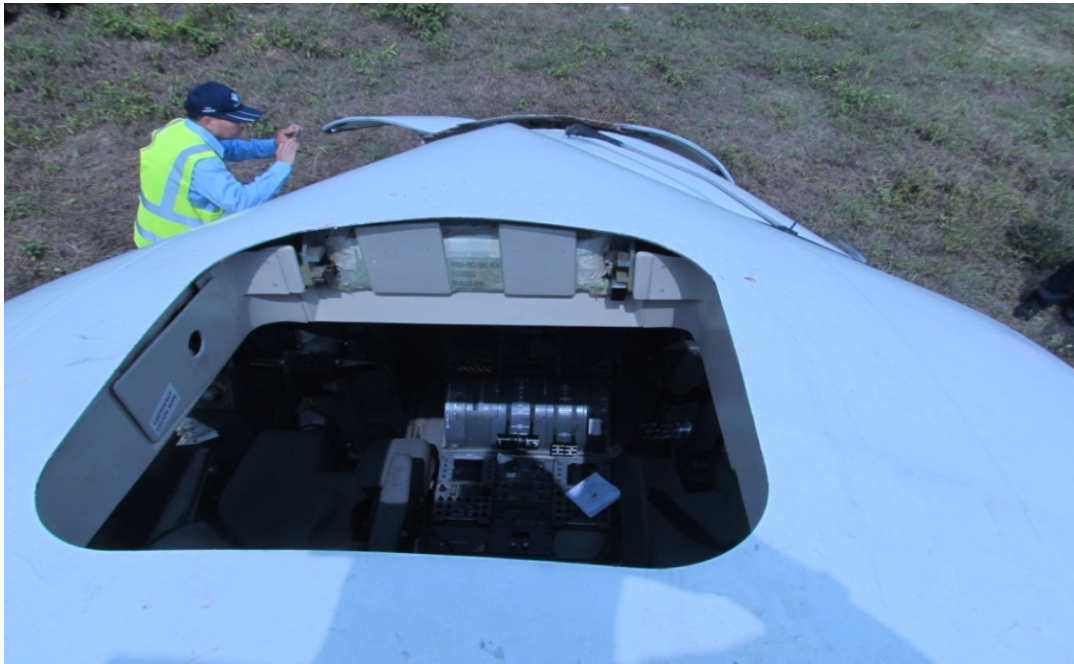
Figure (11) Escape hatch was opened to rescue the flight crew

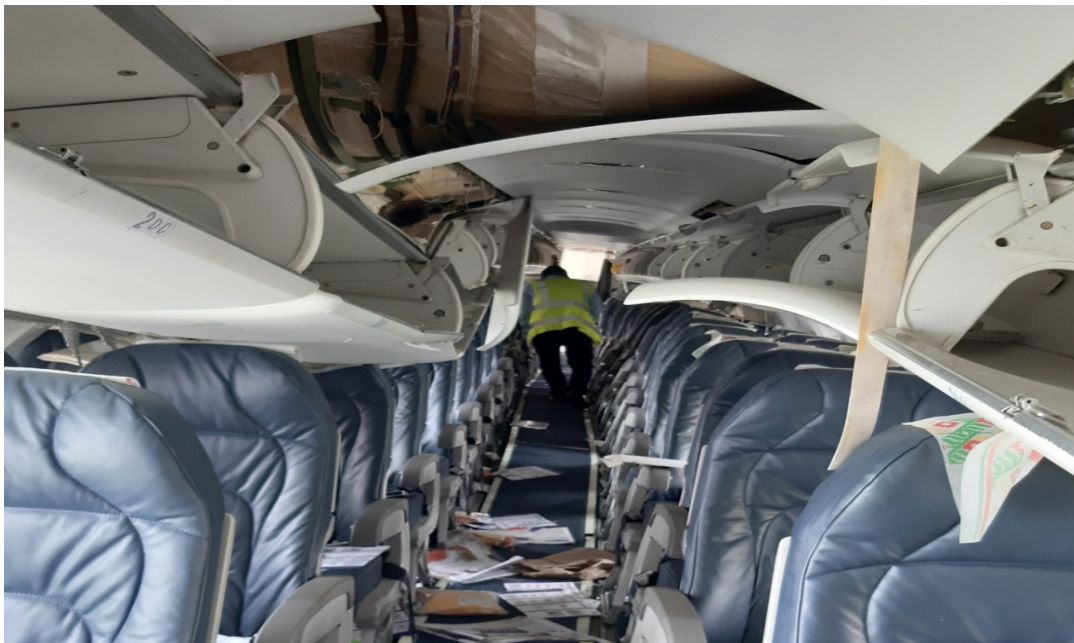
Figure (12) Damaged Cabin Interiors of the Aircraft

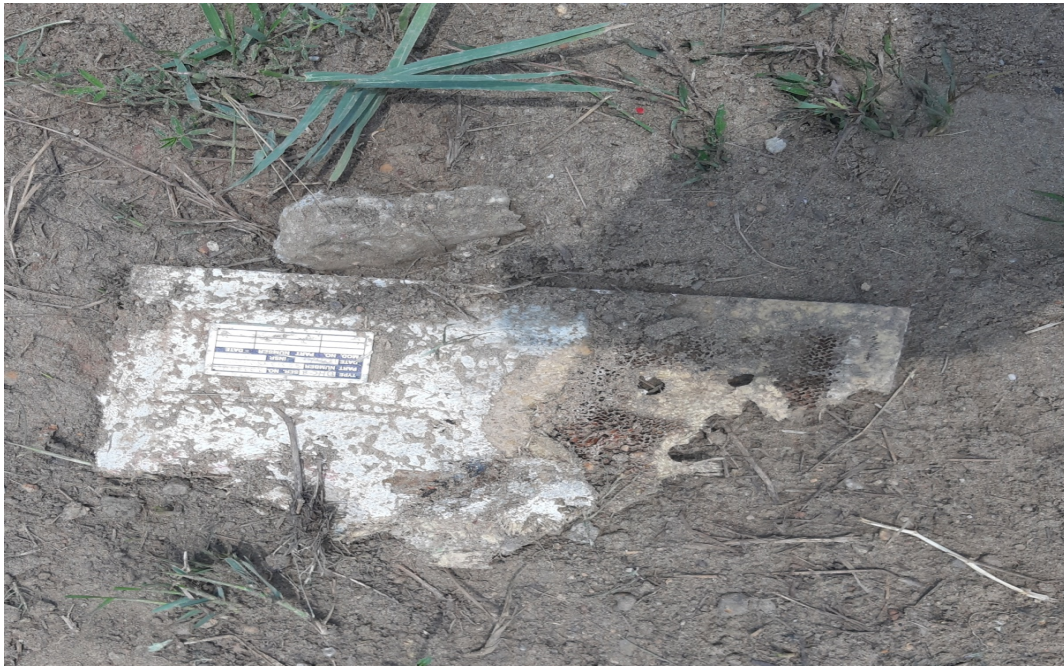
Figure (13) The debris of the Aircraft scattered on the ground

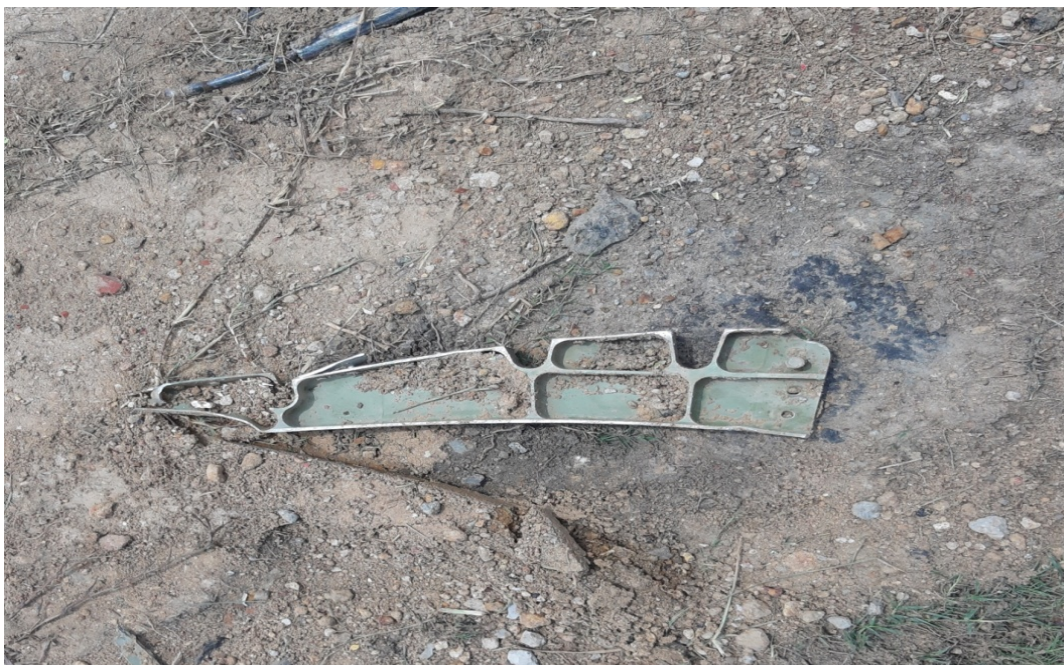
Figure (14) The debris of the Aircraft scattered on the ground

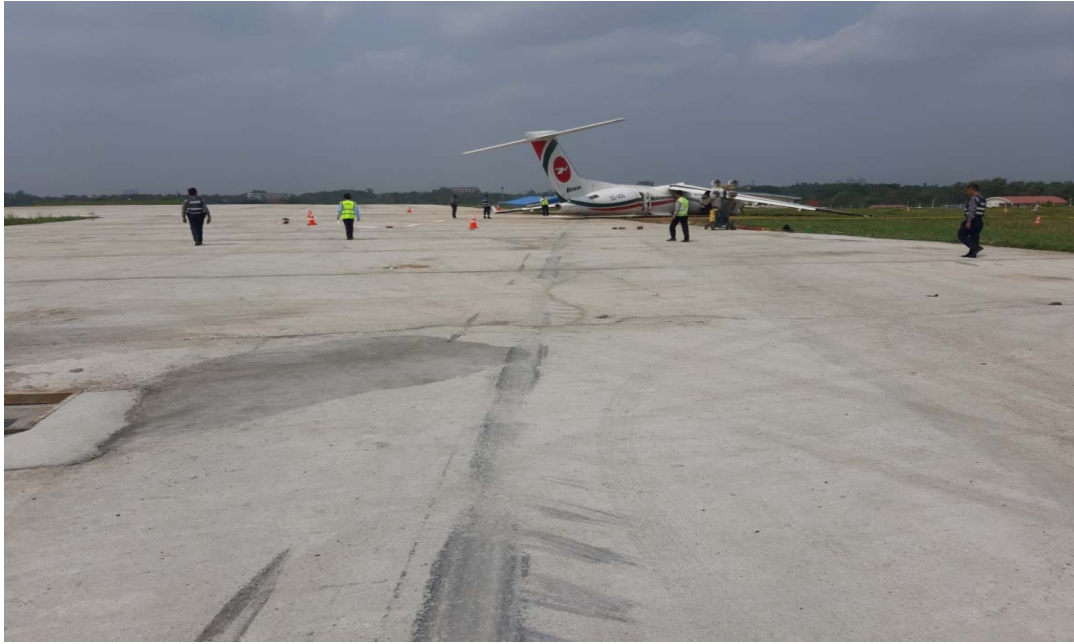
Figure (15) Wheel tracks and propeller striking marks on the overrun

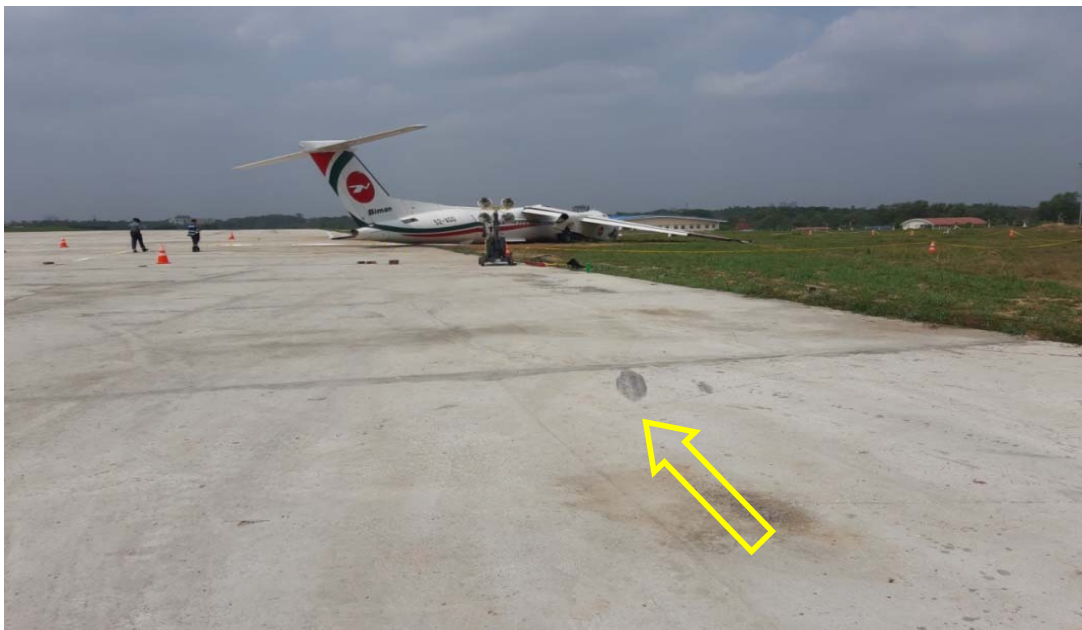
Figure(16) Wheel marks of the Aircraft on the overrun
