Aircraft Accident Investigation Bureau of Myanmar

**FINAL REPORT OF SERIOUS INCIDENT OF NOSE LANDING GEAR
FAILURE EMERGENCY LANDING OF MYANMAR NATIONAL AIRLINES,
EMBRAER-190 AIRCRAFT (REG: XY-AGQ) AT MANDALAY
INTERNATIONAL AIRPORT, ON 12 MAY, 2019**

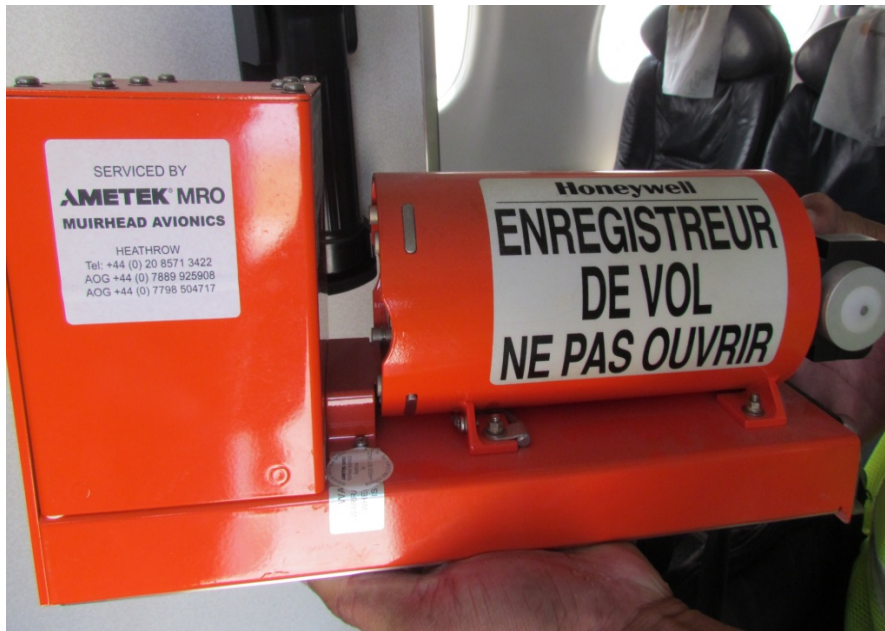
Figure (10) Digital Voice Data Recorder

The recording quality of the FDR data was of good quality. The FDR contained 27 hours and 13 minutes and 47 seconds of flight data that encompassed 23 flights prior to the incident flight. The FDR had 1027 parameters in the data frame file.
