Aircraft Accident Investigation Bureau of Myanmar

**FINAL REPORT OF SERIOUS INCIDENT OF THE NOSE LANDING GEAR
AXLE RUPTURE INVOLVING GOLDEN MYANMAR AIRLINES,
ATR 72-600 AIRCRAFT (REG: XY-AJM) AT YANGON INTERNATIONAL
AIRPORT, ON 2nd AUGUST, 2019**

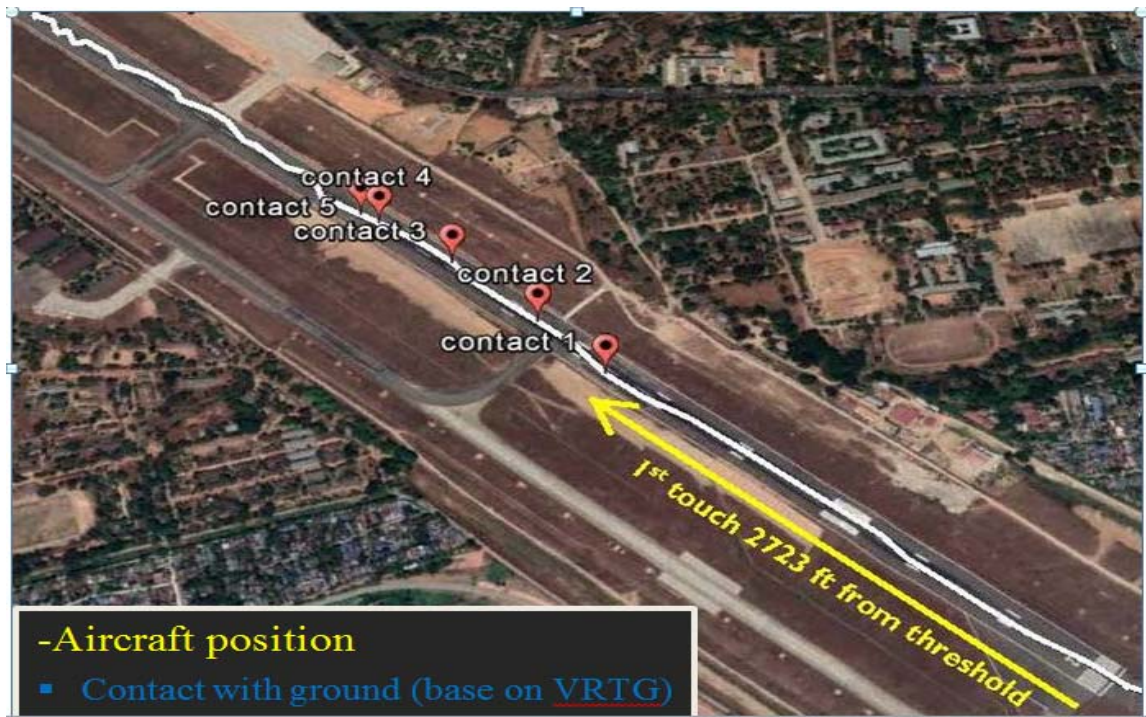
Figure (1) Layout of Serious Incident Site

The aircraft landed with a nose down attitude on the runway 21. It bounced four times forward and came to stop about 7000 ft from the threshold of runway 21. The aircraft encountered a nose gear axle rupture and the right nose wheel broke off.

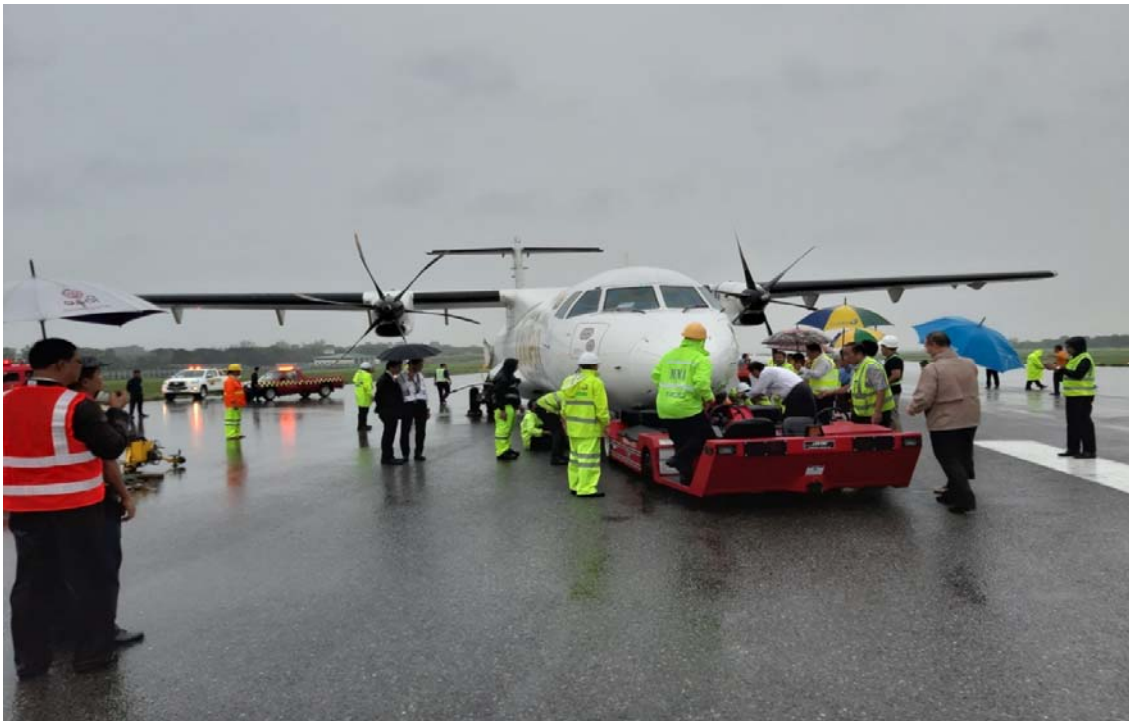
Figure (9) Disabled aircraft removal action

The aircraft reported to the ATC and requested for passenger transportation and disabled aircraft removal. A few minutes later airport fire engine approached the aircraft and took the necessary measures. In the wake of the incident, the authorities concerned and airport emergency team arrived to the scene and removed the disabled aircraft from the runway. The passengers were transported to the airport terminal safe and sound.

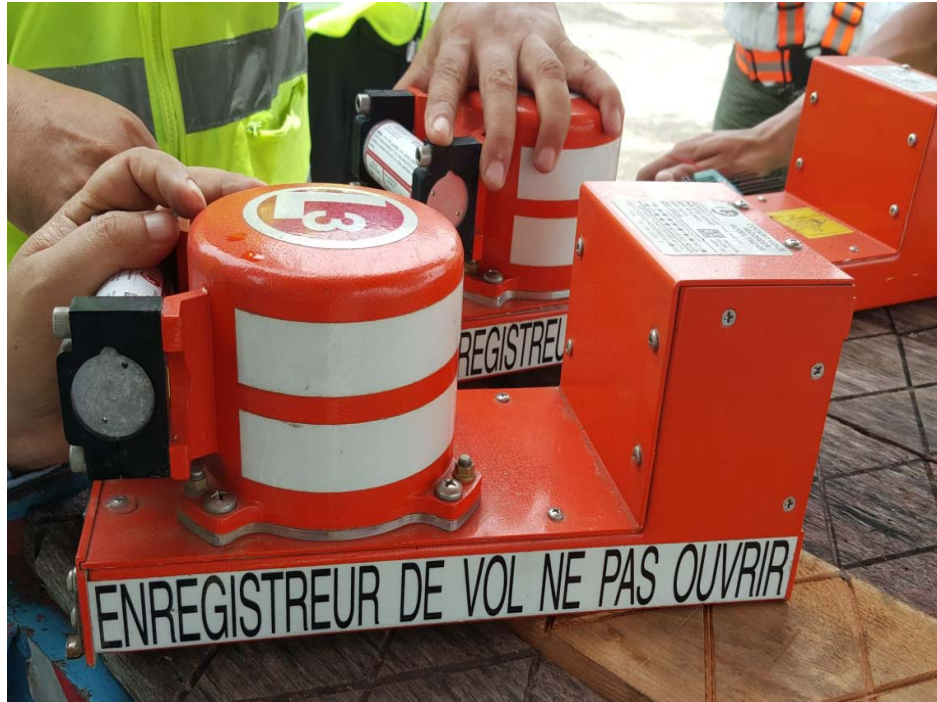
Figure (11) Cockpit Voice Recorder

Cockpit Voice Recorder (CVR), Part Number 2100-1020-02 and Serial Number 001026431.
