**FINAL REPORT ON TAIL STRIKE INVOLVING AN
AIRBUS A330-343 AIRCRAFT (REG: 9V-SSI) AT
YANGON INTERNATIONAL AIRPORT,
ON 25 NOVEMBER 2019**

**Aircraft Accident Investigation Bureau
Ministry of Transport and Communications
Myanmar**

9 November 2021

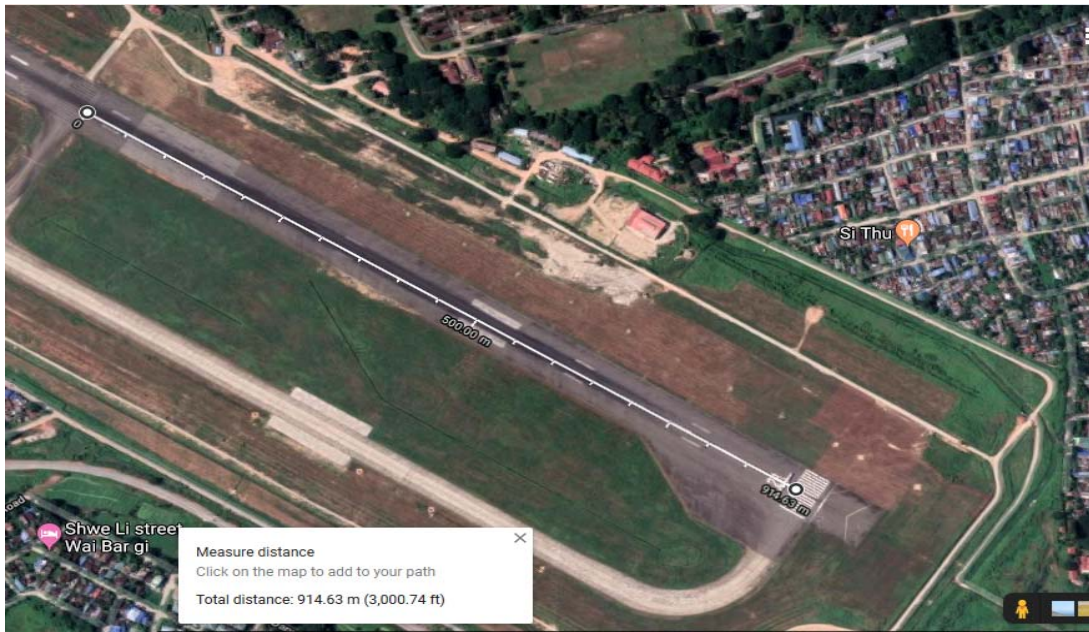
The thrust reversers for both engines were stowed at 09:08:52 and the nose gear made contact with the runway at 09:08:54. The aircraft turned off the runway at 09:09:33 and taxied to its parking bay. According to the flight crew, they were unaware that a tail strike had occurred and were only made aware when a ground maintenance personnel informed them that damage to the tail section was observed during the post flight check.

Figure (1) Layout of the Site

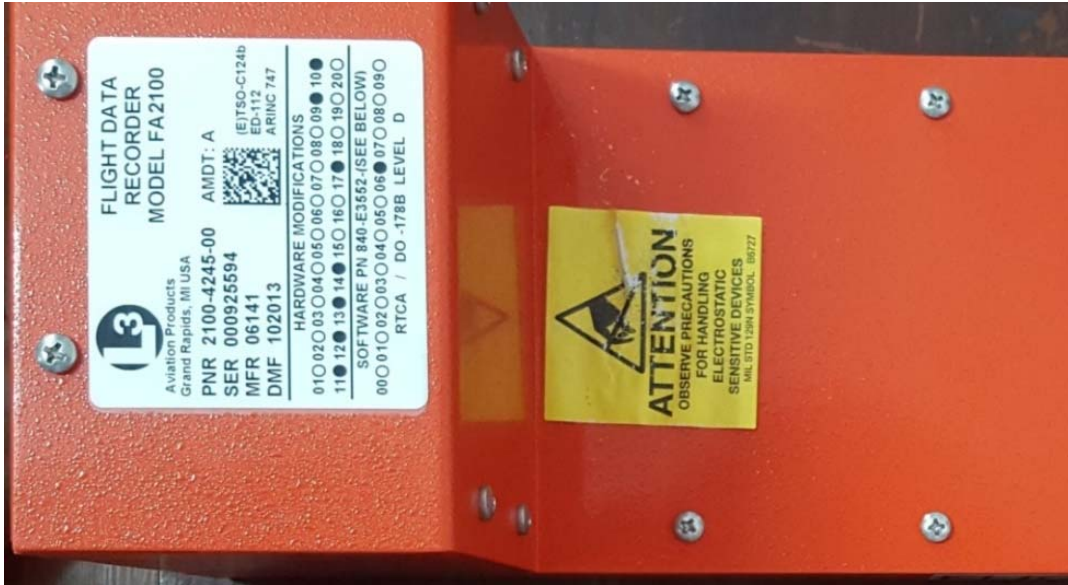
The recording of the FDR data was of good quality. The FDR contained 109 hours and 55 minutes and 58 seconds of flight data that included recorded data of the incident flight. The FDR had 1131 parameters in the data frame file.

The recorded data contained information pertaining to the event flight. The information was useful for the investigation team to analyse the sequence of events related to the occurrence.

Figure (7) Flight Data Recorder

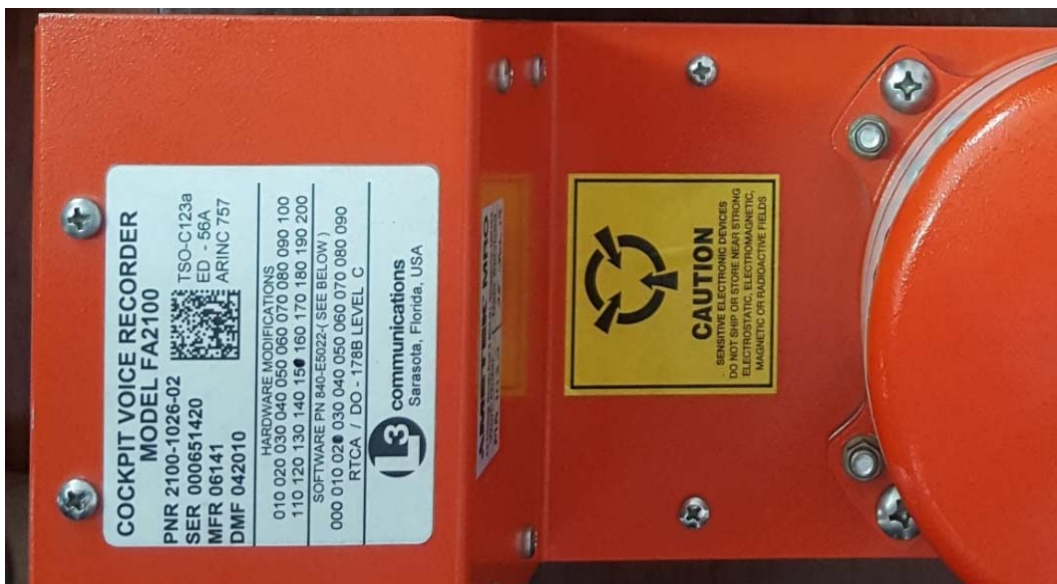
The Cockpit Voice Recorder (CVR) was of Part Number 2100-1026-02 and Serial Number 010651420. The recorded data contained information pertaining to the event flight which was useful for the investigation team to understand the communication among the flight crew members during the occurrence.

Figure (8) Cockpit Voice Recorder
