**FOKKER F-28 MK 0100, XY-AGC  
ACCIDENT NEAR HEHO AIRPORT (VYHH)  
ON 25 DECEMBER 2012**

**Executive Summary**

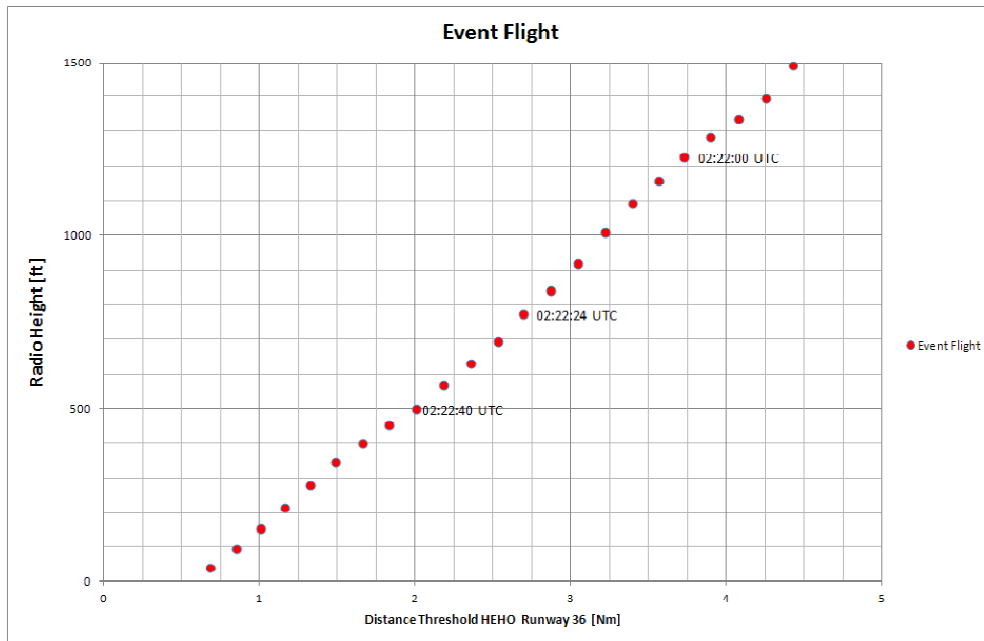
Figure 12: Distance Threshold Event Flight (*FMS latitude and longitude corrected*).

Runway 36 Threshold was determined to be used the recalculated positional data the range distance from the Threshold position was calculated with the Haversine formula.

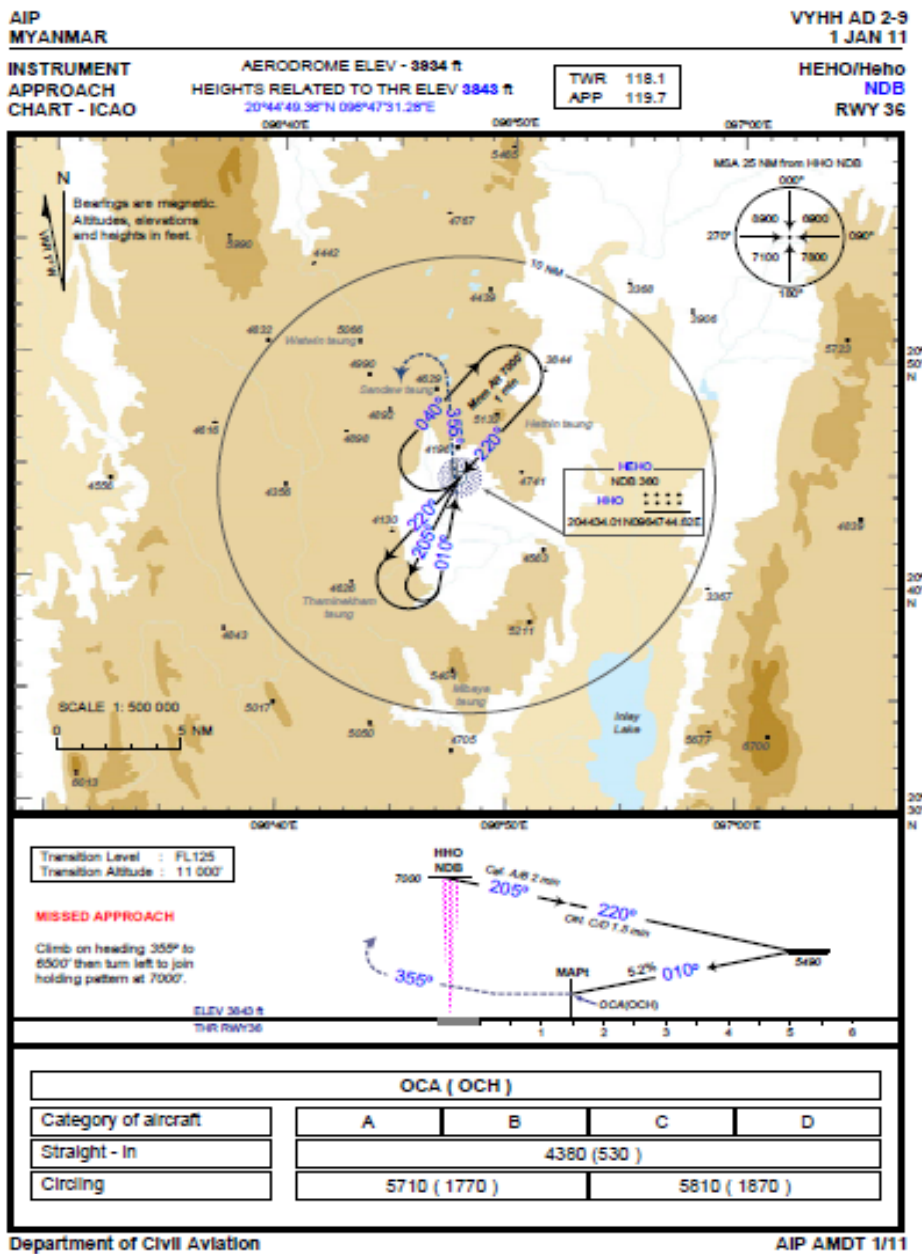
Figure 13: Instrument approach chart

Department of Civil Aviation published the Aeronautical Information Publication (AIP, Myanmar) date 1 Jan 2011 for Heho airport instrument approach chart.
