FINAL REPORT ON ACCIDENT TO  
HELI- UNION COMPANY LTD.  
HELICOPTER SIKORSKY S76 C++  
NEAR YETAGUN IN ANDAMAN SEA  
ON 11.07.2011

| 2. Aircraft type | : Helicopter SIKORSKY S76 C++ |
| 4. Registration | : F-HJCS |
| 6. Date & Time | : 11 July 2011 at 10 h 19 (local time) |

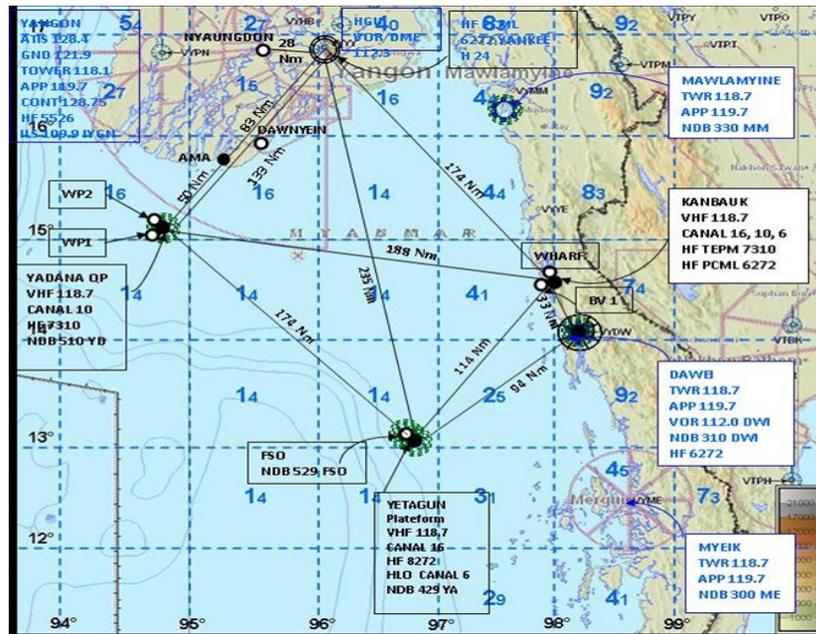
The helicopter ditched near the FSO, at approximately 50 meters. Then it drifted about 700 meters. The wreckage was located at 940 meters in the 328° direction from the last known position. No particular debris were found and the seafloor is flat.

The helicopter was put in a cargo net and was lifted out of water.

The airframe was in good general condition. The tail boom was damaged and partially separated from the cabin probably due to the contact with the sea surface and then with the seabed and increased by the recovery operations. The main gear box was severely damaged due to its housing corrosion. The main rotor head came off during the recovery operation.

All four main rotor blades were broken off from the rotor head and the remaining sections still attached were approximately 50 cm in length. The blades were not recovered.

The tail rotor blades were broken off from the tail rotor assembly and not recovered. The cabin and cockpit including instrument panel and controls were in good condition.

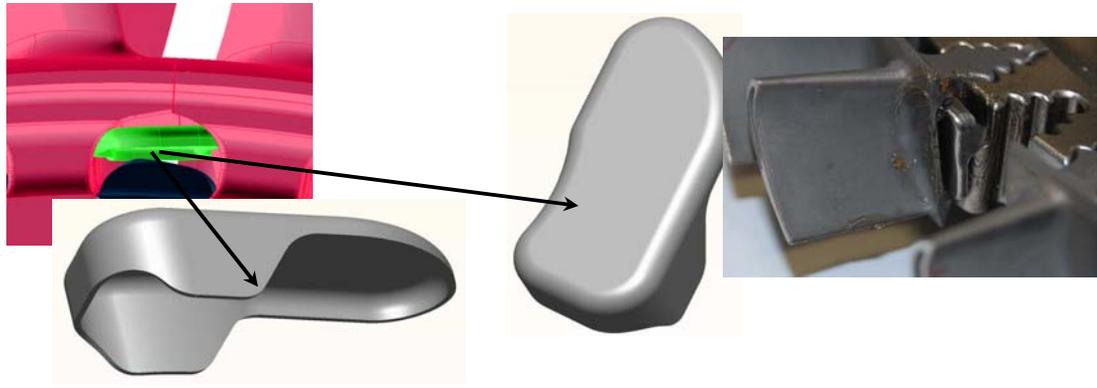
The engine #2 HP turbine wheel assembly was analysed. The examination identified the fatigue rupture of blade #6 below the platform. Damages to the other blades above the platform were consecutive to the rupture of this blade.

Turbomeca has identified blades failure phenomenon on the Arriel HP turbine since 2007.

On Arriel 2S2 engines, 7 cases of HP broken blades and 18 cases of cracked HP blades have been listed between February 2007 and December 2011.

The probable scenario of the blades' failure is a rupture excitation of one of the vibration modes of the HP blade in conjunction with several secondary contributing factors deemed sufficient to reduce the stress margin of the HP blade to a level consistent with the occurrences of ruptures encountered.

The F-HJCS had not been retrofitted with TU166.

It consists of adding a damper in the inter-blade area under the platform and reinforcing inspections on new and repaired HP turbine wheels.

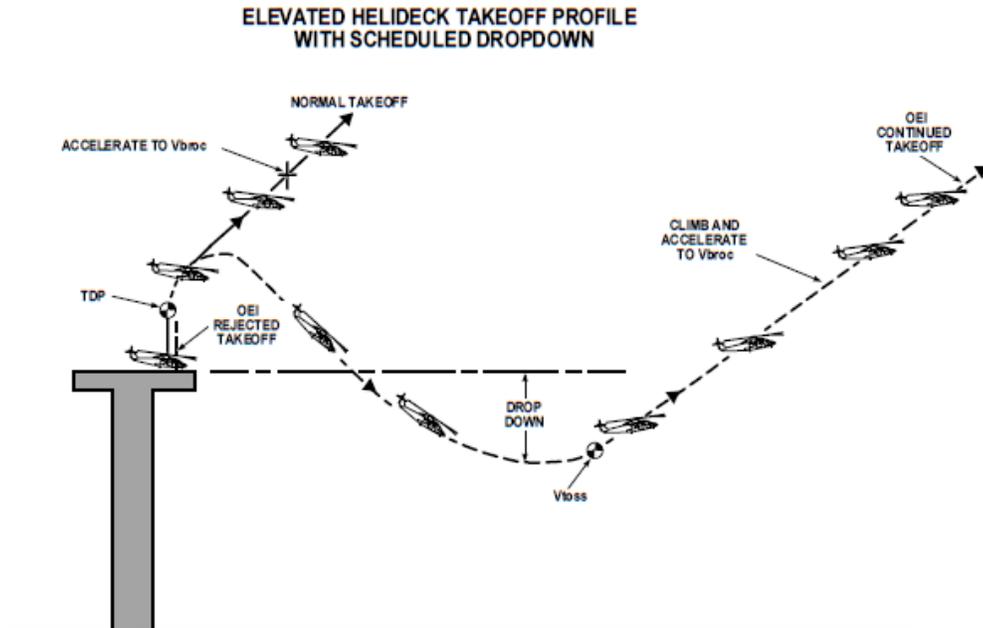
The procedure for an engine failure during take off on elevated helideck describes that: *“the procedure to follow after an engine failure during a vertical take off depends on where in the take off sequence the failure occurs. If the engine fails before the TDP, the take off is rejected and the aircraft is landed on the helideck. The TDP is 30 ft above the take off surface. If the failure occurs after the TDP, the take off will be continued.”* Cf [appendix J](#) (S76C++ Flight Manual, Part 2. section IV, supplemental, performance Data page 4-59)

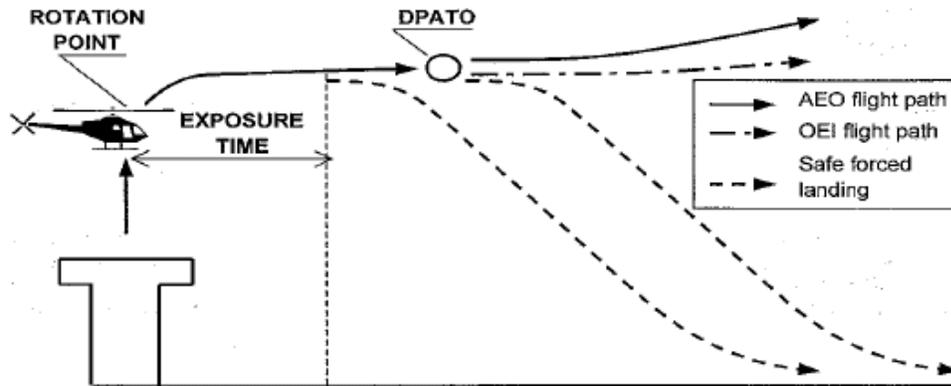
The Interpretation Explanatory Material/IEM OPS 3.520 prescribes that: “in two cases of take off and landing, exposure time is used. During the exposure time (which is only approved for use when complying with Jar OPS 3.517(a), the probability of a power unit failure is regarded as extremely remote. If a power unit failure (engine failure) occurs during the exposure time a safe force landing may not be possible”. Cf [appendix H](#) (JAR, OPS-3, sect-2, subpart H, page 2-H-19)

For Take Off – Non – Hostile Environment without an approval to operate with an exposure time, if an engine failure occurs, procedures are described enabling a safe landing or a safe forced landing whatever the phases of take off.

It prescribes also for “Take Off – Non-Hostile Environment with exposure time”: *If an engine failure occurs after the exposure time and before DPATO, compliance with 3.520(a)(3) will enable a safe force landing on the surface. At or after the DPATO, the OEI flight path should clear all obstacles by the margins specified in OPS3.525.* There are no procedures described for engine failure before the end of exposure time.

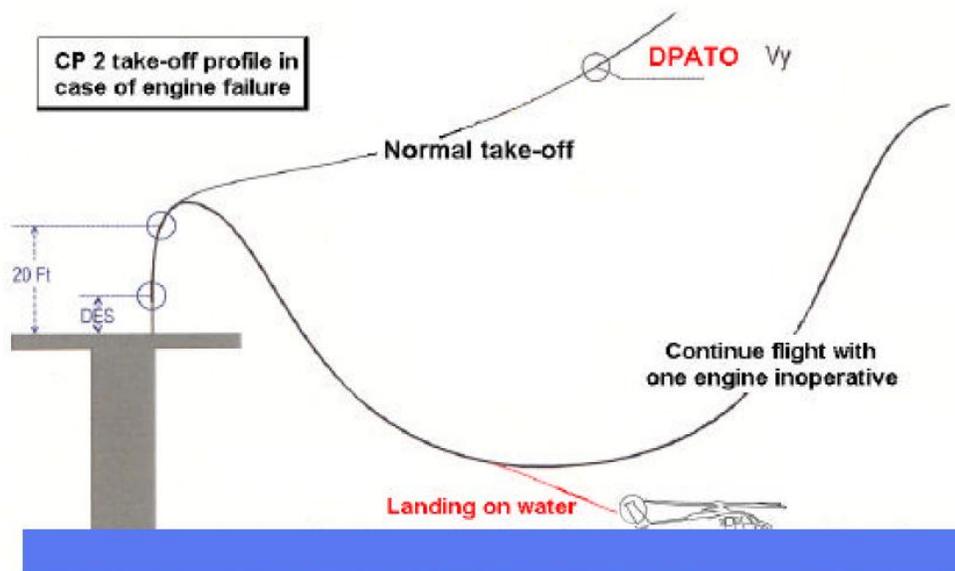
The procedure of an engine failure during take off on a platform over water helideck describes that in case of a failure during or after cyclic input the pilot must set a nose down attitude of approximately  $22^\circ$  in order to avoid any contact between the rear of the helicopter and the edge of the platform. Cf [appendix K](#) (S76C++ operation Manual, part B, sect 2.1, page-27)
