**FINAL REPORT**  
**MA-60, XY-AIP, RUNWAY EXCURSION**  
**ACCIDENT KAWTHAUNG AIRPORT (VYKT)**  
**ON 10 JUNE 2013**

**Executive Summary**

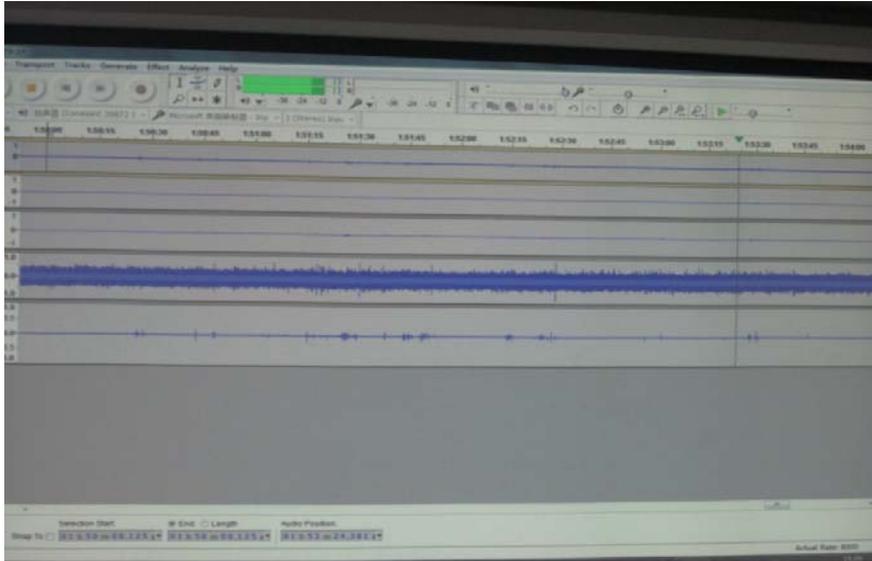
Figure (9). Cockpit Voice Recorder Downloaded

The aircraft was equipped with a Honeywell solid state cockpit voice recorder part No-980-6022-001 (S/N-CVR 120 -12183). The CVR was recovery at accident site. It appearance was intact, no mark of mechanical impact or stretch, neither deformation nor damage and successfully downloaded. CVR information recorded (1-5) channels, (1-3) channels have about 30 min audio files respectively and (4-5) channels are mixed channels (area microphone channels) which hole recording of 2 hours and 5 min for each. **(CVR transcript, Appendix-C)**
