Aircraft Accident Investigation Bureau of Myanmar

**FINAL REPORT OF ACCIDENT OF A COLLISION WITH TERRAIN
INVOLVING BIMAN BANGLADESH AIRLINES AIRCRAFT
BOMBARDIER DHC-8-402, REGISTERED S2-AGQ AT YANGON
INTERNATIONAL AIRPORT, MYANMAR ON 8 MAY, 2019**

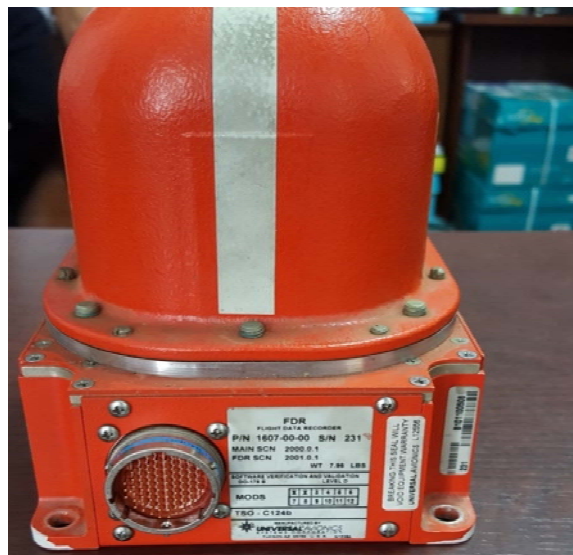
Figure (17) Flight Data Recorder

Approximately 533 hours of data was recorded on the solid state flight data recorder (FDR). The FDR was a Universal Avionics FDR-25, Part Number 1607-00-00 and Serial Number 231.

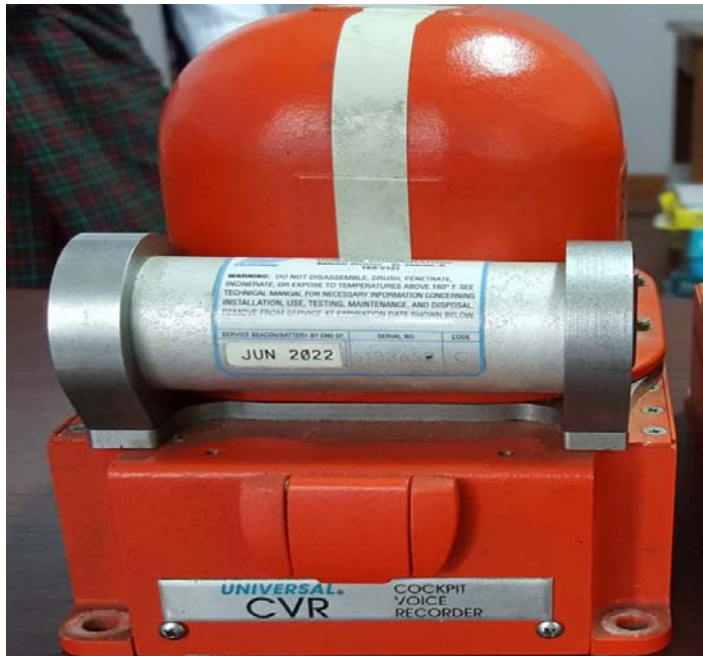
Figure (18) Cockpit Voice Recorder

2 hrs 2min 39 sec of audio was recorded on the cockpit voice recorder (CVR). The CVR was a Universal Avionics CVR-120A model , Part Number 1606-00-01 and Serial Number 461.
